# Collingwood Terminals Engineering Condition Assessment

1 Heritage Drive  
Collingwood, Ontario

Project: TE-29622-17  
June 2018

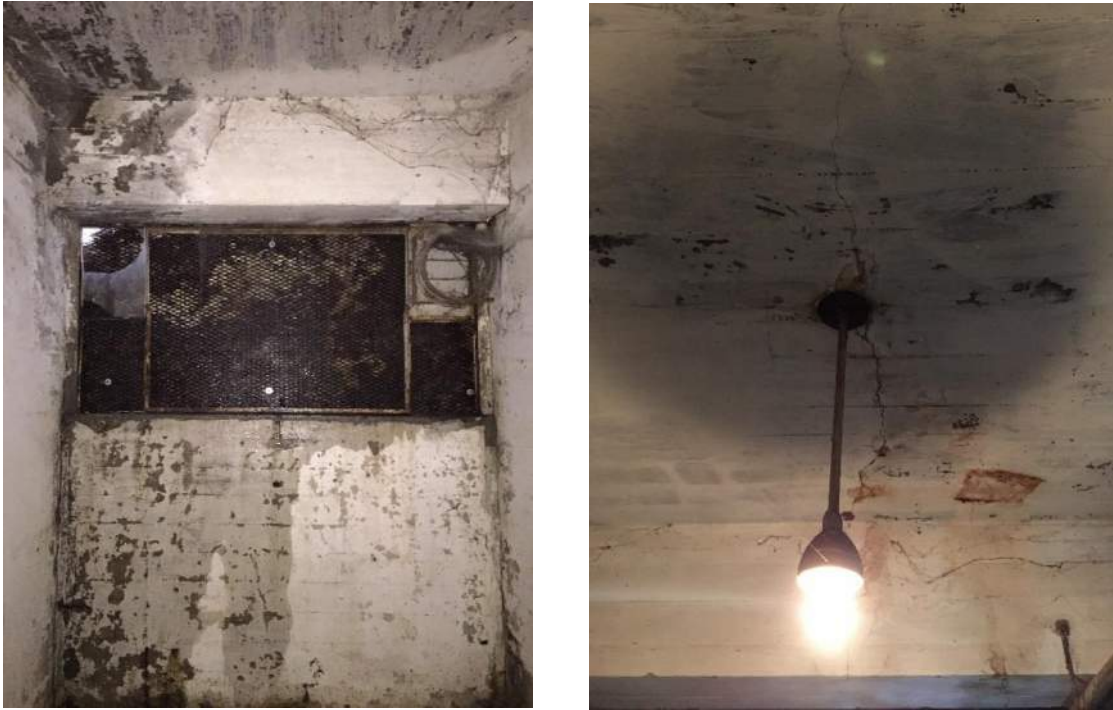
The perimeter concrete foundation walls were found to be in fair condition. In many locations, chronic leakage has resulted in deterioration of the concrete foundation wall. This leakage is generally related to improper exterior grading and a lack of waterproofing.

The suspended concrete slab forming the ceiling of the basement level was also in fair condition. In many areas, concrete delamination, cracking and spalling was identified.

**Figure 7 a, b: Perimeter wall and ceiling concrete leak and deterioration**

The ongoing water infiltration through the perimeter foundation walls and ceiling slab are of concern. Chronic water infiltration will lead to corrosion of the embedded reinforcing steel and deterioration of the concrete matrix. The source of water for the foundation walls is the area immediately exterior of the walls while the source of the water leaking through the ceiling slab is from the upper level roofs.

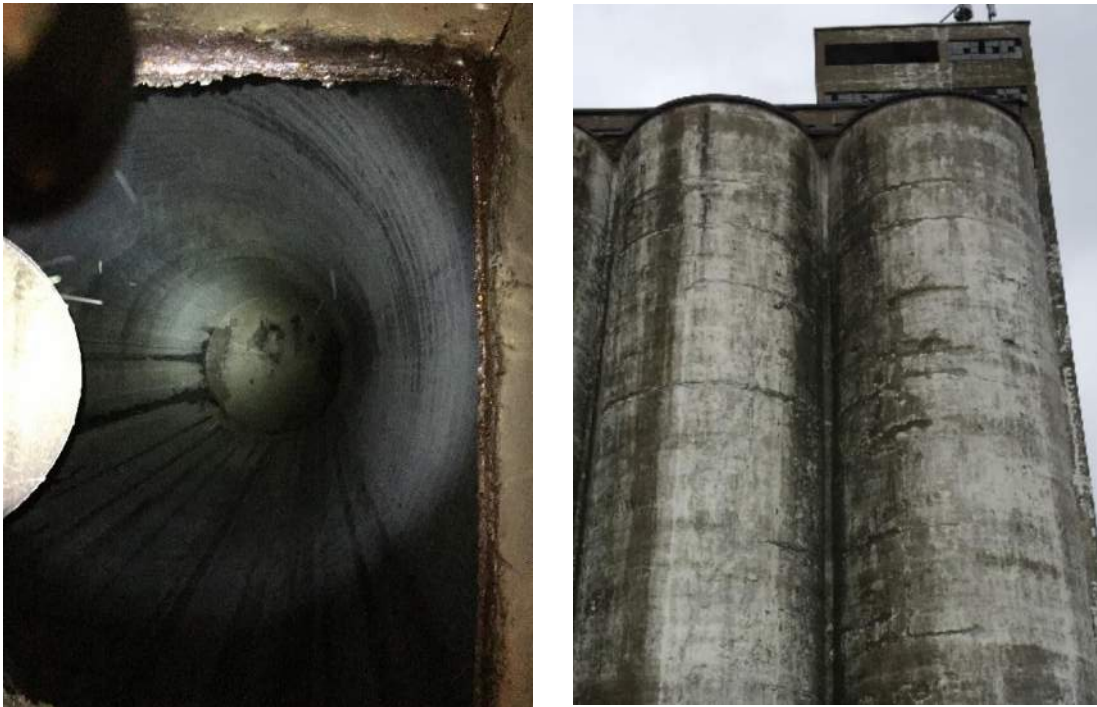
At a macro scale, the concrete silos walls were found to be in good condition with no evidence of structurally significant damage, distress or deterioration. From the interior, our review identified only isolated areas of concrete degradation due to long term contact with stored materials. From the exterior, numerous vertical and horizontal cracks were identified as well as localized concrete spalling.

**Figure 8 a, b: Interior and exterior of typical concrete silo**

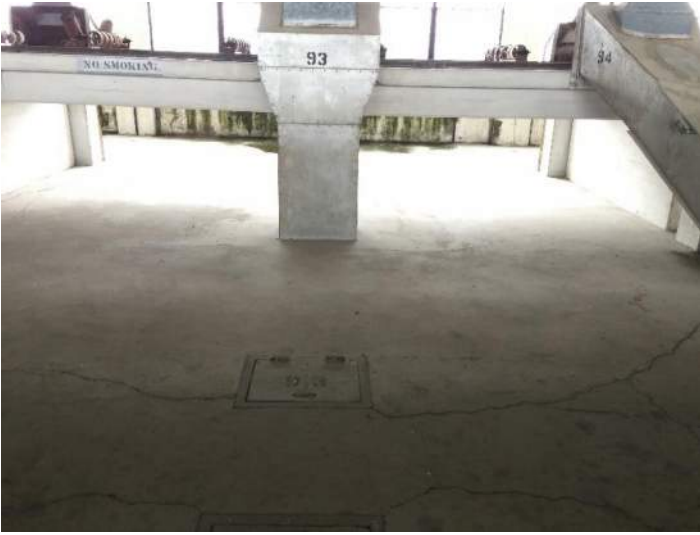
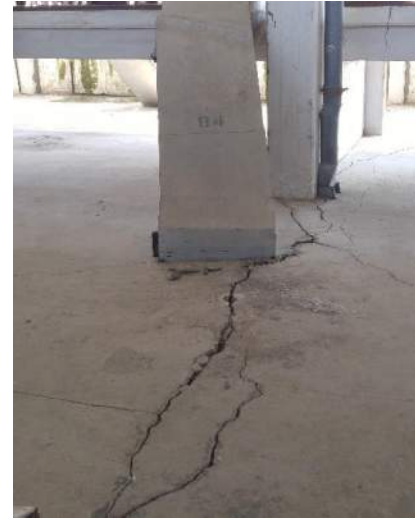
From the interior, significant floor cracks telegraphing the supporting structure were identified. Our survey indicated, that many of these concrete slabs had deflected more than 1” across the width of the silo below. To verify the as-built conditions, Tacoma Engineers retained a concrete testing firm and a concrete scanning firm to assist with material testing. The testing confirmed the slab thickness varies from 7”-10” and includes a concrete topping in localized areas, determined the concrete strength and placement of reinforcing steel. The review also confirmed structurally significant deterioration of the silo concrete slabs. From the underside, approximately half of the slabs had considerable leakage evident and over a quarter of the slabs had evidence of concrete delamination associated with corrosion of the embedded reinforcing steel. In many of these locations, large areas of exposed reinforcing steel were identified.

**Figure 9 a, b: Silo Top Slab Cracking**

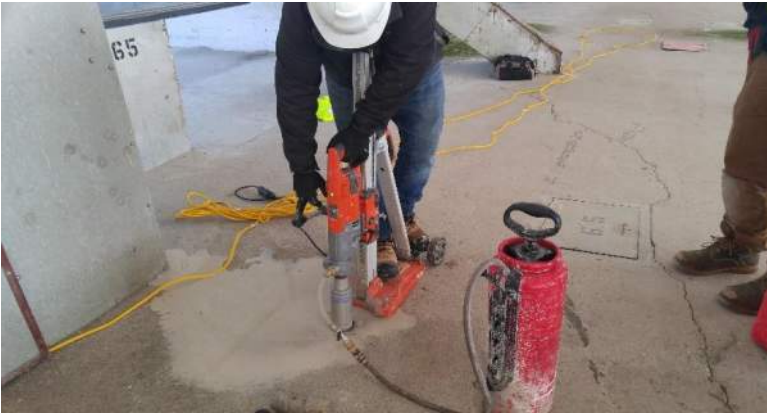
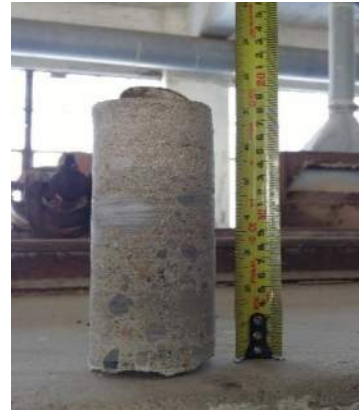
**Figure 10 a, b: Slab Investigation (coring and scanning)**

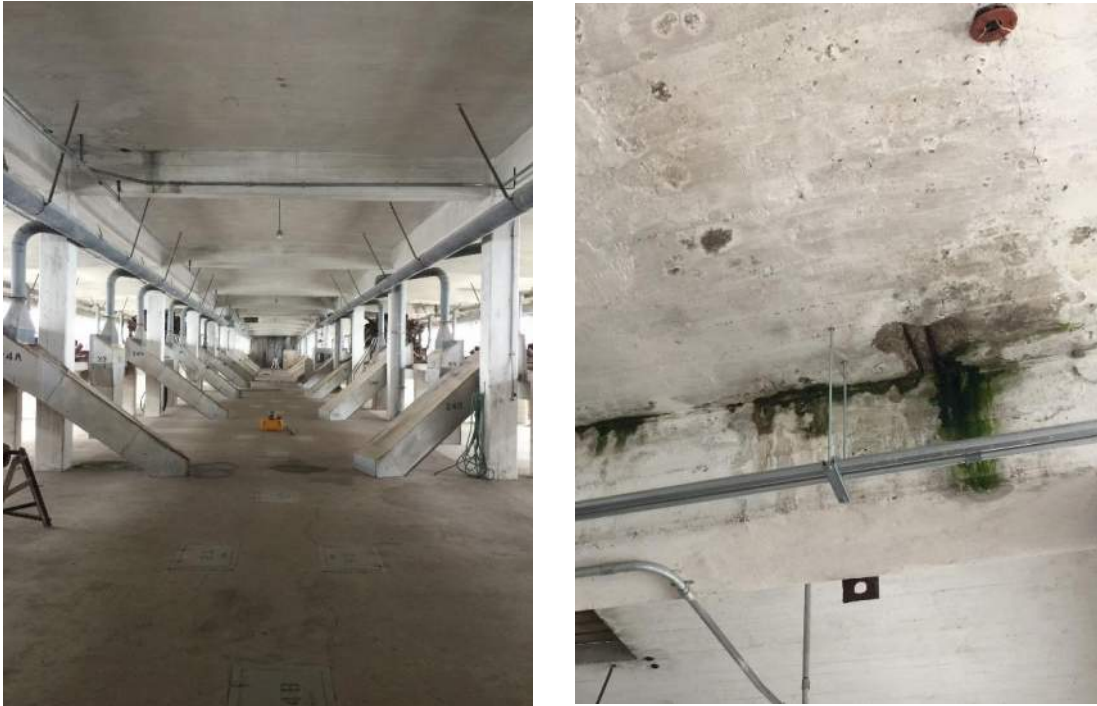
The bin floor structure was found to be good condition except for the perimeter walls which were in fair to poor condition. The principal structure (columns, beams and roof slab) did not present any structurally significant deterioration. In localized areas, chronic roof leakage (see comments in sections 7) has resulted in concrete spalling.

**Figure 11 a, b Bin floor structure and localized roof leakage**

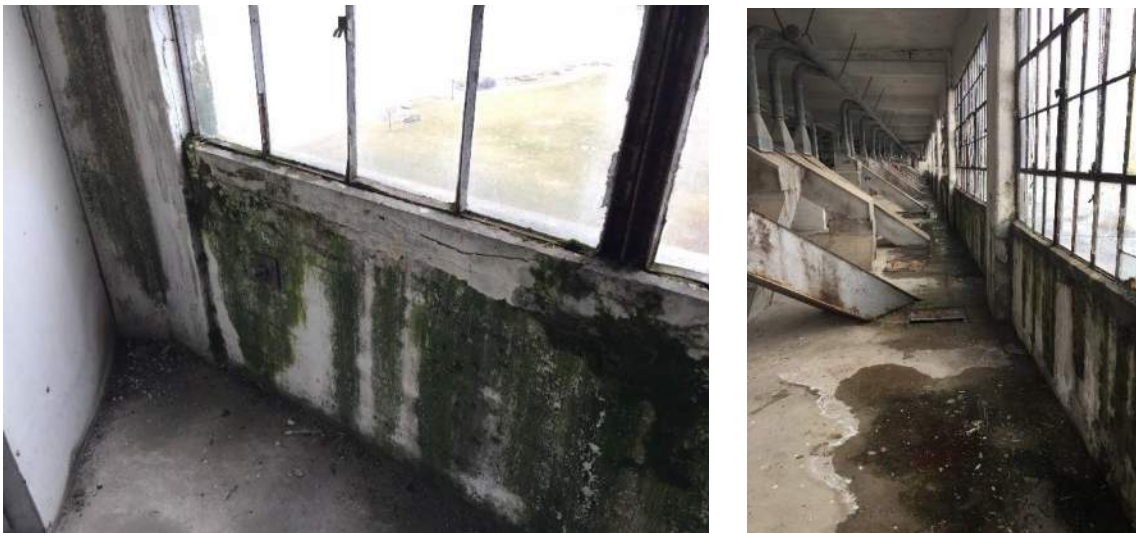
At the perimeter walls, significant water infiltration was identified which has resulted in deterioration of the concrete wall panels and adjacent concrete columns.

**Figure 12 a, b: Bin floor perimeter wall leakage and deterioration**

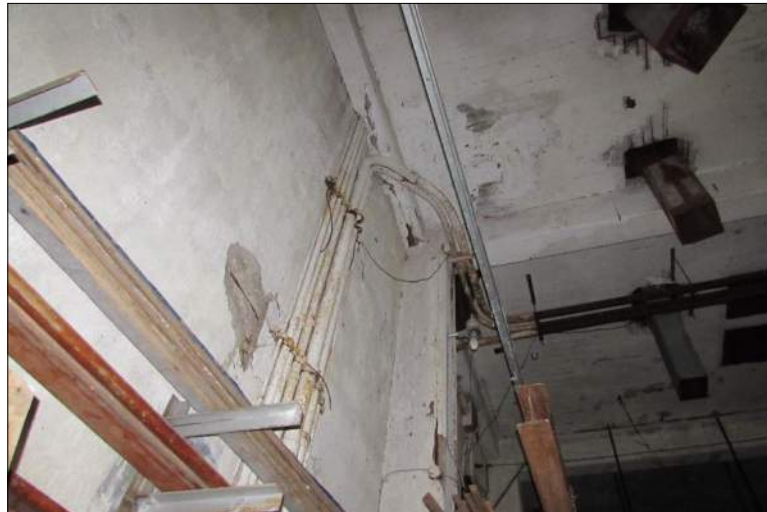
Localized spalling and cracking of the reinforced concrete wall of the Rail Shed (Storage) was observed up against the Storage Bins and within the two-storey Electrical Substation area.

**Figure 13: Spalling of Reinforced Concrete Wall Adjacent Storage Bins**

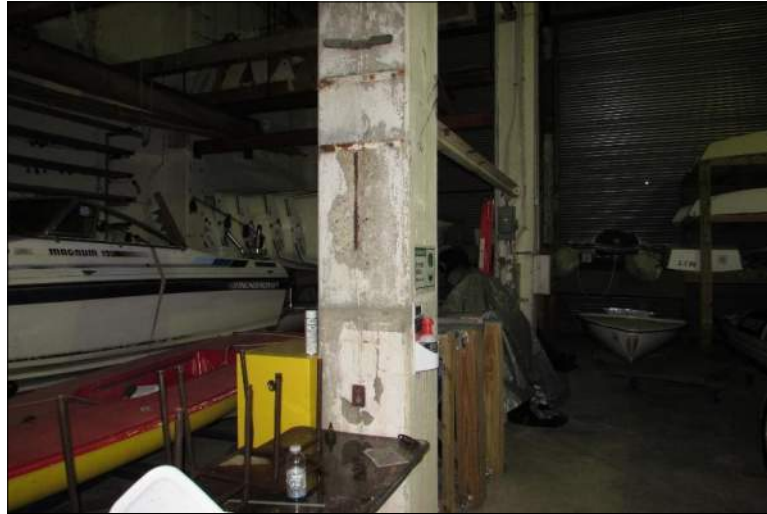
**Figure 14: Spalling Observed at Interior Concrete Column in Rail Shed**

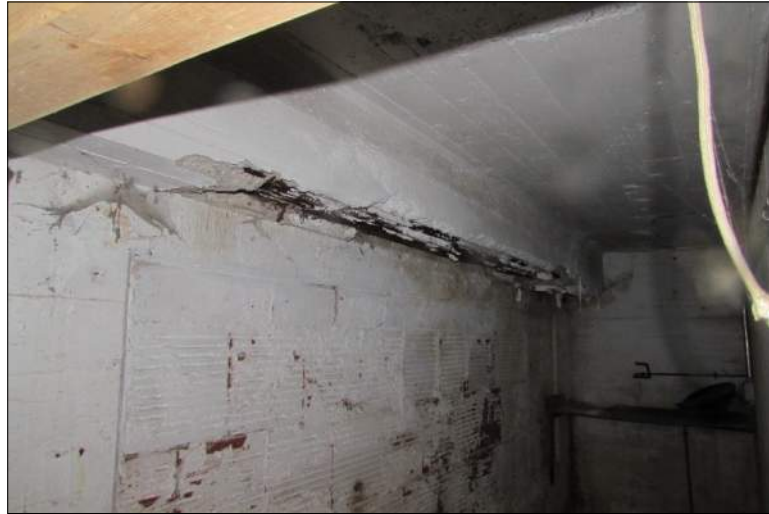
The conditions of the reinforced concrete beams and slabs in the basement was poor. Wide cracking, severe spalling and evidence of reinforcement corrosion was prevalent.

**Figure 15: Damaged Reinforced Concrete Beam in Basement (Shop) below Warehouse**

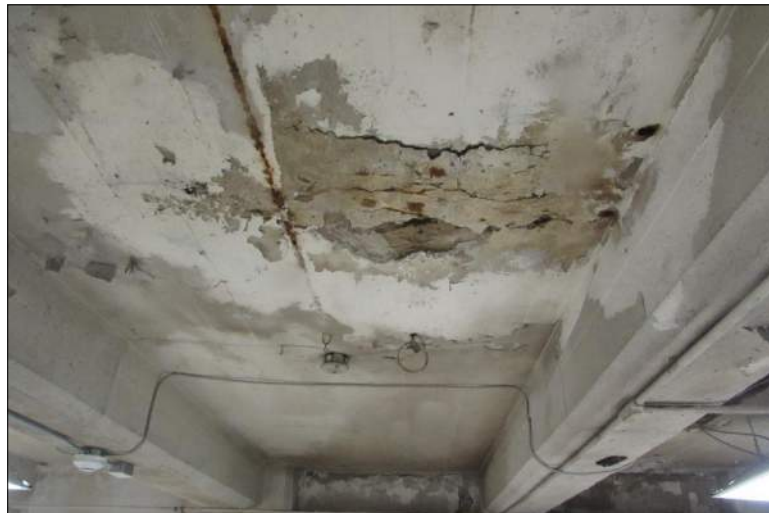
**Figure 16: Very Severe Deterioration of the Suspended Slab in Basement (Shop) below Warehouse**

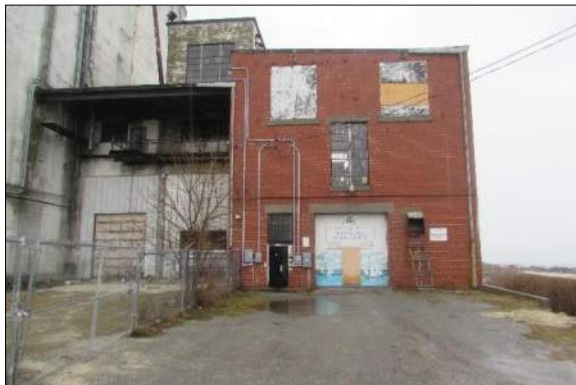
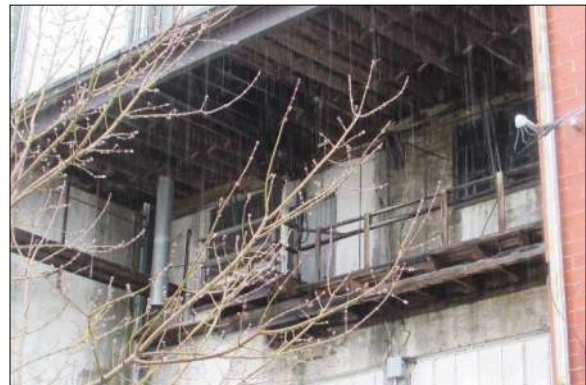
The wood platform on the south side of the building was in poor condition. Access to the platform from the second floor was restricted at the time of our review.

**Figure 17a, b: Suspended Exterior Platform (Outside Second Floor of Bagging Room)**

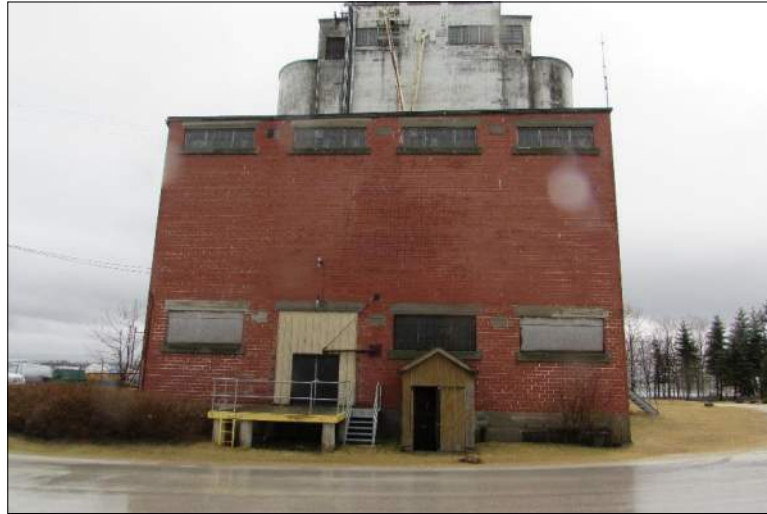
The reinforced concrete shipping platform on the north side of the building was in good condition.

**Figure 18: Exterior Shipping Platform**

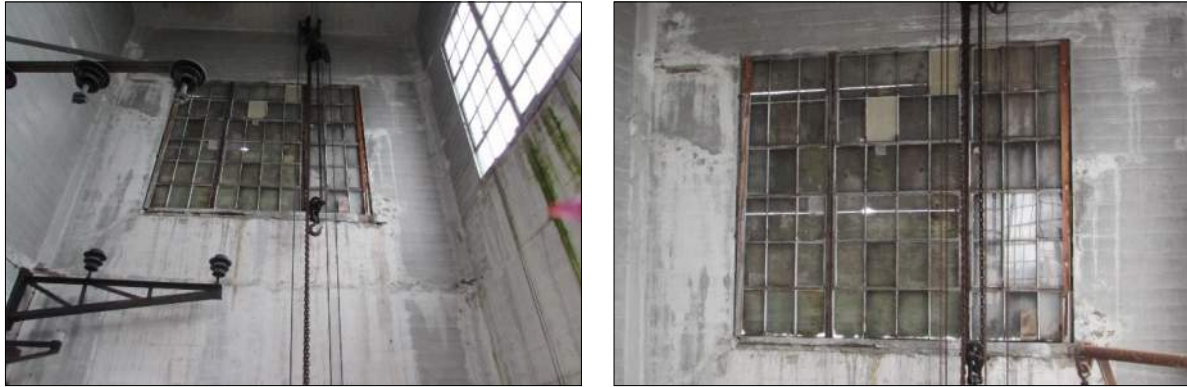
Wire ties had been added in several locations to fasten the steel window muntins to the reinforced concrete sills. Several of the window panes throughout the facility had been replaced. Replacement panes of glass were held in place with silicon.

Widespread organic growth was observed below several of the windows throughout the facility.

**Figure 19a, b: Window at East End of Electrical Substation**

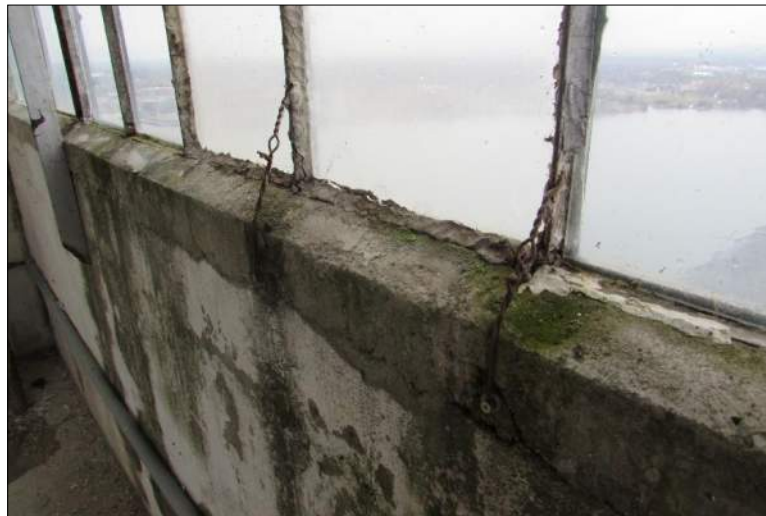
**Figure 20: Multiple Repairs at Window Sill in Shipping Tower**

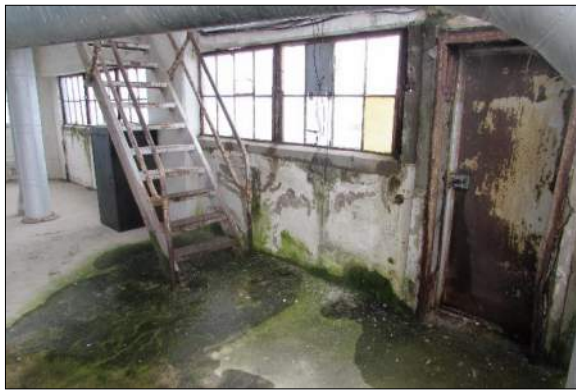
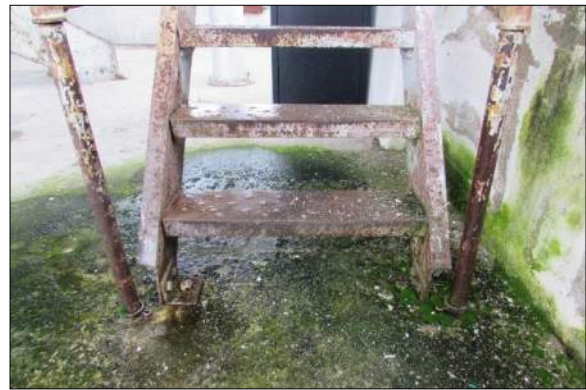
The majority of the interior stairs were in fair condition. Light corrosion was observed. In a few locations stairs and stair guards were noted to be in poor condition. The most significant deterioration was observed at the base of mezzanine stair at Shipping Tower Floor 4. Medium Corrosion was observed at this location. In other locations where poor conditions were observed, the stair guards had been damaged or were missing railings.

**Figure 21a, b: Steel Stair to Shipping Tower Mezzanine in Poor Condition (Floor 4)**

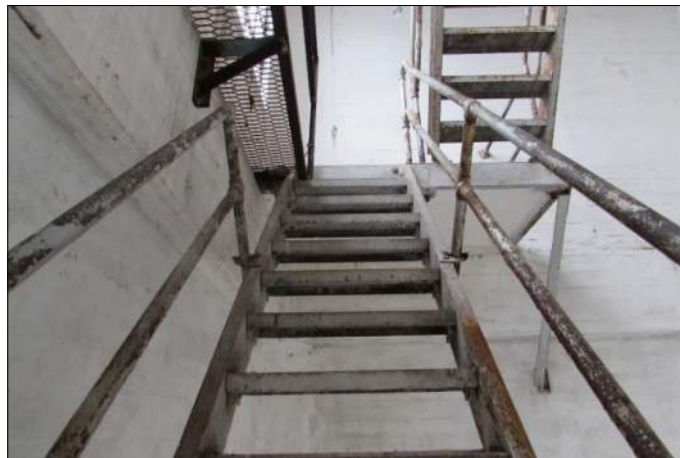
**Figure 22: Missing Guard Railing at Floor 3 Mid-Landing of Shipping Tower**

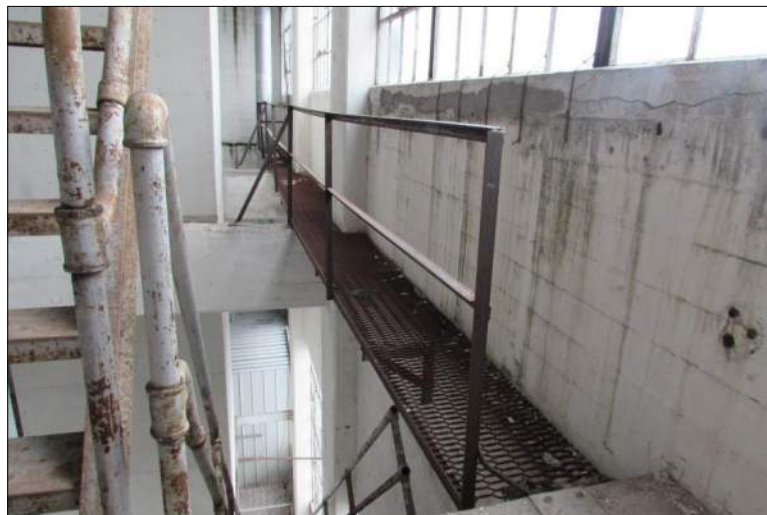
Figure 23: Service Platform from Floor 3 Mid-Landing of Shipping Tower

In general, the platforms were in poor condition. Open steel grating had deteriorated resulting in concerns about the adequacy to support a person. The anchorage to the building was also a concern. Medium corrosion of the steel framing and anchorage points was noted. Guards around service platforms were found to be in poor condition.

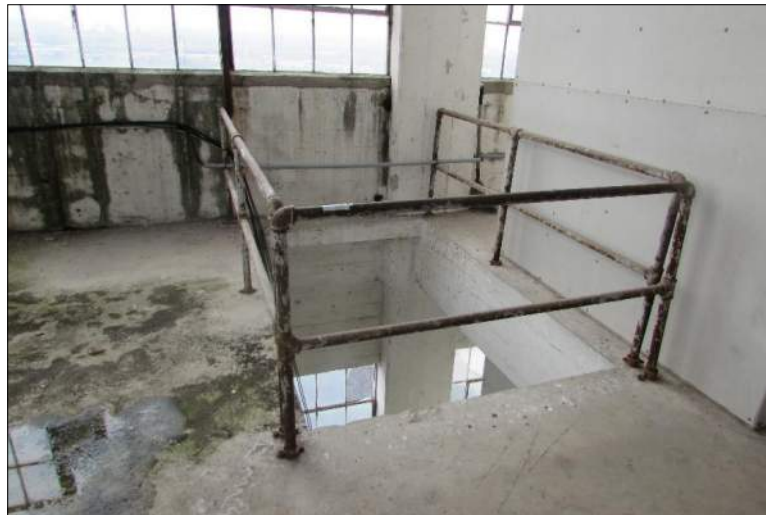
**Figure 24: Guard Around Floor Opening in Shipping Tower**

Guards were found to be in generally good condition. As previously noted, missing railing elements were observed at a few of the interior steel stairs in the Shipping Tower.

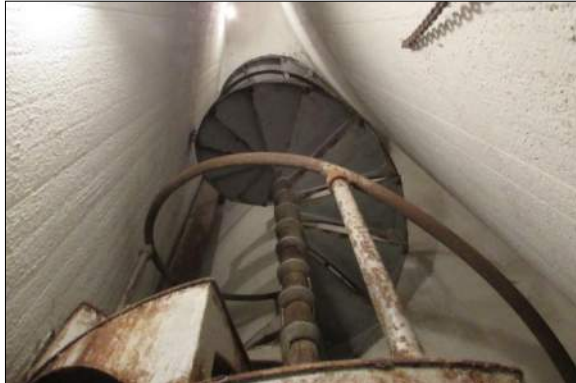
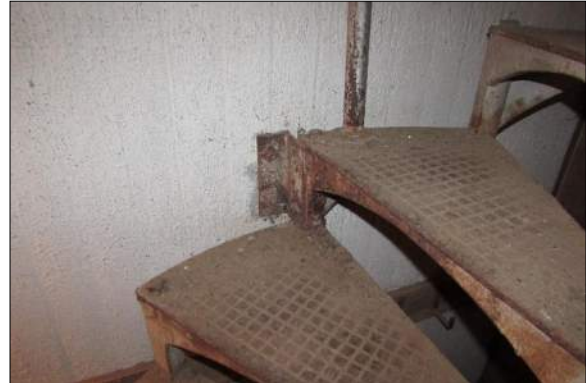
**Figure 25a, b: Spiral Stair in Star Bin between Rail Shed and Storage Bins**

The main stair was in good condition. The smaller stair was in fair condition. The connections for the smaller stair to the bin walls were noted to have medium corrosion. Lateral movement of the smaller spiral stair was noted when walking up the treads.

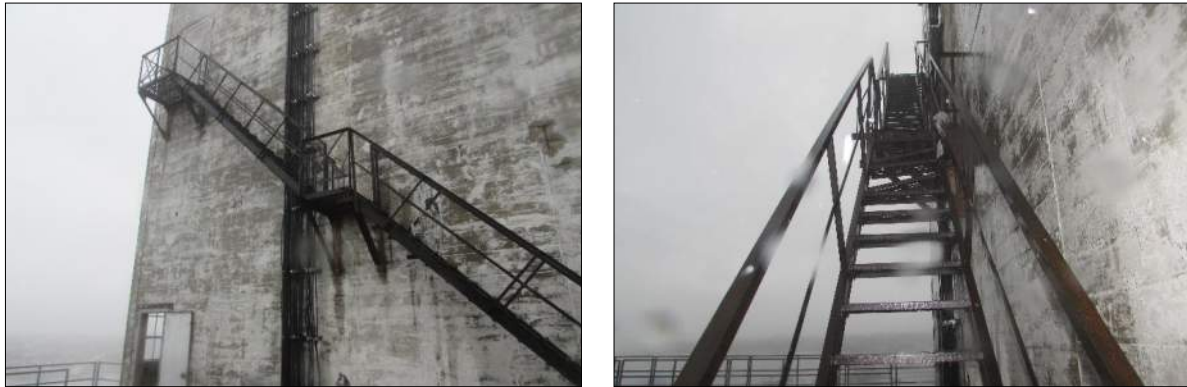
Figure 26a, b: Exterior Steel Stair Outside Marine Tower

Although it was difficult to review the conditions of the Marine and Shipping Tower exterior stair as access has been restricted. From grade, the stair appeared to be in fair to poor condition.

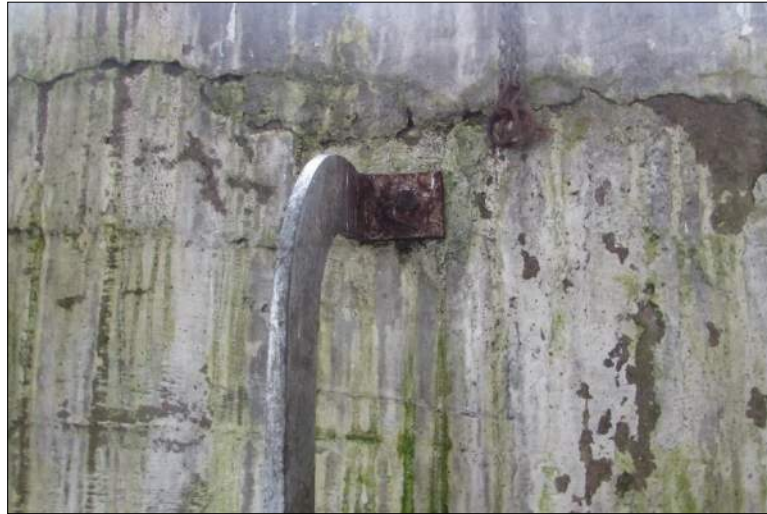
Anchorage of access ladder from Switchgear Room to Substation Mezzanine was in poor condition with moderate steel corrosion was observed.

**Figure 27: Corrosion of Substation Mezzanine Access Ladder Anchorage**

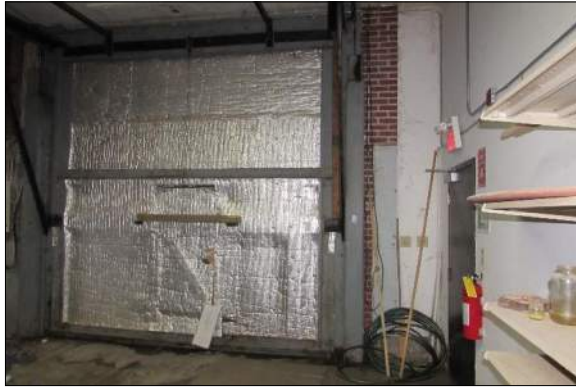
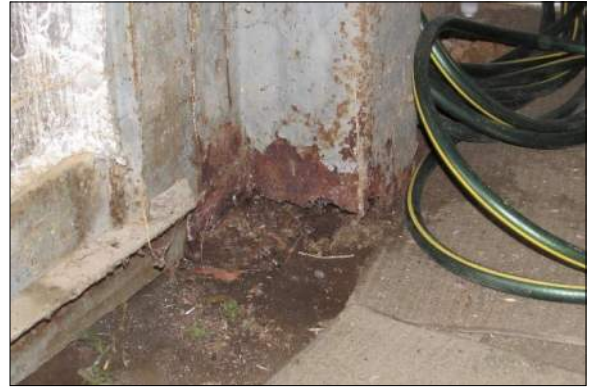
Many door frames were found to be in poor condition with severe corrosion was observed at the base of the hollow structural steel (HSS) columns.

Figure 28a, b: Corrosion of Steel Door Jambs in Warehouse (Shop)

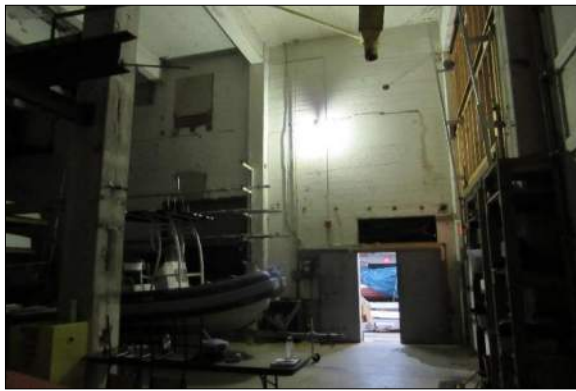
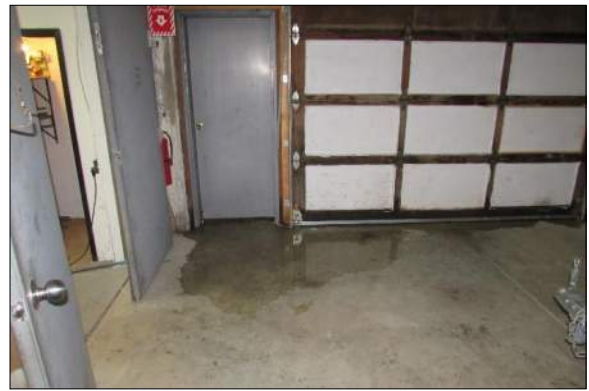
It was raining at the time of our structural assessment. Significant rain water infiltration below and around doors was identified. While not a structural concern itself, active water infiltration can eventually lead to structural issue if not mitigated.

Figure 29a, b: Water Infiltration Under Overhead Doors in Rail Shed (Storage)

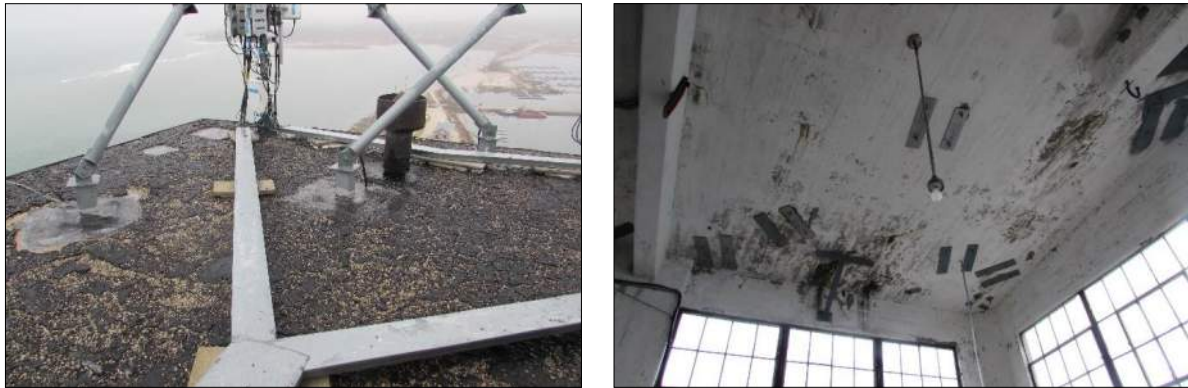
Figure 30a, b: Roof Top Equipment Anchorage in Shipping Tower

Active water infiltration at numerous roof top anchors was identified.

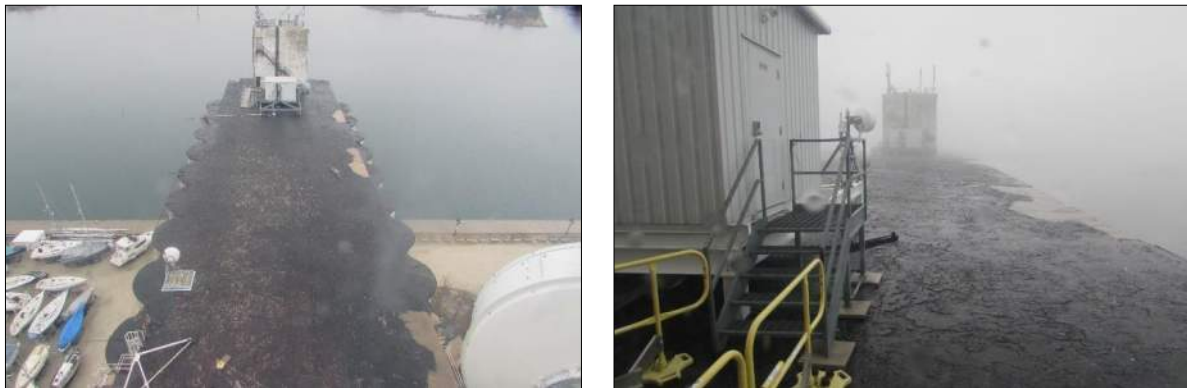
There is no effective fall arrest system installed on the roof of the Collingwood Terminal. Temporary guards have been provided to restrict travel on the roof and provide a delineated path of safe travel for service personnel.

**Figure 31a, b: Primary roof without fall arrest system**

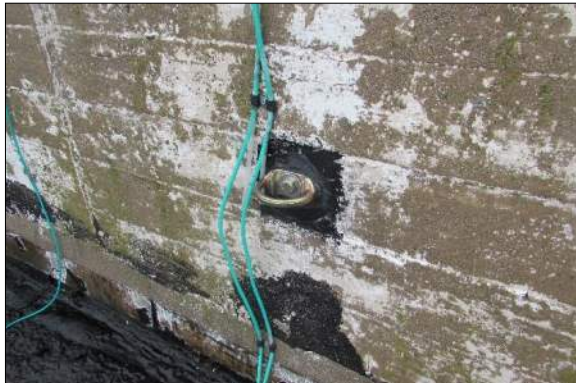
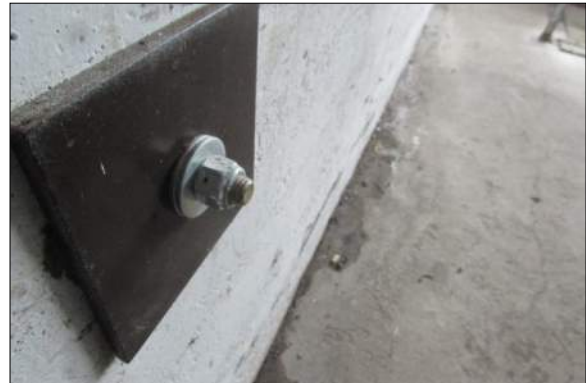
Figure 32a, b: Fall Arrest Anchor at Shipping Tower roof

While the anchor itself appeared to be in good condition and suitably located, there is no certified Roof Anchor drawing posted at the access to the roof level as required by OHSA. Without posted documentation about design of the fall arrest system, instructions for use and certified inspections, the fall arrest system should not be used.

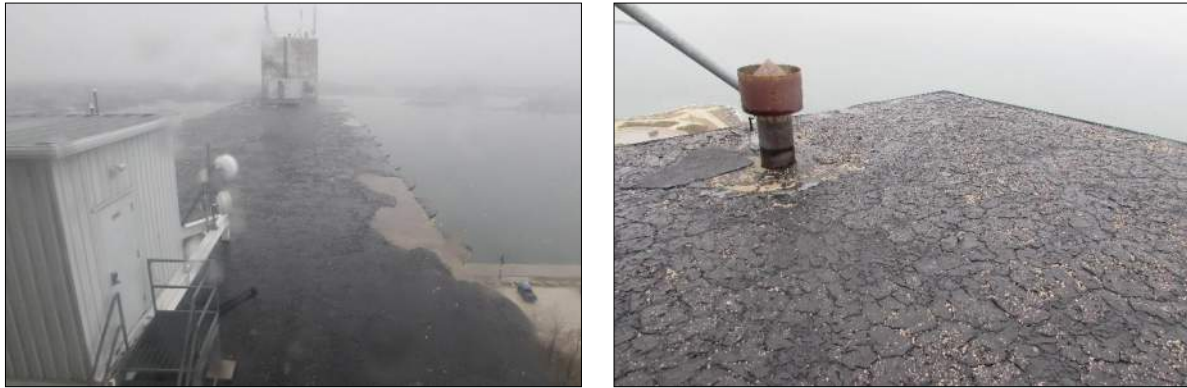
The tar roofs have exceeded their service life and can be deemed to have failed. Typically, the membrane has become brittle and extensive cracking was identified. In many locations, the membrane has completely delaminated from the concrete roof. Considerable concrete delamination was identified at areas of complete membrane failure.

Figure 33a, b: Upper roof membrane failure

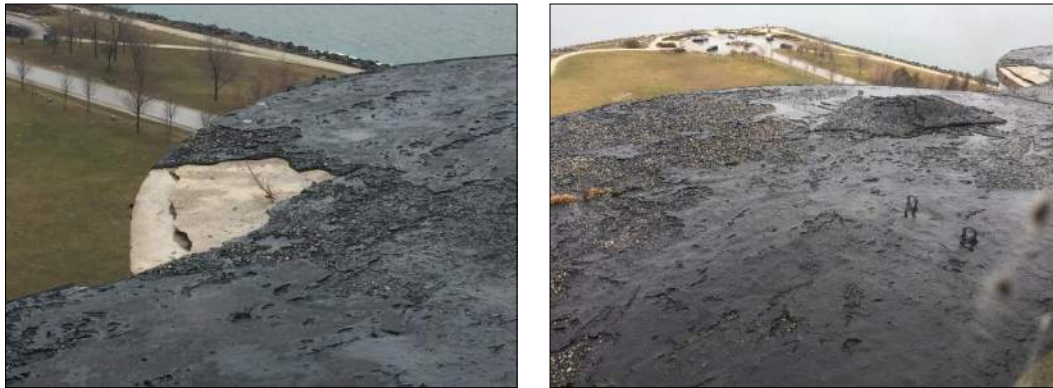
Figure 34a, b: Bin roof membrane failure

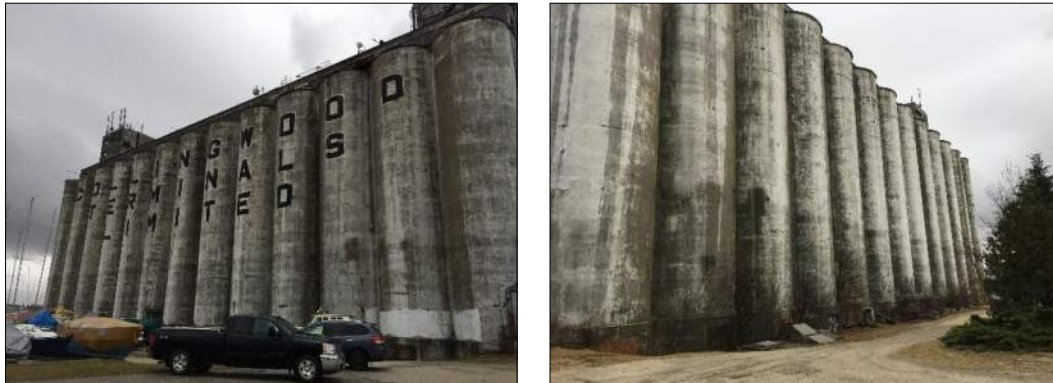
Figure 35a, b: South & North Elevations

In general, the existing coating has failed and no longer provides any effective protection for the concrete substrate. Similarly, the existing sealants have become brittle and have completely failed and no longer provide an effective weather tight enclosure.
