**RE: Shoreline Hazards Review  
Cranberry – Bear Estate, Collingwood  
Our file 07-1108**

We are pleased to present the findings of our shoreline hazards review for the Cranberry - Bear Estates property in Collingwood. We have considered the erosion, flooding and dynamic beach hazards at the site, as defined by MNR.

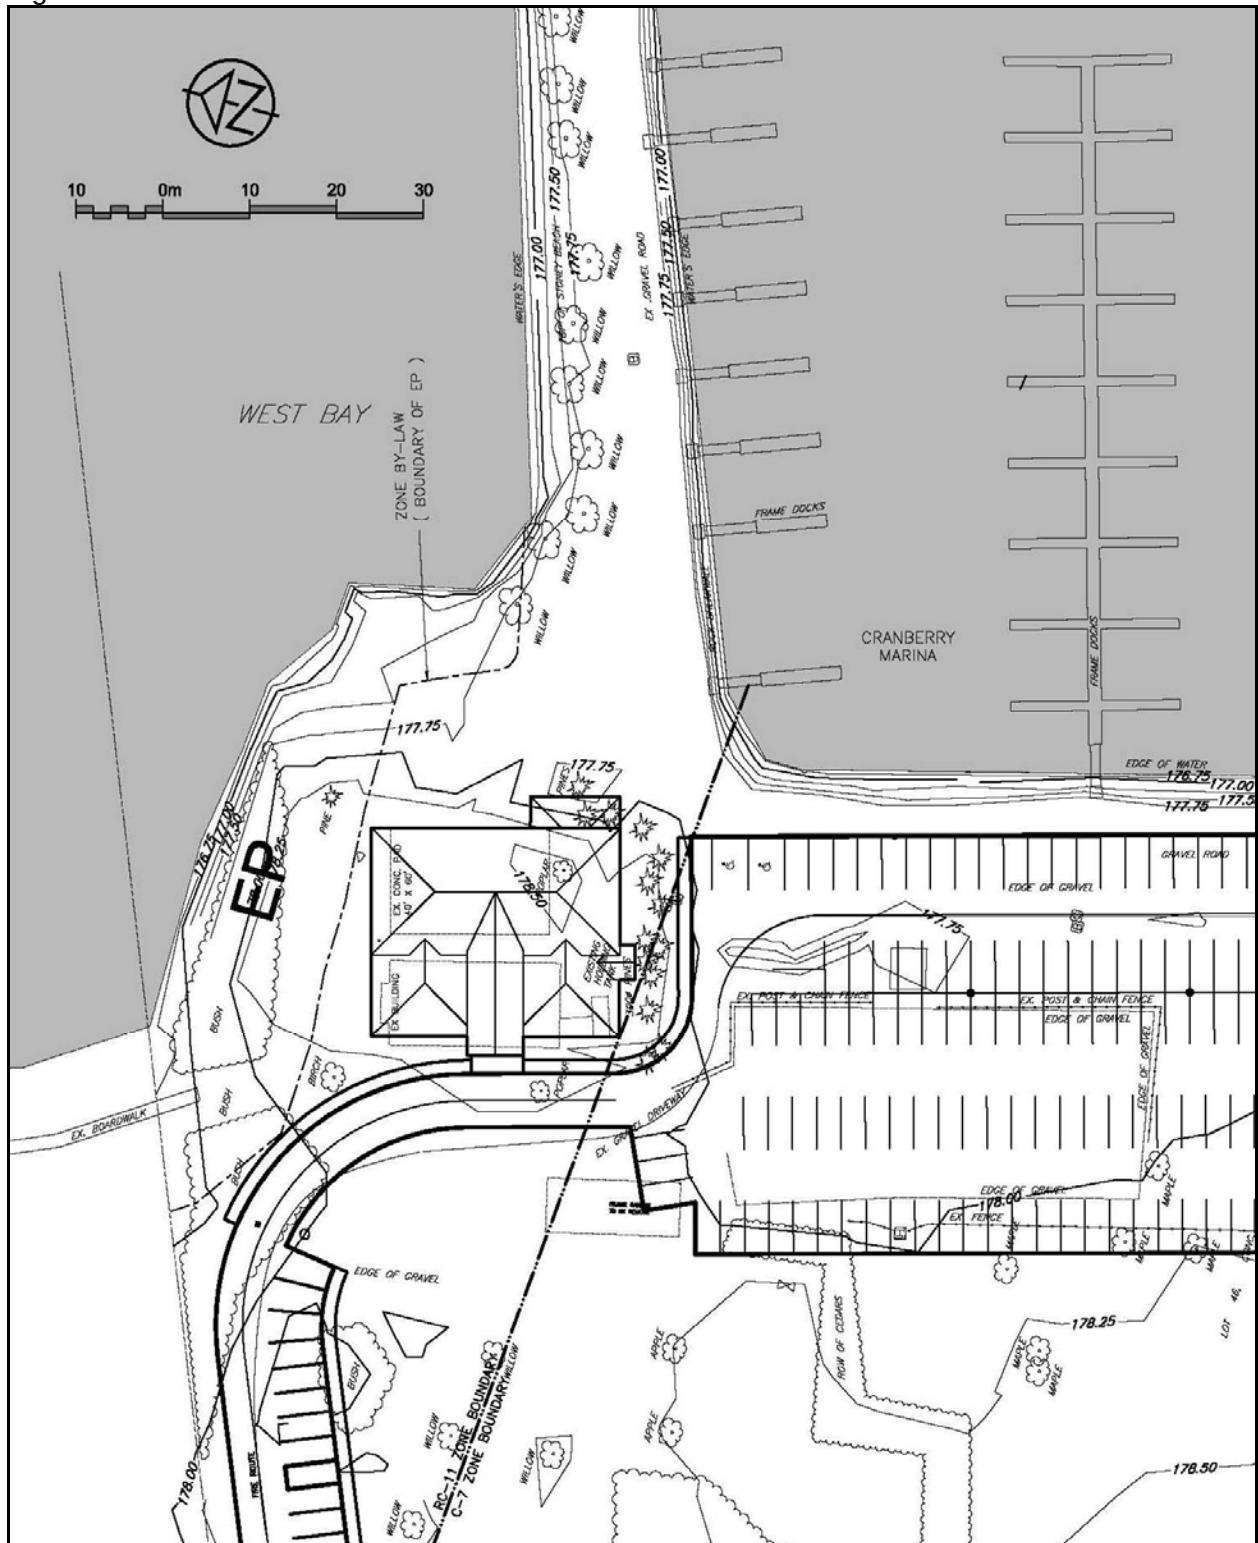
Figure 2 Site Plan

The planned development involves the construction of a banquet hall that will overlook the West Bay of Collingwood Harbour. Figure 1 is a location plan that shows the location of the site within the harbour. Figure 2 is a site plan which shows the location of the proposed building and existing contours. Photo 1 is a roughly westward looking view of the site of the proposed building. The location of the proposed new building with respect to the existing building can be seen in Figure 2. Photos 2 and 3 show more detailed views of the shoreline visible in Photo 1.

The crest elevation of the existing bank is approximately 177.5 metres. The land rises gently until it hits the base of a small "plateau" where it appears as if additional fill was placed to surround the location of the existing structure (and the proposed new structure). The top of the plateau is above elevation 178.25 metres.

We carried out a wave uprush analysis for a 0.4 metre wave using a profile derived from the site plan. Assuming a water level of 178.0 metres, the wave overtops the existing bank and breaks between the bank and the “plateau” described previously. The limit of wave uprush was determined to correspond with the front edge of the plateau. The limit of the flood hazard may therefore be defined by the 178.25m contour line on Figure 2. That places the proposed new structure at or outside the flood hazard limit.

Considering that the top of the plateau is relatively flat and the wave uprush limit just reaches the crest of the plateau, we recommend that the elevation of

the plateau be raised marginally during construction of the new banquet hall. That will provide an extra buffer against possible flooding. The land should also be graded to provide positive drainage away from the structure. A land elevation of 178.3 metres at the edge of the plateau with a grade of 2% or more up to the dwelling would suffice.

We also consider it prudent to not have any openings in the structure below an elevation of 178.3 metres unless those openings are specifically flood-proofed. That is 0.3 metres higher than the design 100-year instantaneous water level for a margin of safety.

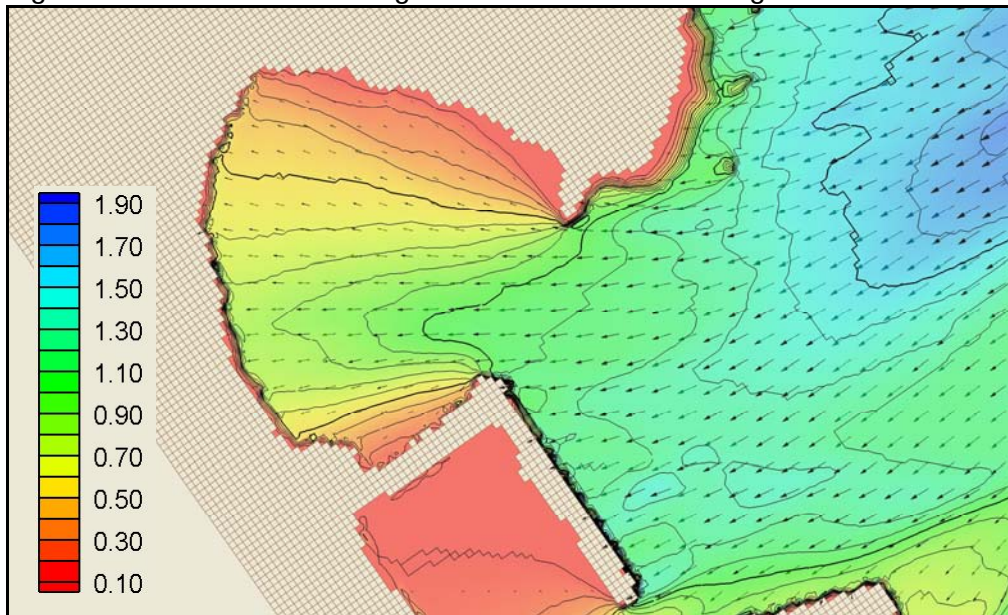
Figure 3 Nearshore Wave Height Contour and Vector Diagram

The subject property is well sheltered within the West Bay with only a very narrow opening, towards the northeast, through which waves can pass and still reach the site. Using the results of a wave hindcast analysis carried out as part of our 2004 work on the Collingwood Shipyards redevelopment project, we determined that northeasterly offshore wave conditions can have a significant wave height of 3.6 metres with a peak wave period of 7.5 seconds. Figure 3 shows nearshore wave height contours (contour interval 0.1 metres) and wave vectors from the results of a wave transformation analysis of a 3.6 metre 7.5 second wave coming from a deep water direction of 45 degrees. It can be seen from Figure 3 that significant wave heights of 0.4 metres or less can strike the shoreline fronting the proposed new building.

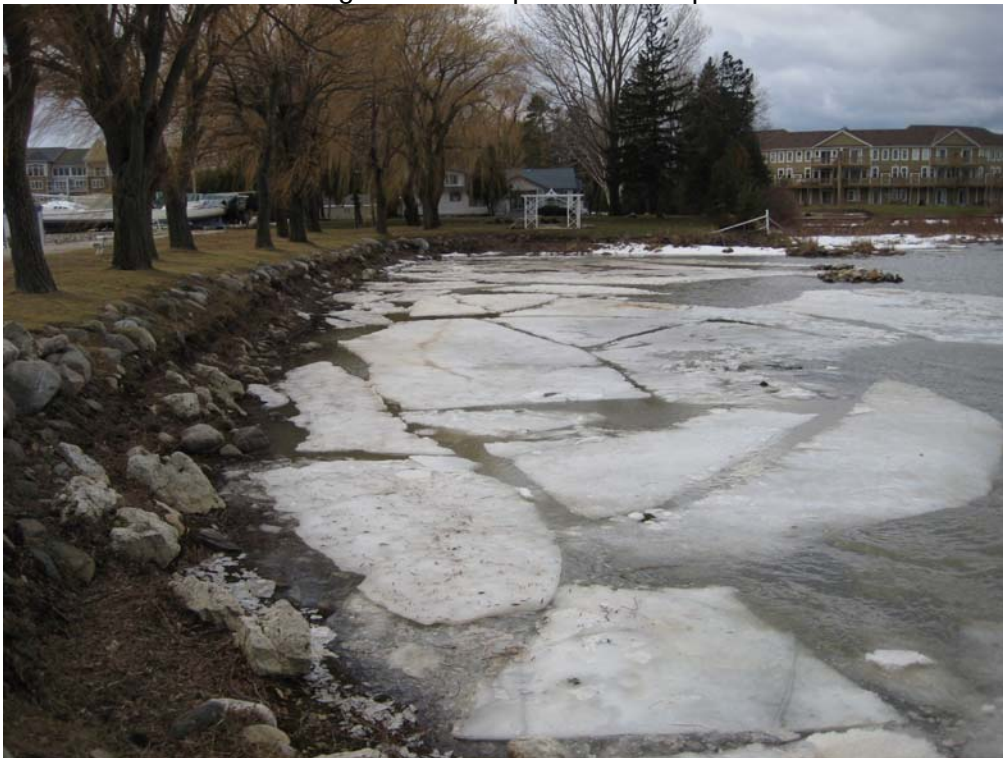
Photo 1 Westward Looking View of Proposed Development Site

This shoreline is artificial in that it was created from placed fill. There are a number of field stones of varying sizes along the edge of the bank, but not enough of them to be considered a protection structure. There is no evidence of filter cloth or a stone filter layer along the shoreline. We are not sure exactly when the “spit” forming the north side of the marina basin (and hence this shoreline) was constructed but the size of the trees suggests that it was a number of decades ago. A 1988 field sheet indicates “high trees”, suggesting that the trees were already mature 20 years ago. We assume that the field stones were placed on the bank when the spit was constructed as there is no evidence that it was carried out as any sort of remedial work. This in turn suggests that there is no real erosion at this site, as is discussed in more detail below.

Visible evidence suggests that there is no long-term recession at this site. As discussed previously, we believe the shoreline has not been altered since it was constructed a number of decades ago. It appears as if some fines have washed out of the upper part of the bank, allowing the field stones to settle, but there has been no measurable recession. It is certainly not in the order of 0.1 metres per year so the flooding hazard will be the governing hazard limit at this site.
