THOMSON WATSON CONSULTING ARBORISTS Inc

December 12, 2022 (revised July 14 and November 14, 2023, January 4 and November 7, 2024)

Re: Tree Preservation and Protection Report (Arborist Report) for Canadian Tire Store at Old Mountain Road and Balsam Street, Collingwood

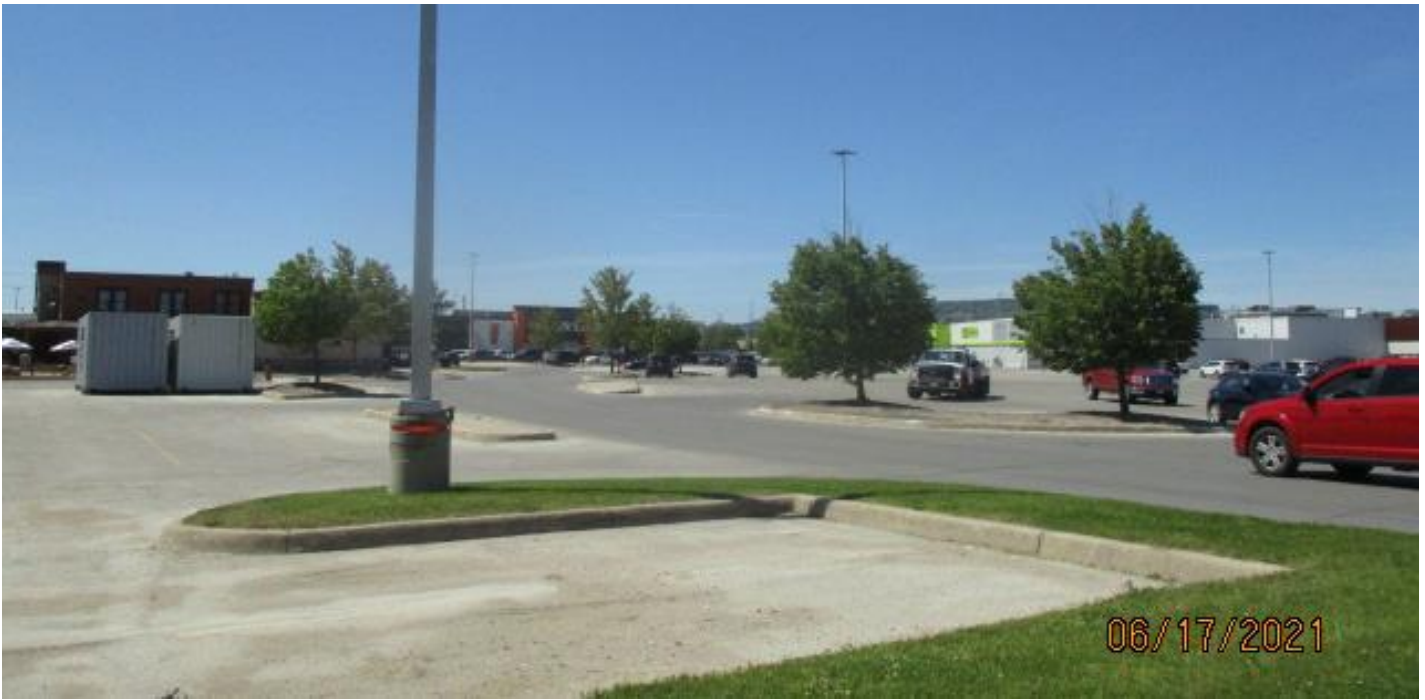
Trees 7, 8, 9, 10 and 11 are growing in landscape islands to the east and north of the relocated garden centre compound. Trees 7, 8, 10 and 11 are Little Leaf Lindens; the tight arrangement of branches on the stem has resulted in the death of the main stem. These

trees could be preserved with the dead leader pruned. A Tree Protection Fence should be placed around the edge of the three islands, to keep construction equipment away from the trees.

Trees 7 to 11 within parking lot to east of building

Trees 7, 8, 9, 10, 11 – around edge of landscape islands

2.4 The Fence around Trees 7, 8, 9, 10 and 11 will be a constructed of L-shaped supports created from 2 by 4 wood placed 4 feet apart covered with orange snow fencing. A 2-inch by 4-inch wood board will be attached to the top, bottom and diagonals of the snow fencing to provide rigidity to the Fence. The fencing will be securely fastened to the supports. The supports will be anchored in such a way that the Fence cannot be moved but roots are not injured. The bottom of the fence will touch the ground. There will be no gaps in the fence. (See Detail STD No. 1110 below)

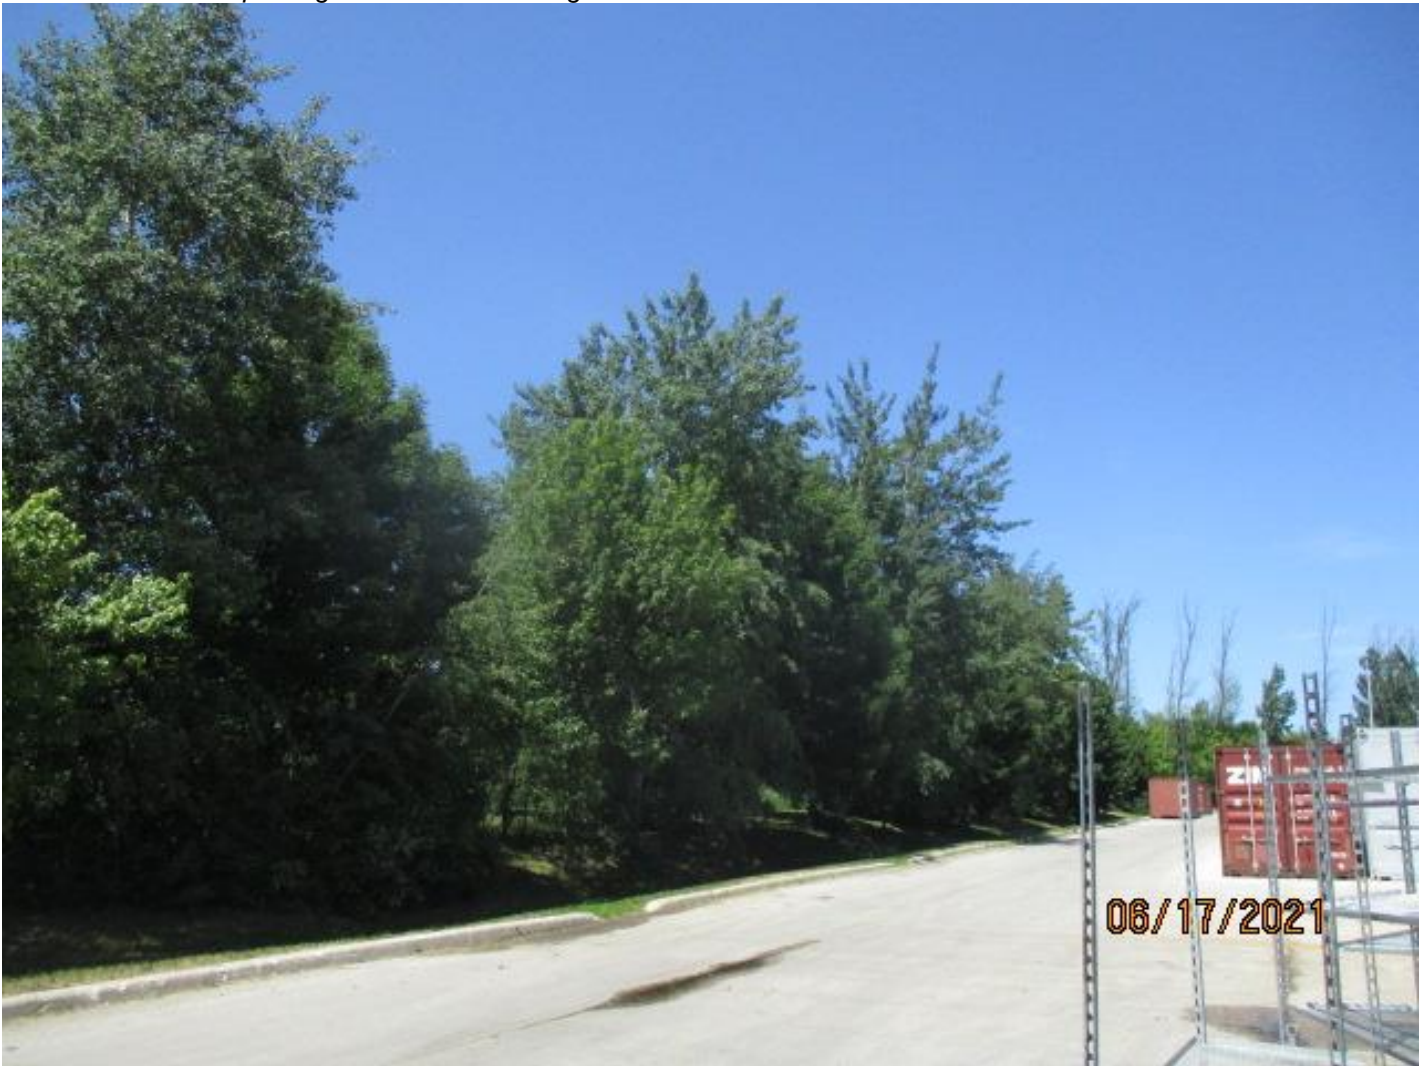
Trees 123 to 160 are growing to the west of the existing building in a landscape area. A curb separates the landscape area from the asphalt driveway. The addition will extend toward the trees but it is not proposed to expand the width of the existing driveway towards the trees. An engineering storm line will be installed from the driveway curb to the conservation area and creek. This excavation will require the removal of Trees 123, 124 and 125. Trees 123 and 124 are within the excavation and soil storage area. A Tree Protection Fence should be erected approximately 1.8 metres north of Tree 126, extending from the driveway curb to the creek area, to keep soil and excavation equipment off the root system of remaining trees. The Fence will be continued along the driveway curb, to west of Tree 159, to keep construction equipment and materials off the landscape area. Only Trees 123 and 124 will be removed or injured in this area for construction purposes; Tree 125 is dead and should be removed.

Trees growing to west of driveway at back of building, with curb shown

Trees 126 – 160 – along edge of driveway curb, extending length of building, along north side of grouping 1.8 metres north of Tree 126, extending from curb to creek.

2.5 The Fence adjacent to Trees 126 to 160 will be a barricade constructed of L-shaped supports created from 2 by 4 wood placed 4 feet apart covered with 3/4-inch thick, 4-foot high by 8-foot wide plywood or an equivalent material acceptable to the Town of Collingwood. The plywood fencing will be secured attached to each support it covers. The supports will be anchored in such a way that the Fence cannot be moved but roots are not injured. The bottom of the fence will touch the ground. There will be no gaps in the fence. (See Detail STD No. 1110 below)
