December 4, 2025

## ARBORIST REPORT

151 Peel Street, Collingwood, Ontario

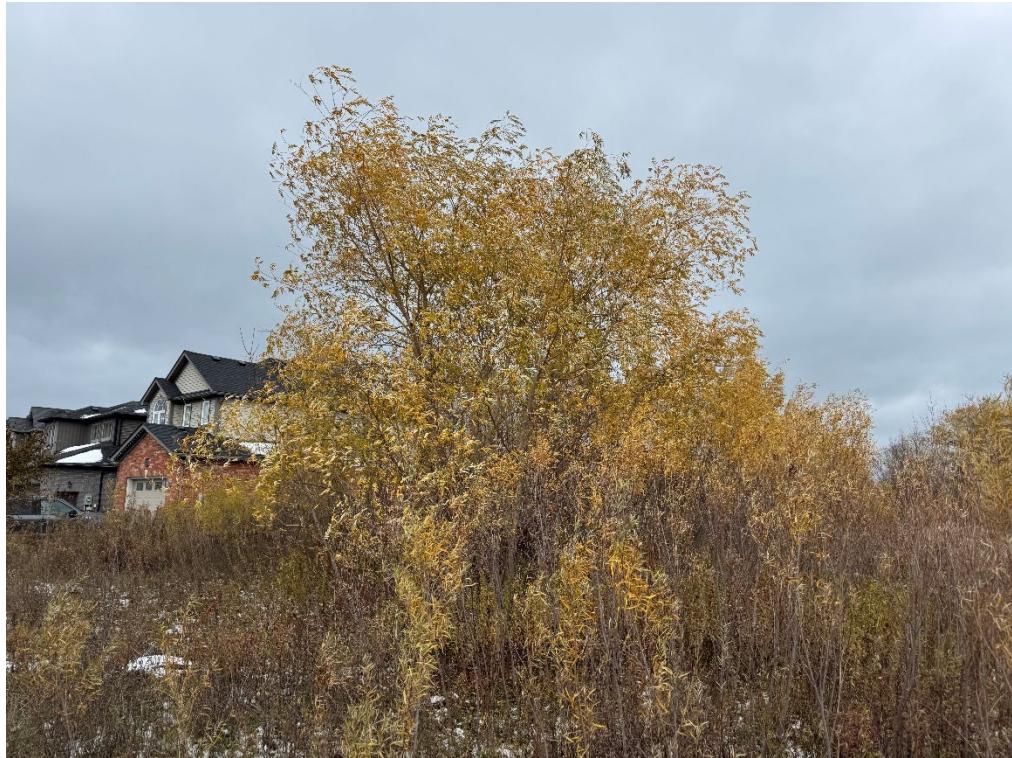
Tree 924

Tree #	Common Name	Botanical Name	DBH (CM)	Condition	Comments	Recommendation
924	Black Willow	<i>Salix nigra</i>	15	F	Multi-stem	Retain
925	Black Locust	<i>Robinia pseudoacacia</i>	23	F	Vines growing throughout	Remove due to construction
926	Birch Sp.	<i>Betula Sp.</i>	38	F	Growing within Cedar Hedge grouping	Remove due to construction
927	Birch Sp.	<i>Betula Sp.</i>	32	F	Mild lean away from development site	Remove due to construction
928	Birch Sp.	<i>Betula Sp.</i>	19	F	Mild lean away from development site, 2 stem at base	Remove due to construction
929	Poplar Sp.	<i>Populus Sp.</i>	27	F	Moderate lean away from development site	Retain
930	Poplar Sp.	<i>Populus Sp.</i>	24	F	Mild lean away from development site	Remove due to construction
931	Poplar Sp.	<i>Populus Sp.</i>	23	F	Mild to moderate lean away from development site	Remove due to construction
932	Trembling Aspen	<i>Populus tremuloides</i>	32	F/P	2 stem at base, smaller, stem with wound at base showing rot column throughout trunk	Remove due to construction

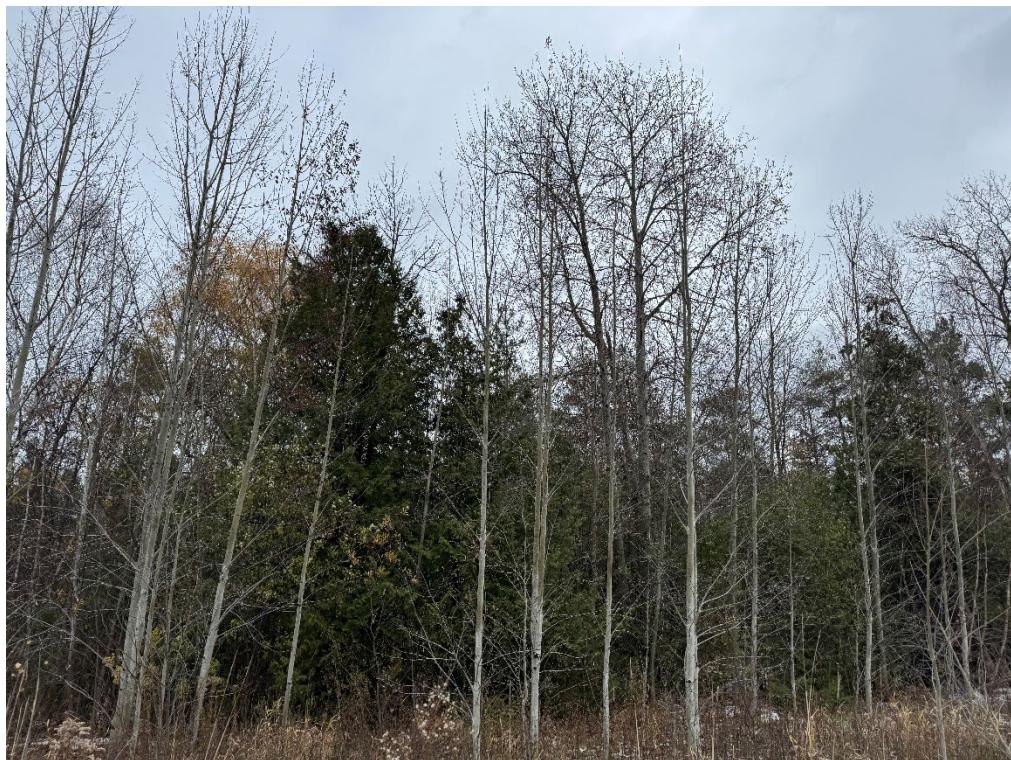
Trees 932 – 935

933	Trembling Aspen	<i>Populus tremuloides</i>	25	F		Remove due to construction
934	Cedar Sp.	<i>Thuja Sp.</i>	20	F/P	Bow at base, vertical wound at base showing potential rot column in trunk	Remove due to construction
935	Cedar Sp.	<i>Thuja Sp.</i>	26	F	4 stem at 0.3 metres, minor deadwood throughout	Remove due to construction
936	Black Willow	<i>Salix nigra</i>	22	F	Mild lean	Remove due to construction
937	Trembling Aspen	<i>Populus tremuloides</i>	21	F		Remove due to construction

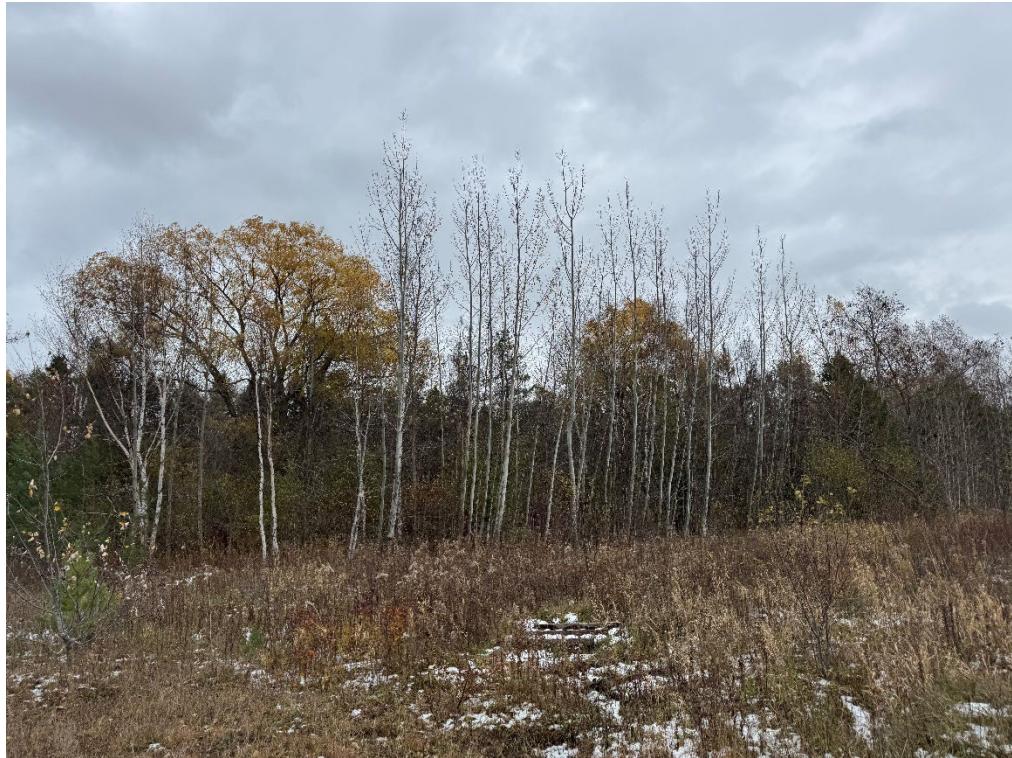
Trees 936 – 949, O1 – O7

938	Black Locust	<i>Robinia pseudoacacia</i>	20	F		Remove due to construction
939	Birch Sp.	<i>Betula Sp.</i>	24	F	Mild lean away from development site	Remove due to construction
940	Birch Sp.	<i>Betula Sp.</i>	17	F	Mild lean away from development site	Remove due to construction
941	Birch Sp.	<i>Betula Sp.</i>	20	F	Mild lean away from development site	Remove due to construction
942	Black Willow	<i>Salix nigra</i>	17	F	Moderate lean away from development site, mild bow at base	Remove due to construction
943	American Elm	<i>Ulmus americana</i>	15	F	Moderate to significant lean away from development site	Remove due to construction
944	Trembling Aspen	<i>Populus tremuloides</i>	18	F	Mild lean towards development site	Remove due to construction
945	Trembling Aspen	<i>Populus tremuloides</i>	15	F	Mild lean towards development site	Remove due to construction
946	Trembling Aspen	<i>Populus tremuloides</i>	19	F		Remove due to construction

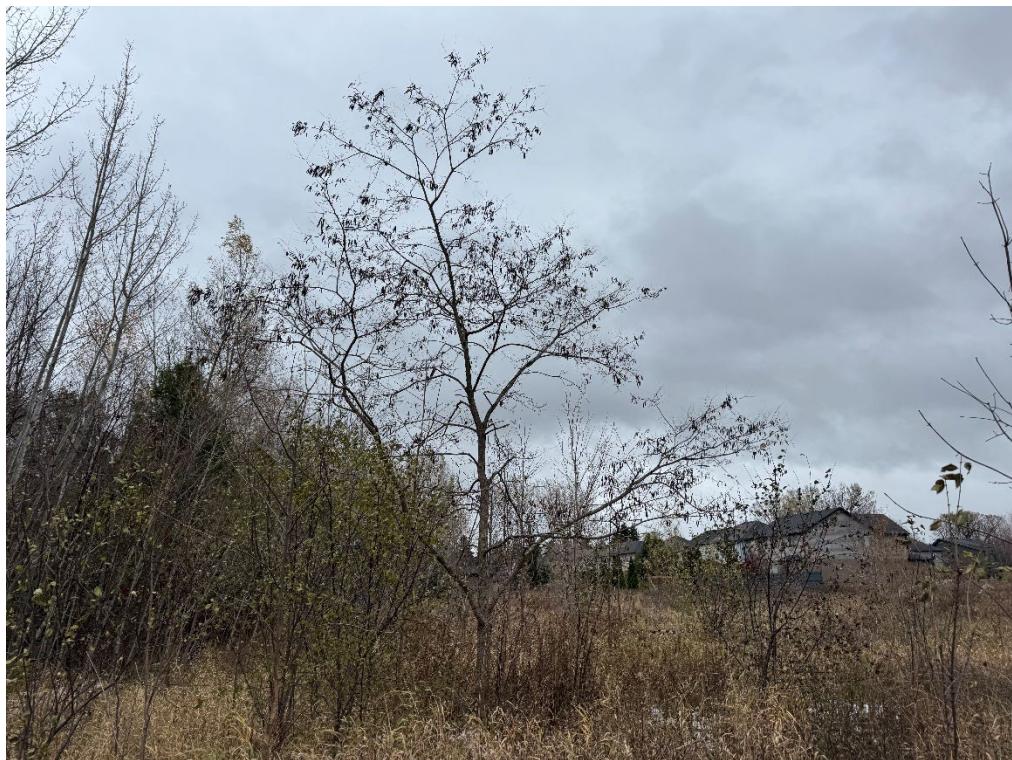
Tree 950

947	American Elm	<i>Ulmus americana</i>	18	F	Mild lean away from development site	Remove due to construction
948	Birch Sp.	<i>Betula Sp.</i>	17	F	Mild lean away from development site	Remove due to construction
949	Birch Sp.	<i>Betula Sp.</i>	17	F	Multi-stem	Remove due to construction
950	Black Locust	<i>Robinia pseudoacacia</i>	16	F		Remove due to construction
951	Black Locust	<i>Robinia pseudoacacia</i>	16	F		Remove due to construction
952	Black Locust	<i>Robinia pseudoacacia</i>	19	F		Remove due to construction
953	Trembling Aspen	<i>Populus tremuloides</i>	24	F		Remove due to construction
954	Trembling Aspen	<i>Populus tremuloides</i>	18	F		Remove due to construction
955	Trembling Aspen	<i>Populus tremuloides</i>	15	F		Remove due to construction
956	Trembling Aspen	<i>Populus tremuloides</i>	15	F		Remove due to construction
957	Poplar Sp.	<i>Populus Sp.</i>	18	F		Retain
958	American Elm	<i>Ulmus americana</i>	29	F/P	Suckers at base, Internal rot suspected, minor deadwood throughout	Retain

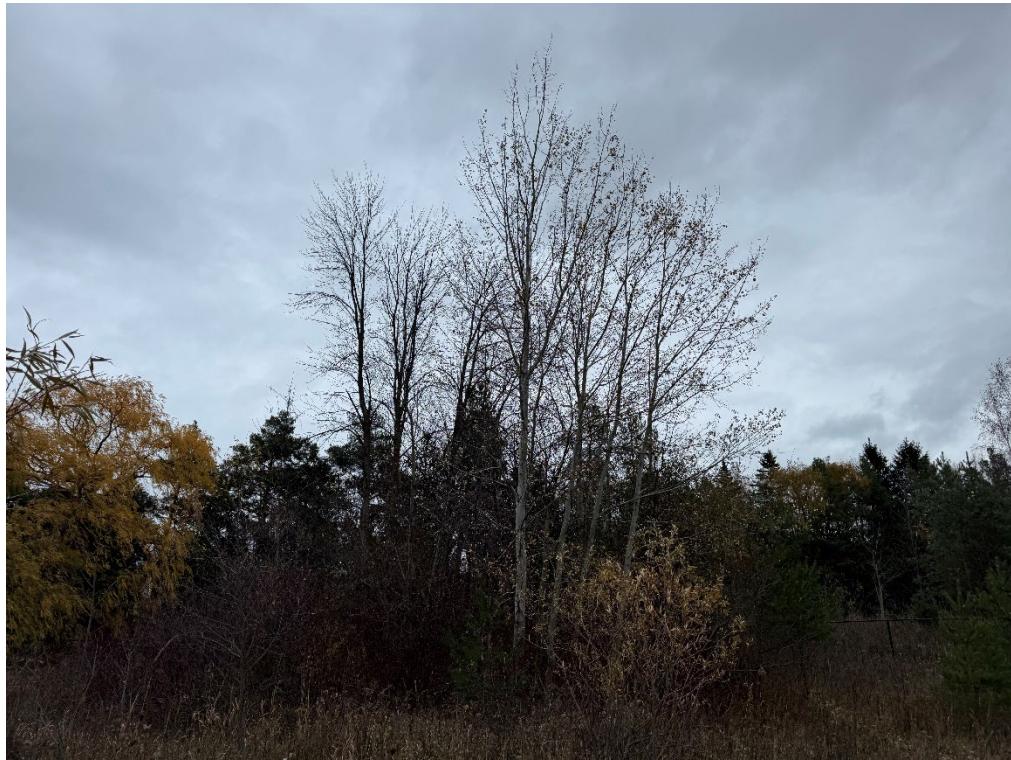
Trees 953 – 960

959	American Elm	<i>Ulmus americana</i>	25	F	2 stem at base	Retain
960	American Elm	<i>Ulmus americana</i>	31	F/P	Suckers at base, 3 stem at 0.5 metres, 2 stems with vertical splits throughout trunk	Retain
961	Red Pine	<i>Pinus resinosa</i>	17	F		Remove due to construction
962	Black Locust	<i>Robinia pseudoacacia</i>	16	F	Bow at base, multi-stem	Retain
963	Black Willow	<i>Salix nigra</i>	20	F		Remove due to construction
964	Black Locust	<i>Robinia pseudoacacia</i>	31	F	Vertical split at main union	Remove due to construction
965	Black Locust	<i>Robinia pseudoacacia</i>	15	F		Remove due to construction
966	Manitoba Maple	<i>Acer negundo</i>	25	F	Moderate lean, bows throughout	Remove due to construction
967	American Elm	<i>Ulmus americana</i>	22	F	Bow in trunk	Remove due to construction
968	American Elm	<i>Ulmus americana</i>	34	F		Remove due to construction
969	Black Locust	<i>Robinia pseudoacacia</i>	23	F		Remove due to construction

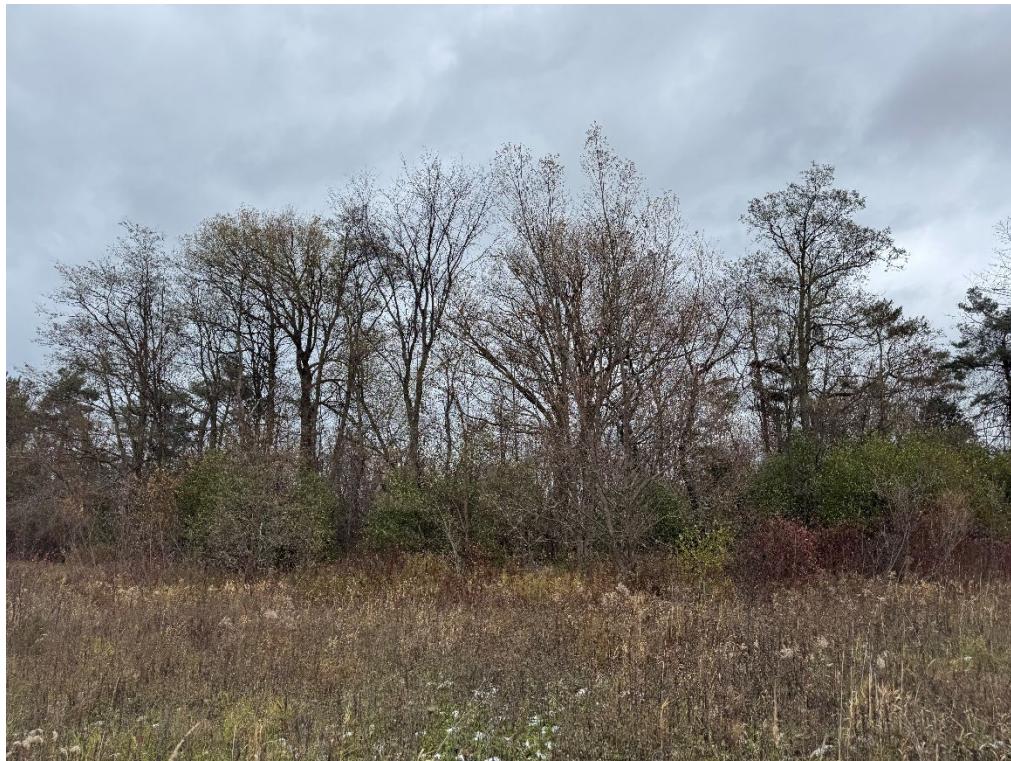
Trees 962 – 978, O11 – O22

970	Manitoba Maple	<i>Acer negundo</i>	44	P/D	Internal rot evident at main union, multiple previous limb failures evident, water shoots throughout, large cavity at main union	Remove due to construction
971	Black Locust	<i>Robinia pseudoacacia</i>	29	F		Retain
972	Ash Sp.	<i>Fraxinus Sp.</i>	28	F		Retain
973	Black Locust	<i>Robinia pseudoacacia</i>	19	F	Mild lean towards development site	Retain
974	Manitoba Maple	<i>Acer negundo</i>	21	F/P	Significant lean towards development site	Retain
975	Norway Maple	<i>Acer platanoides</i>	36	F	2 stem at base	Retain
976	American Elm	<i>Ulmus americana</i>	40	F	2 stem at base	Retain
977	Black Locust	<i>Robinia pseudoacacia</i>	42	F		Retain
978	Manitoba Maple	<i>Acer negundo</i>	29	P	Main limb previously failed in upper canopy	Retain
979	Black Locust	<i>Robinia pseudoacacia</i>	29	F		Remove due to construction
980	Black Willow	<i>Salix nigra</i>	16	F		Retain
981	Black Locust	<i>Robinia pseudoacacia</i>	42	F		Retain

O7	Scots Pine	<i>Pinus sylvestris</i>	~16	F/P	Sparse canopy	Retain
O8	Black Willow	<i>Salix nigra</i>	~56	F	Mild lean towards development site, canopy overhangs into development site	Retain
O9	Black Willow	<i>Salix nigra</i>	~82	F	Canopy overhangs into development site	Retain
O10	Black Willow	<i>Salix nigra</i>	~98	F	Canopy overhangs into development site	Retain
O11	Manitoba Maple	<i>Acer negundo</i>	~20	P	Multiple previous limb failures, significant lean into development site, tree is structural hazard	Retain
O12	Manitoba Maple	<i>Acer negundo</i>	22	F/P	Significant lean into development site, tree is parallel to ground	Retain
O13	Manitoba Maple	<i>Acer negundo</i>	~25	F/P	Significant lean into development site	Retain
O14	Manitoba Maple	<i>Acer negundo</i>	~24	F/P	Significant lean into development site, 2 stem at 0.2 metres, rot suspected at stem union	Retain
O15	Black Willow	<i>Salix nigra</i>	~77	F		Retain

O18	Black Willow	Salix nigra	~62	F		Retain
O19	Black Locust	Robinia pseudoacacia	~58	F		Retain
O20	Black Locust	Robinia pseudoacacia	~30	F		Retain
O21	Black Locust	Robinia pseudoacacia	~49	F		Retain
O22	Manitoba Maple	Acer negundo	~28	F/P	Moderate lean	Retain
O23	Black Willow	Salix nigra	~125	F	Minor deadwood throughout, canopy overhangs into development site	Retain
O24	Manitoba Maple	Acer negundo	~27	F		Retain
O25	Black Willow	Salix nigra	~34	F	Canopy overhangs into development site	Retain
O26	Black Willow	Salix nigra	~100	F	Minor deadwood throughout, canopy overhangs into development site	Retain
O27	Black Willow	Salix nigra	~95	F	Minor deadwood throughout, canopy overhangs into development site	Retain
O28	Black Willow	Salix nigra	~59	P	Major previous limb failures throughout, moderate deadwood throughout, tree is expected to decline, canopy overhangs into development site	Retain
O29	Manitoba Maple	Acer negundo	28	F		Retain

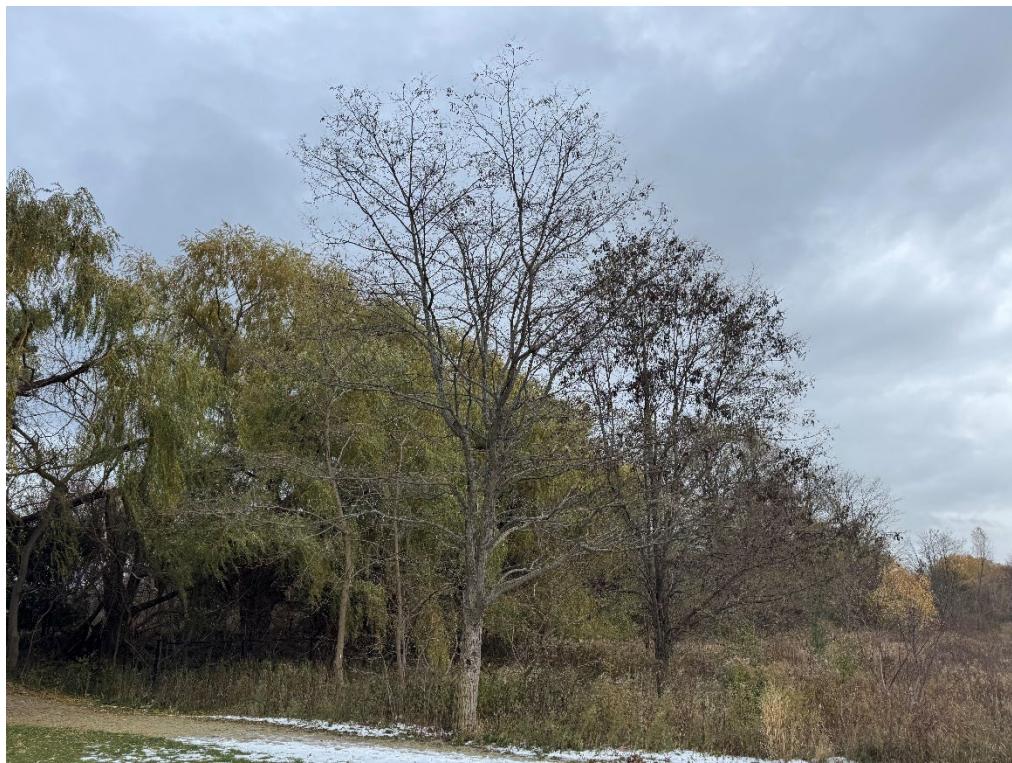
Trees 980 – 982

982	Black Locust	<i>Robinia pseudoacacia</i>	35	F	2 stem at 0.8 metres	Remove due to construction
983	Black Willow	<i>Salix nigra</i>	25	F	Multi-stem	Retain

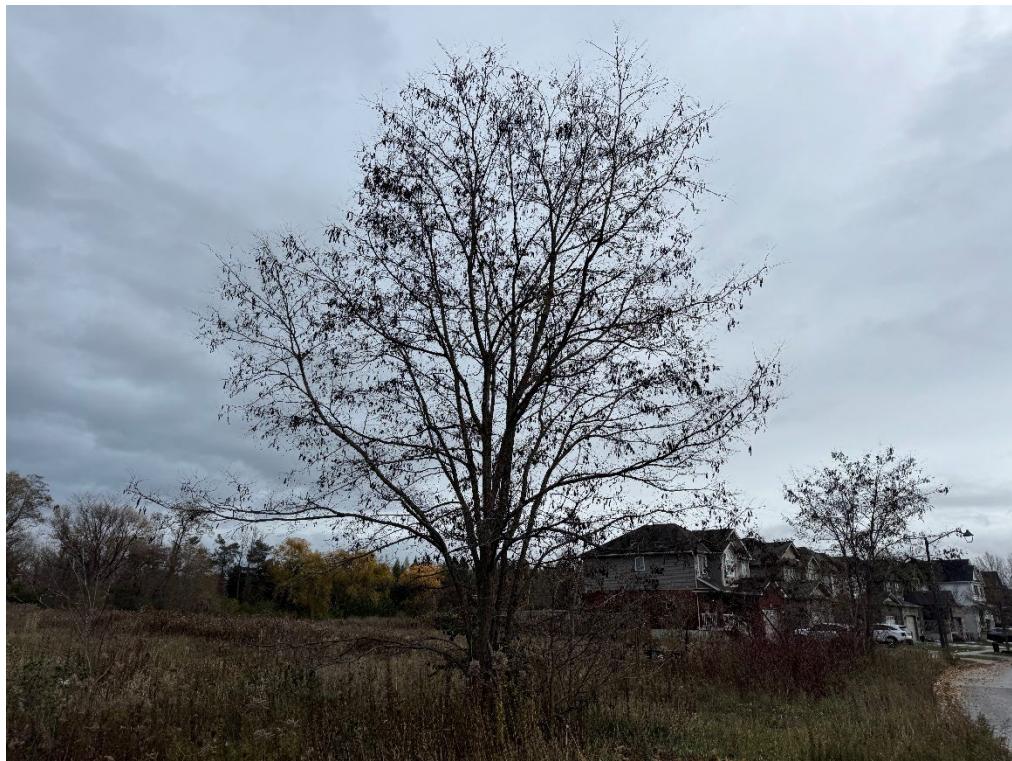
Trees 986, 987

984	Common Hackberry	<i>Celtis occidentalis</i>	15	F		Retain
985	Common Hackberry	<i>Celtis occidentalis</i>	15	F		Retain
986	Black Locust	<i>Robinia pseudoacacia</i>	15	F	2 stem at base	Remove due to construction
987	Black Locust	<i>Robinia pseudoacacia</i>	15	F	Multi-stem	Remove due to construction
988	Black Locust	<i>Robinia pseudoacacia</i>	12	F/P	Exposed root flare	Remove due to construction
989	Black Locust	<i>Robinia pseudoacacia</i>	13	F	Wound at base	Remove due to construction
990	Black Locust	<i>Robinia pseudoacacia</i>	13	F		Remove due to construction
O1	Black Willow	<i>Salix nigra</i>	~110	F	Muti-stem at 1.7 metres	Retain
O2	American Elm	<i>Ulmus americana</i>	~20	F		Retain
O3	Black Willow	<i>Salix nigra</i>	~58	F		Retain
O4	Birch Sp.	Betula Sp.	~15	F	Mild lean towards development site	Retain
O5	American Elm	<i>Ulmus americana</i>	14	F		Retain
O6	American Elm	<i>Ulmus americana</i>	14	F		Retain

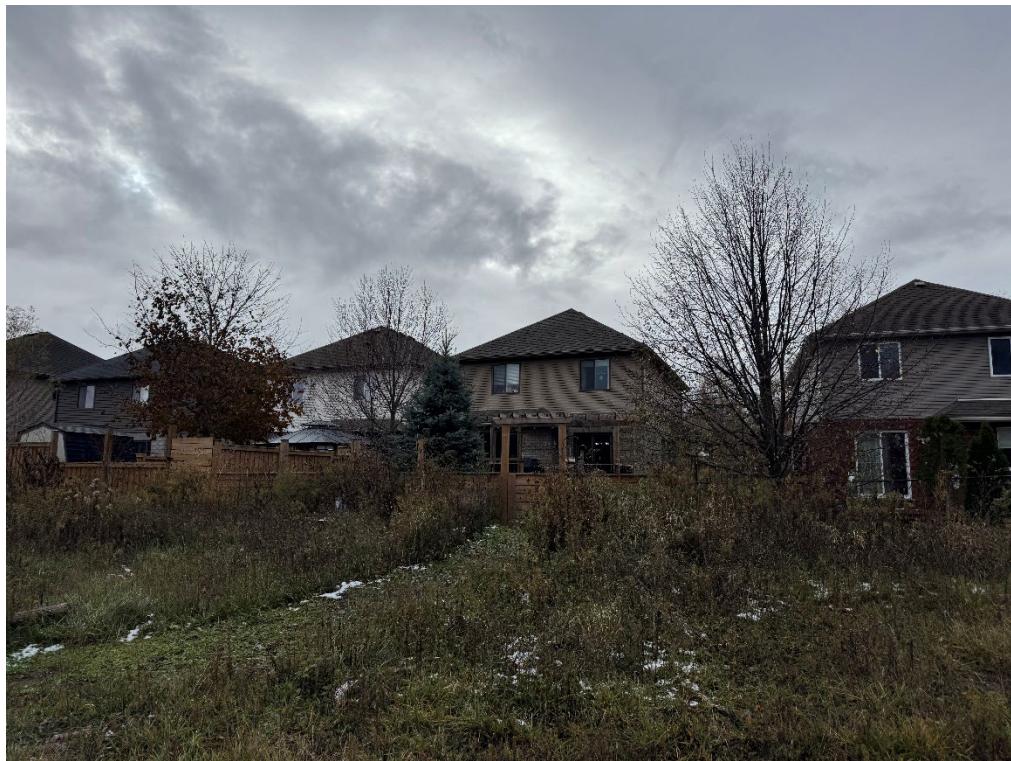
Trees O30 – O33

O30	Basswood	Tilia americana	~18	F/G	Canopy overhangs into development site	Retain
O31	Colorado Blue Spruce	Picea pungens var. glauca	~10	F/G		Retain
O32	Red Maple	Acer rubrum	~14	F/G		Retain
O33	Norway Maple	Acer platanoides	~13	F		Retain
O34	Red Maple	Acer rubrum	~16	F/G		Retain
O35	Red Maple	Acer rubrum	~33	F/G	Canopy overhangs into development site	Retain
O36	Red Maple	Acer rubrum	~34	F/G	Canopy overhangs into development site	Retain
A	Cedar Sp.	Thuja Sp.	-	F-F/P	Cedar Hedge with ~20 stems at 10-20cm, minor to moderate deadwood throughout	Remove due to construction
