Collingwood Terminals Foundation Pile Assessment

1 Heritage Drive
Collingwood, Ontario

Project: TE-35355-20
August 2020

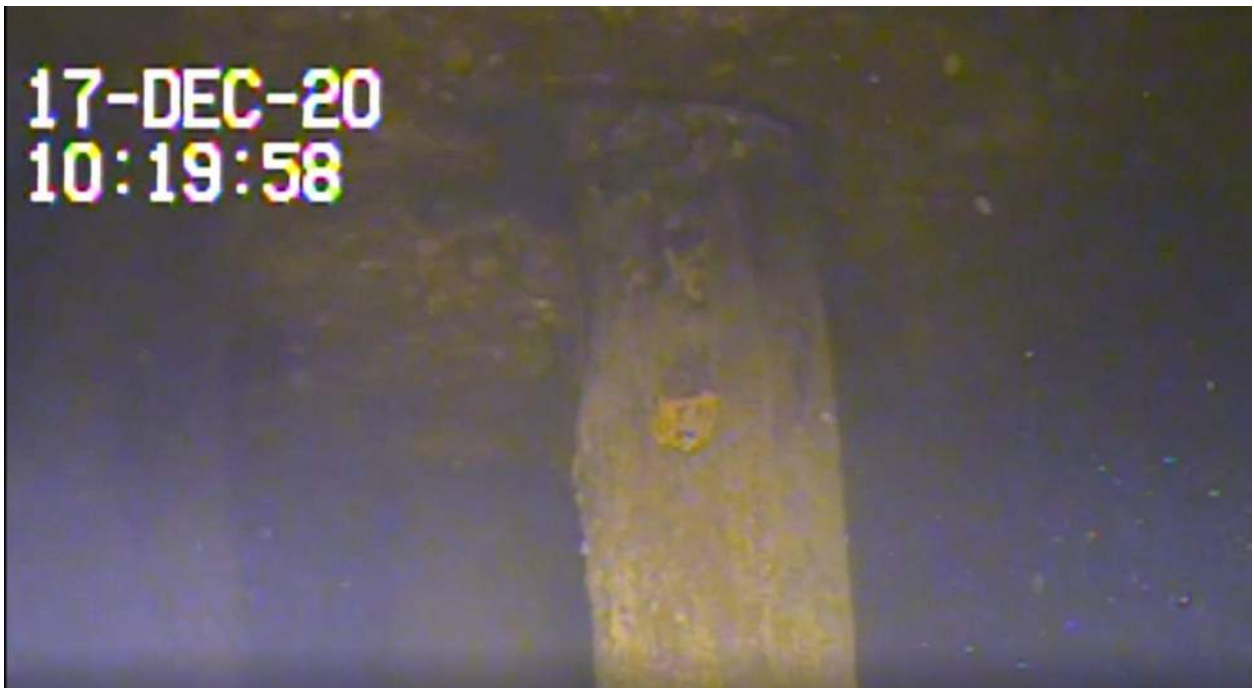
Photo with time stamp 10:19:58 illustrates a pile in relatively good condition which is fully engaged in the concrete wharf slab above.

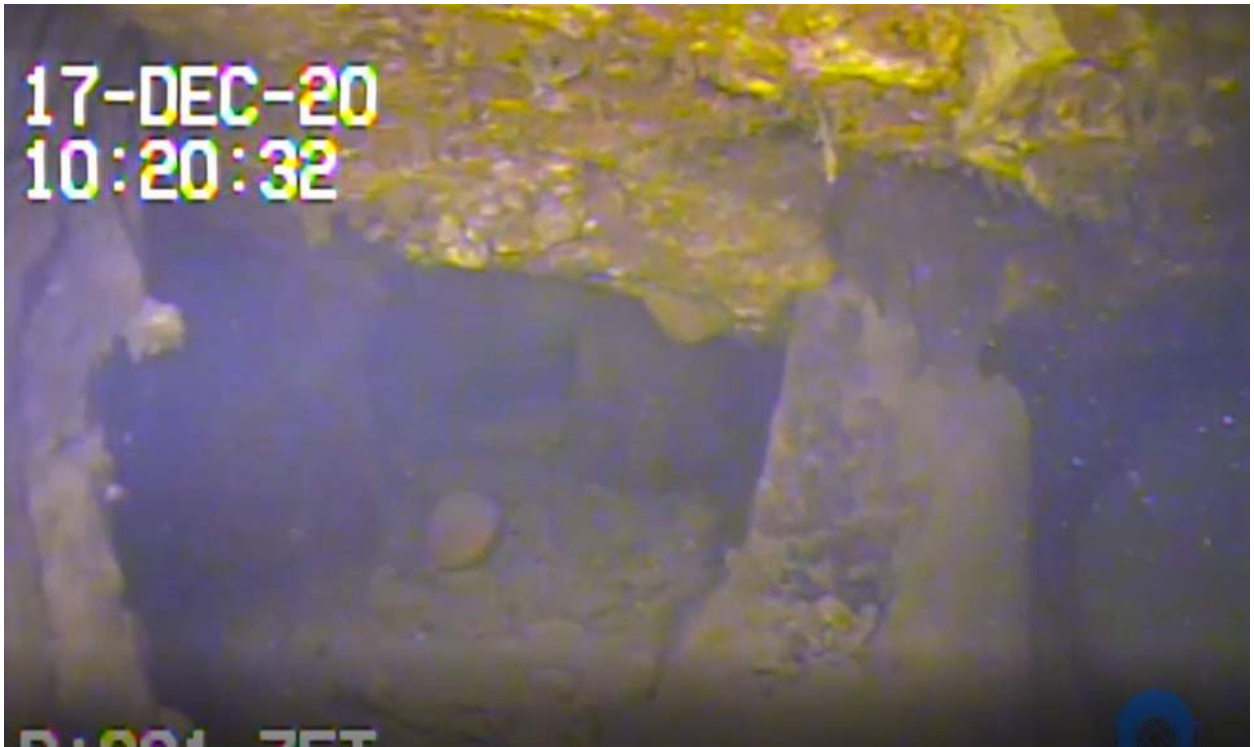
Photo 10:20:32 illustrates a pile with significant deterioration where over 75% of the pile section is completely decayed.

The damage and deterioration identified during the sub-surface investigation is structurally significant. Approximately 25% of the crib face is damaged and/or deteriorated; there is considerable granular washout adjacent to these areas; and approximately 50% of the piles exposed exhibited a certain degree of wood decay and/or deterioration with over 10% exhibiting significant or complete decay.

While our sub-surface review identified significant pile deterioration, the deterioration appears limited to a localized area below the wharf that is exposed to more severe conditions. The damaged/missing face of the cribbing allows significant wave and ice action to impact the piles. Given there is no evidence of any slab settlement or distress and the fact that the Terminals are empty, there is no significant risk to persons or property. We would recommend that if the Terminal was to remain vacant for an extended period of time, it would be prudent to prepare and implement repair strategies to mitigate further decay to the exposed piles and granular fill.

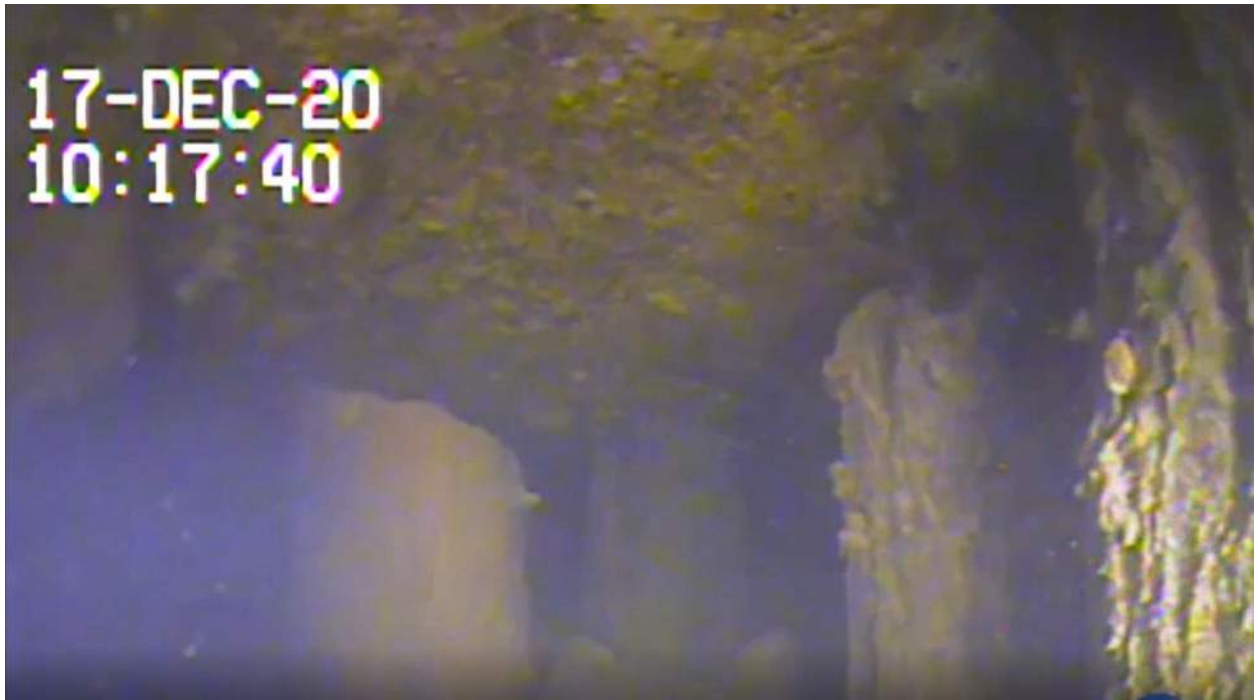
Photo 10:17:40 illustrates 3 adjacent piles where the top of the pile has completely decayed and is no longer in contact with the wharf slab above.

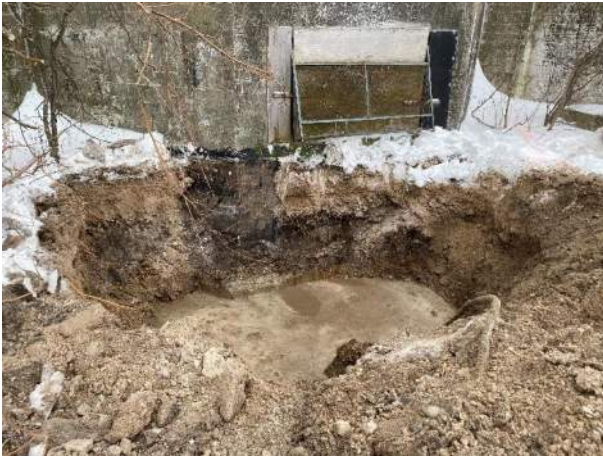
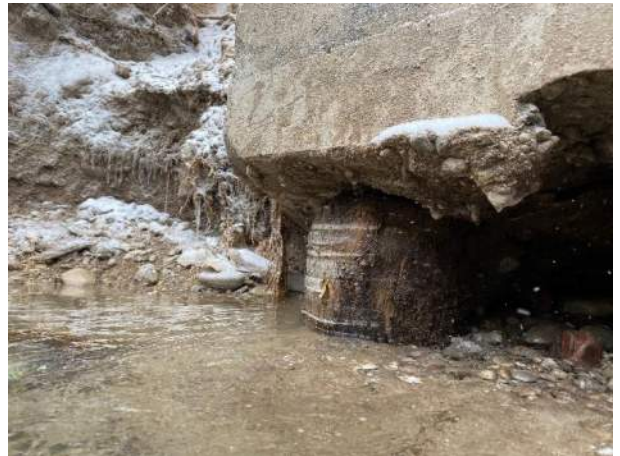
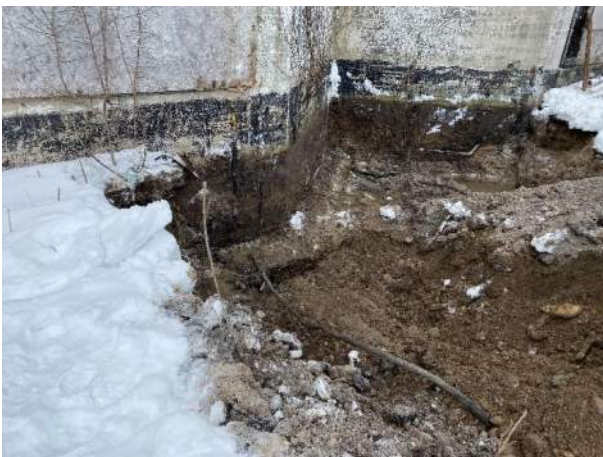
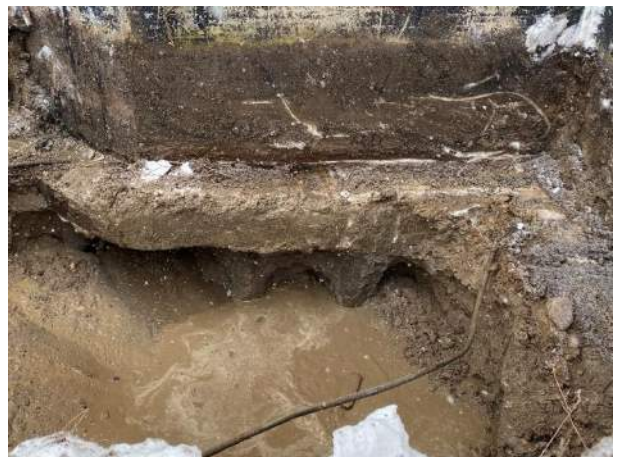
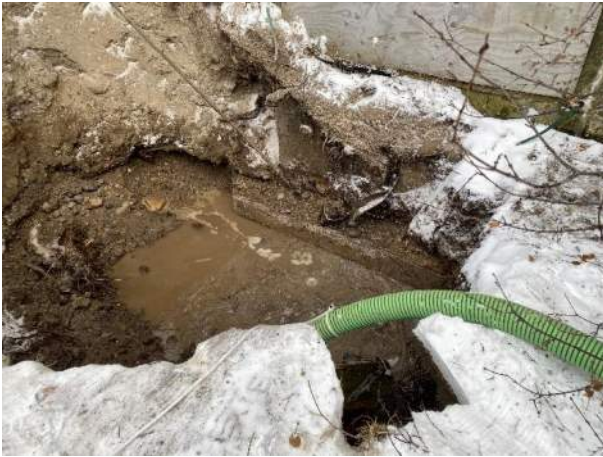
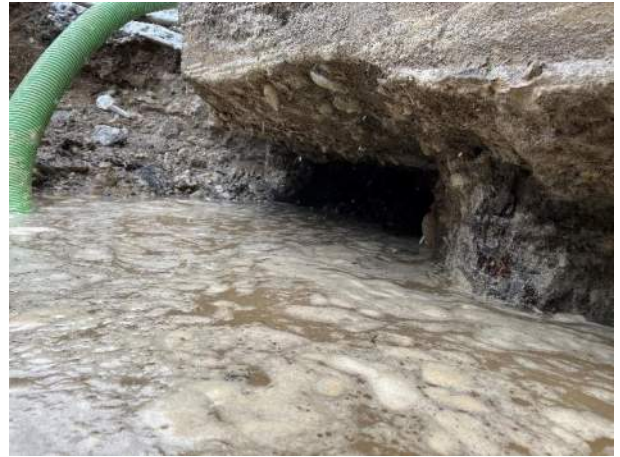
Through the use of high capacity pumps and rapid entry/exit from the excavations, it was clear that the conditions at all three excavations were similar. The foundation walls and concrete slabs were found to be in good condition. The top of the base slab is approximately 5'-0" below the basement windowsills which is consistent with the geometry measured on the interior.

Similarly, our review of the exposed wood piles in the three test pits did not identify any significant damage, deterioration or decay. All of the exposed piles were fully engaged with the concrete slab and penetration probes found the wood to be sound.
