**July 6, 2022**

Andy Gnaedig  
Certification No. 13343823  
The Arborist - Professional Tree Care  
535 Maple St., Unit 4, Collingwood  
705.444.9011

Monika Schnarre  
32 Oak Street, Collingwood  
mschnarre@gmail.com  
647.289.7723

To assess and grade all trees located at 32 Oak St., Collingwood.

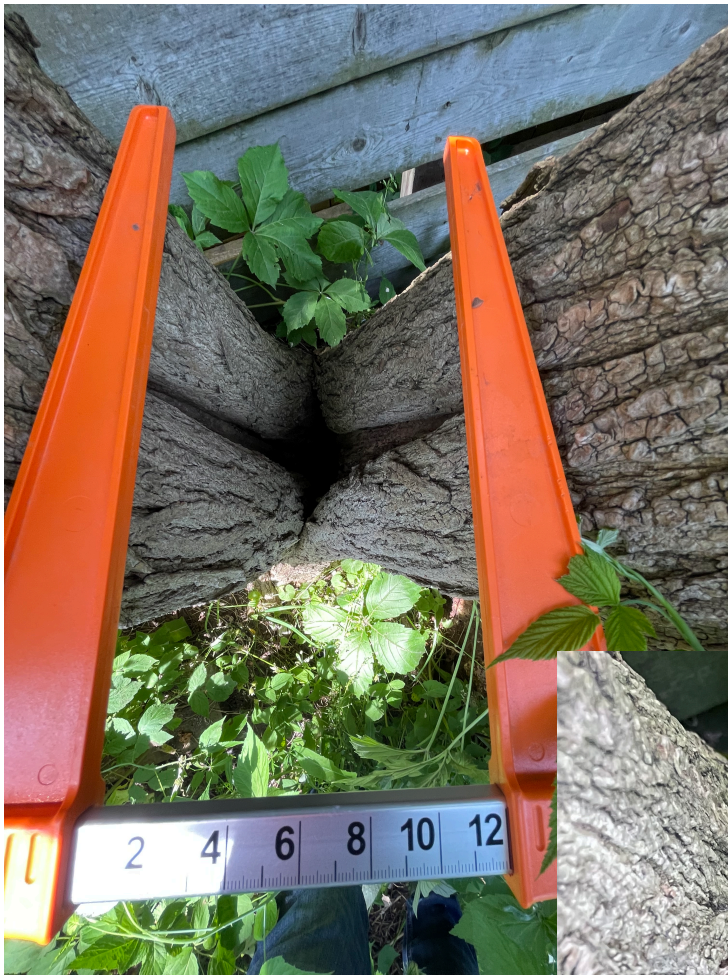
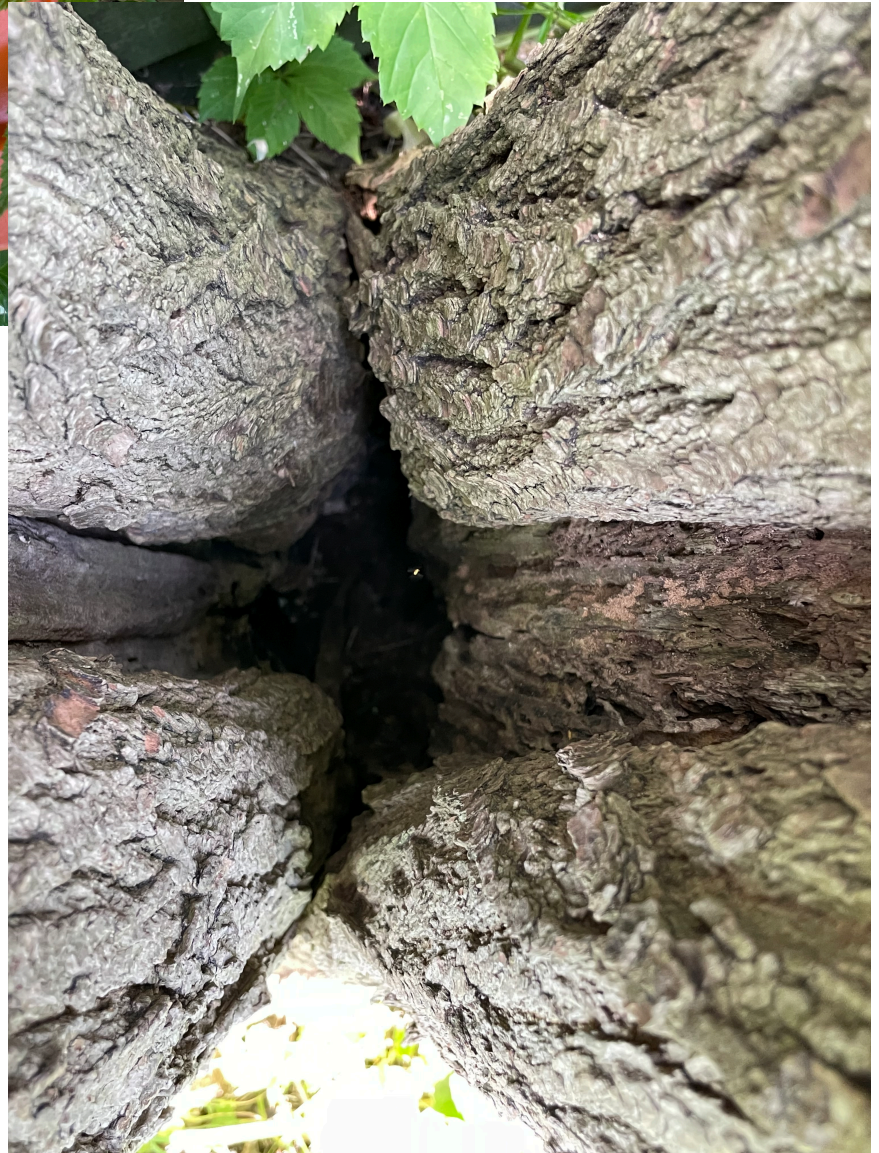
## 9. Blacklocust

This grouping of 3 Blacklocusts is volunteer growth that has achieved adolescent/mature size. The photo found on page 6 shows a defect within the included bark (*stems or limbs with poor attachments*) between two of the stems. This defect is located at the basal area and compromises both stems which causes a higher likelihood of failure. The manner in which the third stem has grown due to proximity to the grouping makes it poor specimen for retention. Therefore, it is recommended that all three stems are removed.

A tight union between stems often collects debris and retains moisture, Especially with the absence of cambium (*bark*) this can lead to an advanced rate of decay and eventually failure.

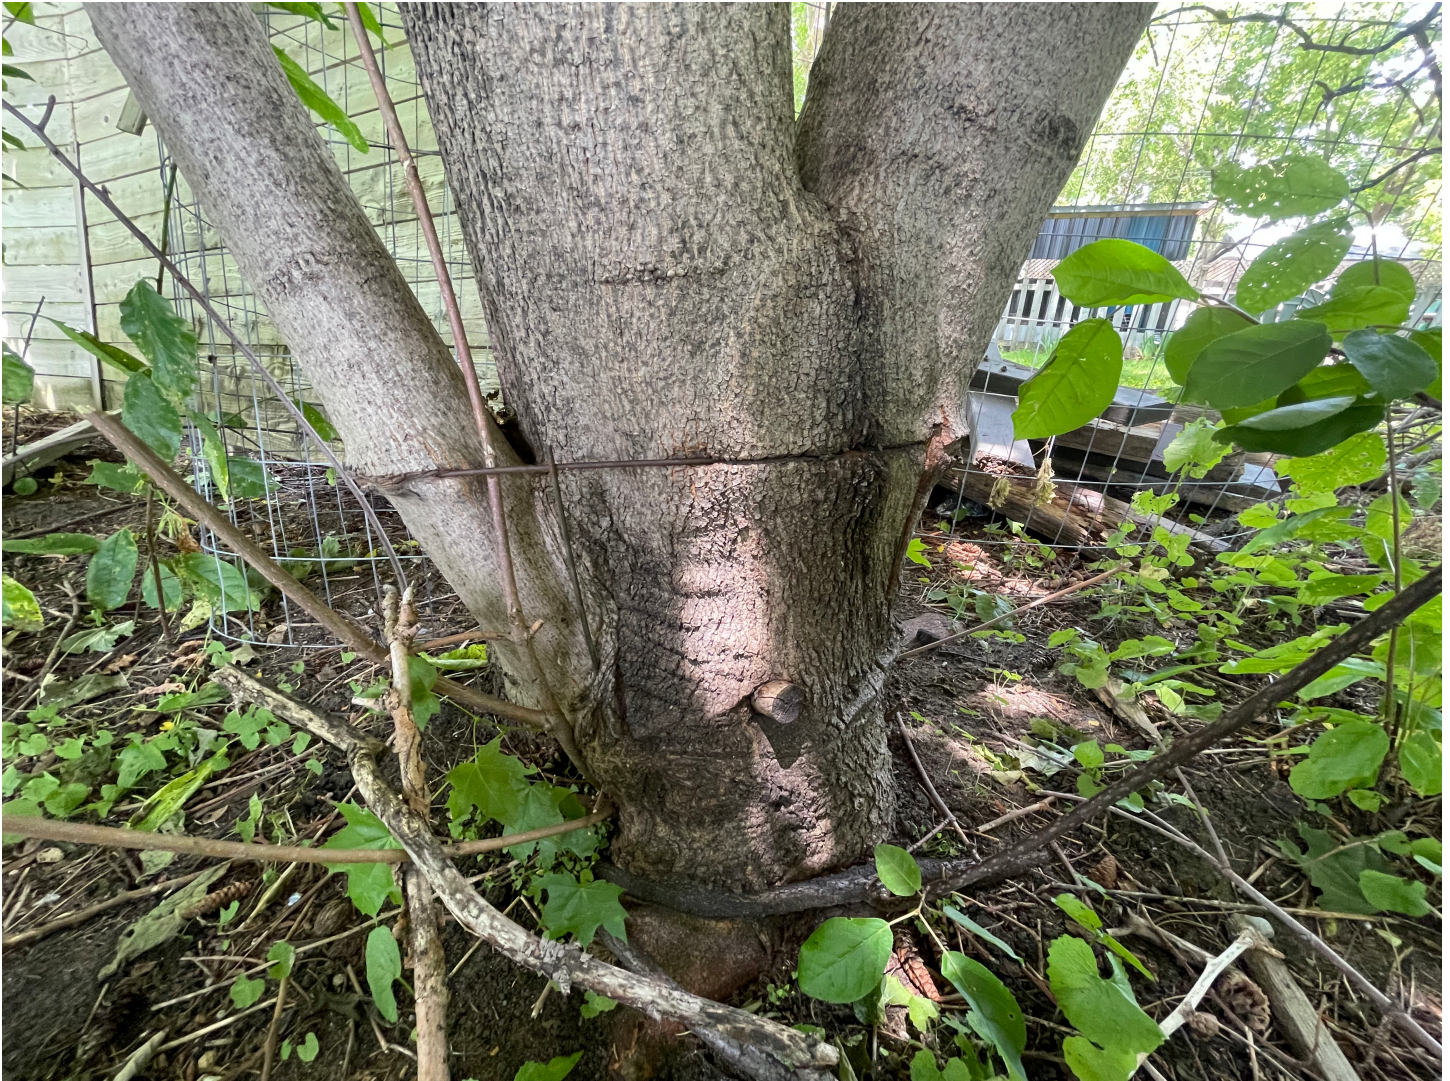
## 15. Norway maple

This Norway maple is of average health. It has poor stem attachment and has grown through an old fence which can be seen in the photo on page 7. This poor multi stem structure is prone to failure. This specimen is highly recommended of removal.

Poor stem attachments such as these have a high possibility of failure. The addition of the fence wire makes this possibility greater.

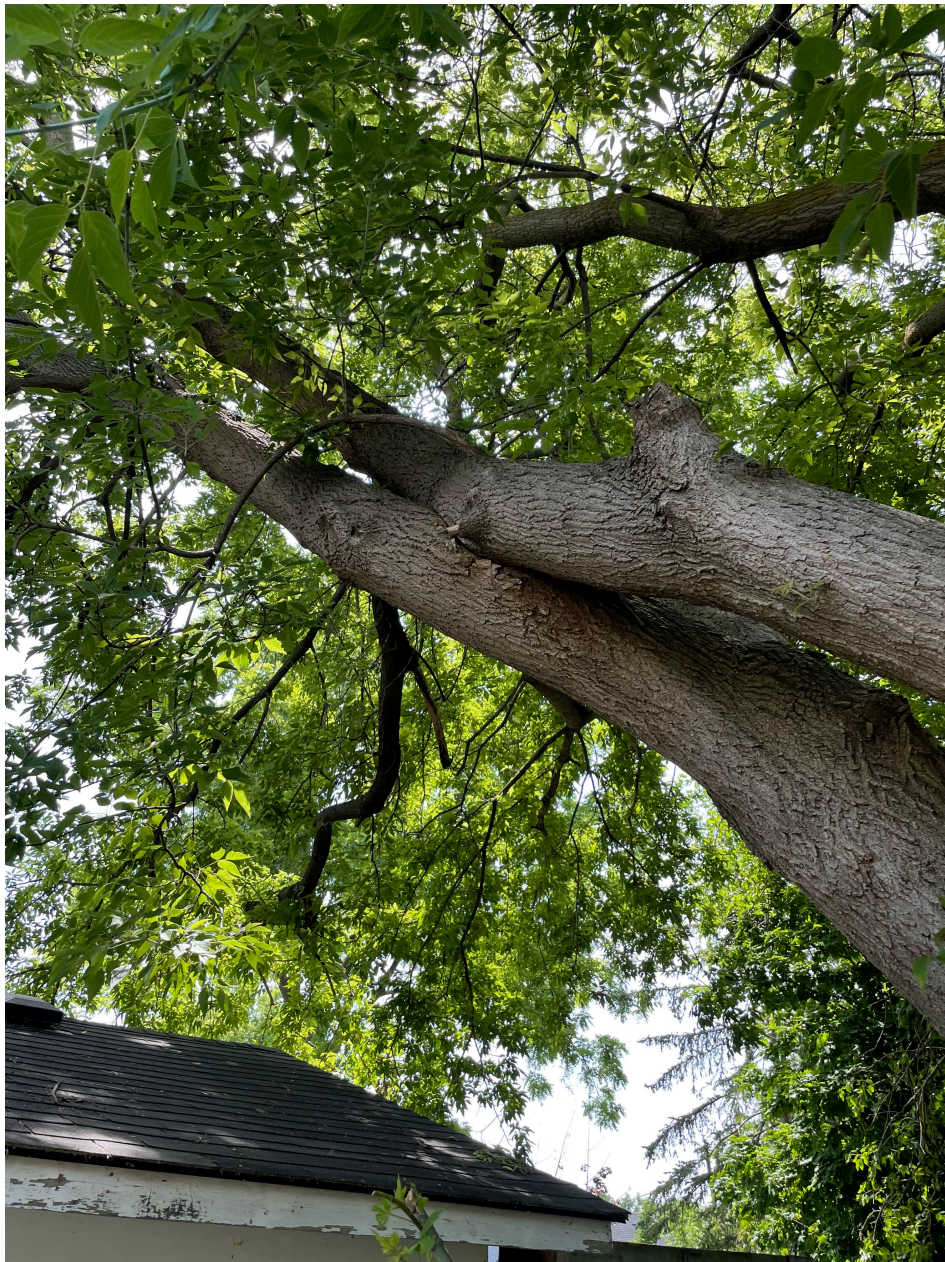
## 20. Manitoba maple

Average health but a poor specimen due to badly formed structure. This tree has three substantial limbs that extend over the property line and require removal for the new building construction. One of the limbs that requires removal is supporting another which could fail once removed (*photos on page 8*). There is also a large wound on the tree from a stem that had previously failed (*photo on page 9*). This heavy pruning will create large wounds that this specimen will not likely compartmentalize before significant decay sets in. Additionally, these aggressive pruning reductions will cause undesirable advantageous growth that is detrimental to the overall structural stability of the remaining plant structure. Therefore complete removal is recommended.

This upper stem is being supported by the stem beneath it. Due to this support it will not have likely grown the reactive tissue to support its own weight.

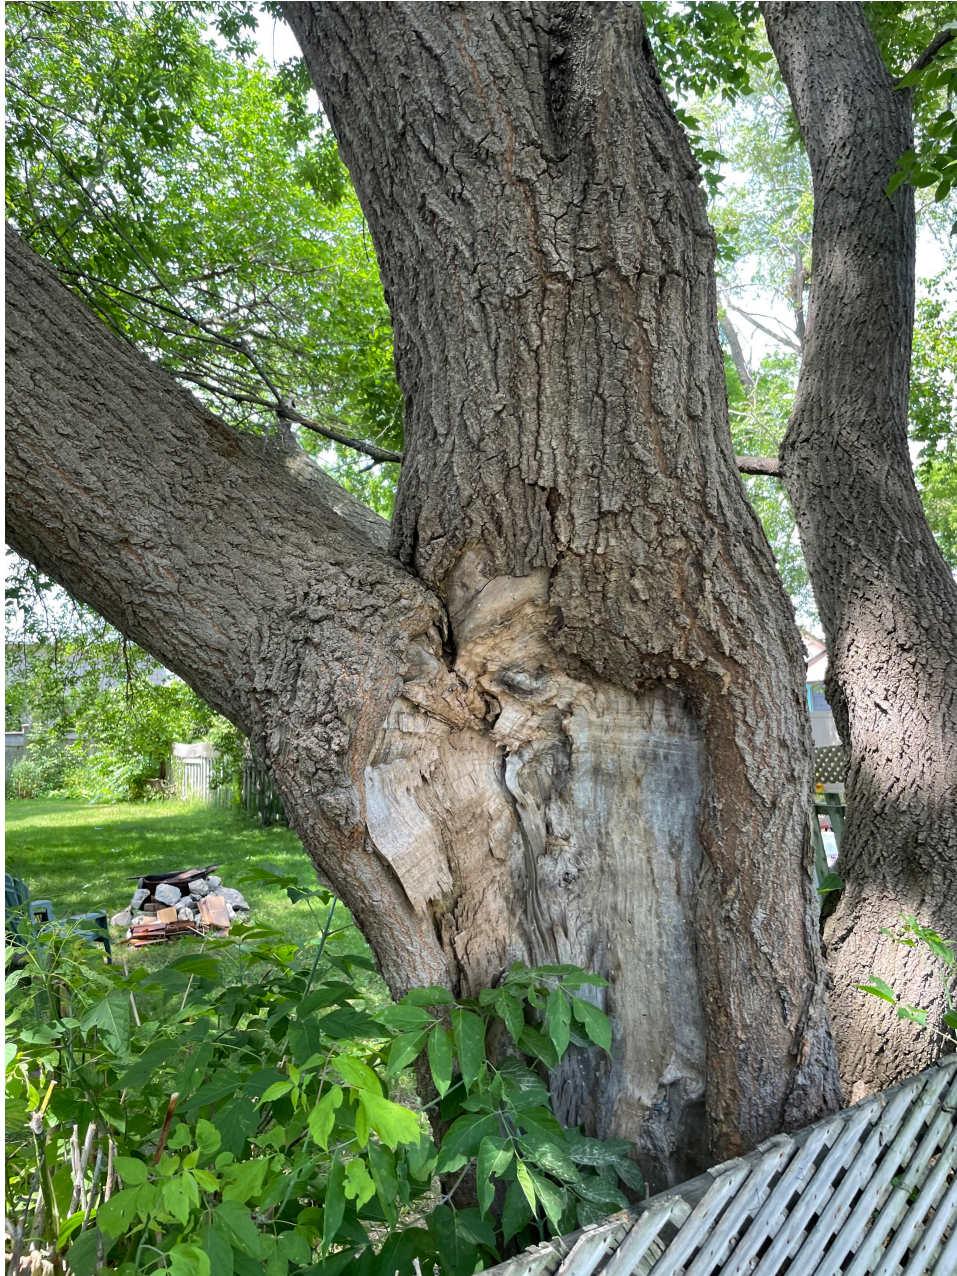
## 20. Manitoba maple

This wound is far too large for this Manitoba maple to compartmentalize within its expected lifetime. This reason alone makes this specimen a candidate for removal.
