PROJECT NO: 1953-5729

**RE: 400 MAPLE STREET, TOWN OF COLLINGWOOD
TREE INVENTORY AND ASSESSMENT UPDATE**

Arborist Report

Anex Project – Silver maples along Fifth Street, Collingwood

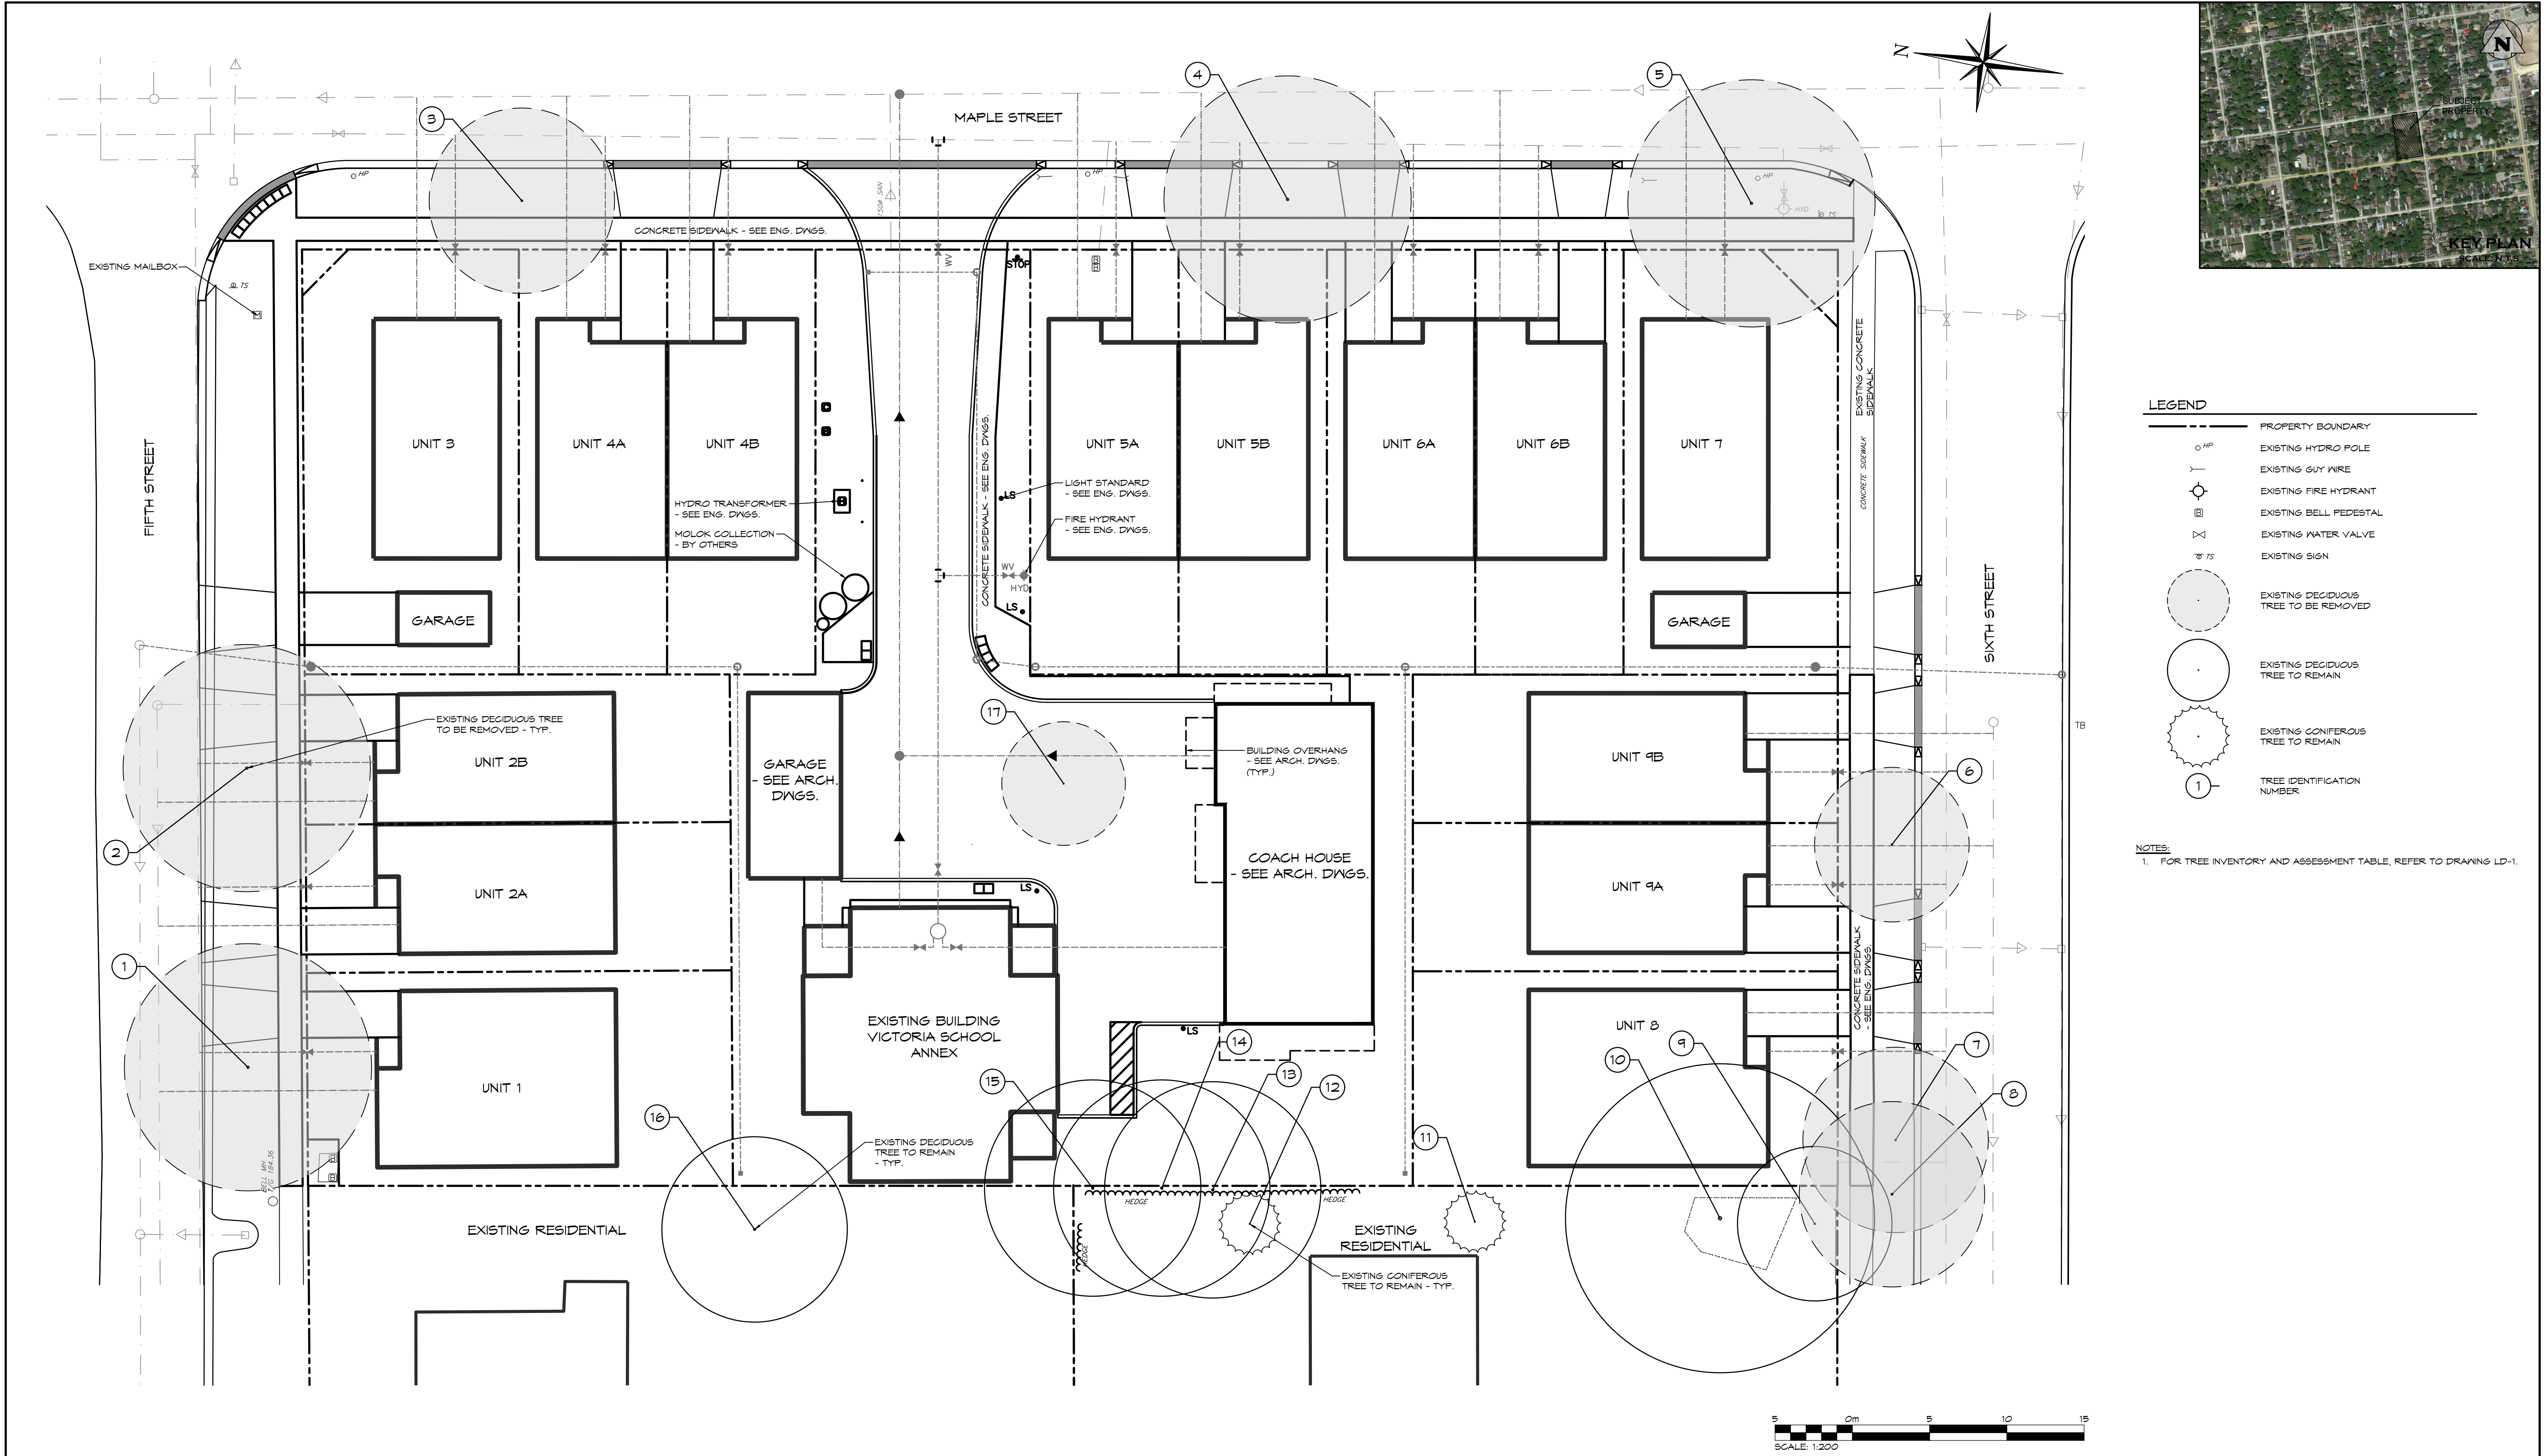
Project: **400 MAPLE STREET**
TOWN OF COLLINGWOOD
Drawing: **TREE MANAGEMENT PLAN**

Seventeen (17) trees were inventoried: one (1) on the development, eight (8) within Town right-of-way, and eight (8) on the neighbouring properties. The inventory is summarized graphically in the Tree Management Plan (attached), which shall always be read in conjunction with this letter. The trees are identified in terms of species, condition and recommendations. The condition of trees range from excellent to poor.

Overall, the general condition of the trees inventoried were of low quality. A number of the trees have coppice growth, and several of those stems create a hazardous situation (greater than 30° lean). Due to the proximity to the proposed development works, nine (9) trees are recommended for removal, and five (5) trees are recommended for pruning due to hazardous limbs, which may facilitate their removal. Engagement with the neighbouring property owner will be required.

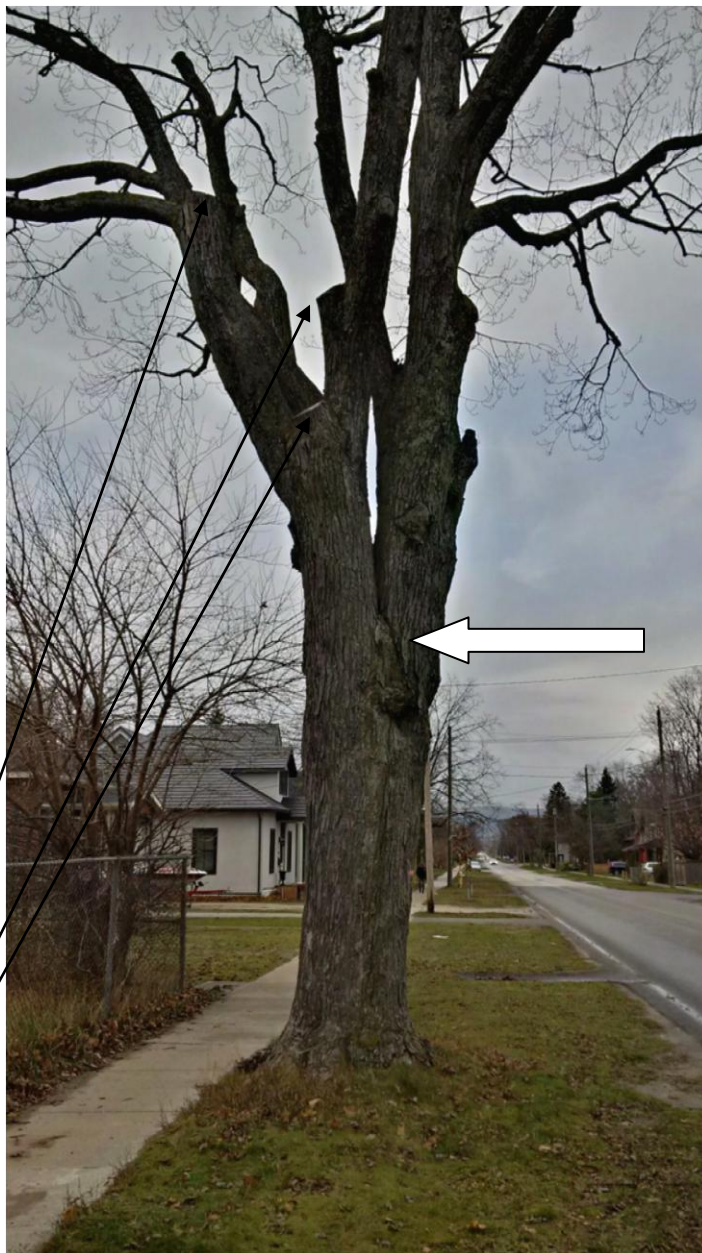
Tree # 1 – Western silver maple – showing included bark at main union and large pruning cuts as entry points to decay

These mature specimens exhibit several points of concern, and while pruning and cabling may stabilize the canopy, the tree is left vulnerable to complete failure at the trunk/soil interface due to the compromised southern root flares. Shoot elongation has seen a notable decline in our assessment period and for the past 5-7 years the growth was negligible; ongoing activity under the dripline will weaken the trees further, leading to more rapid decline and dieback. It is the sum of these effects and stresses which lead us to recommend complete removal for both of these trees. Planting of suitable species following the construction projects completion is recommended.

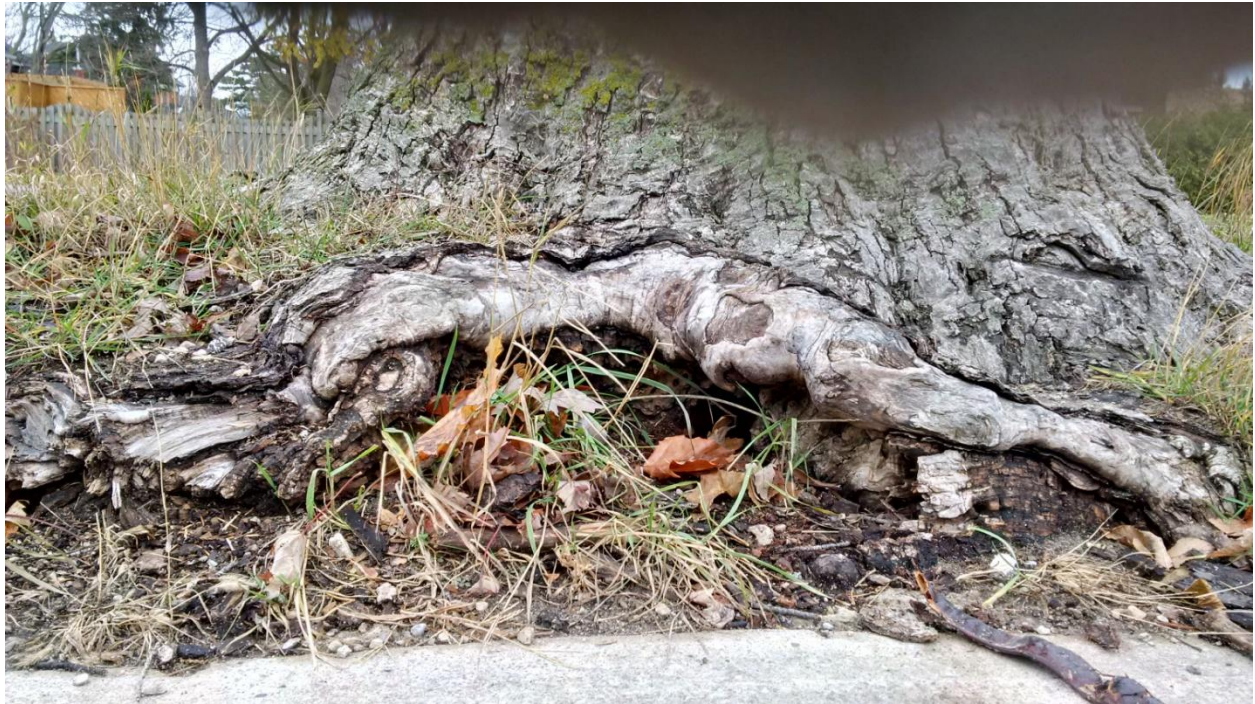
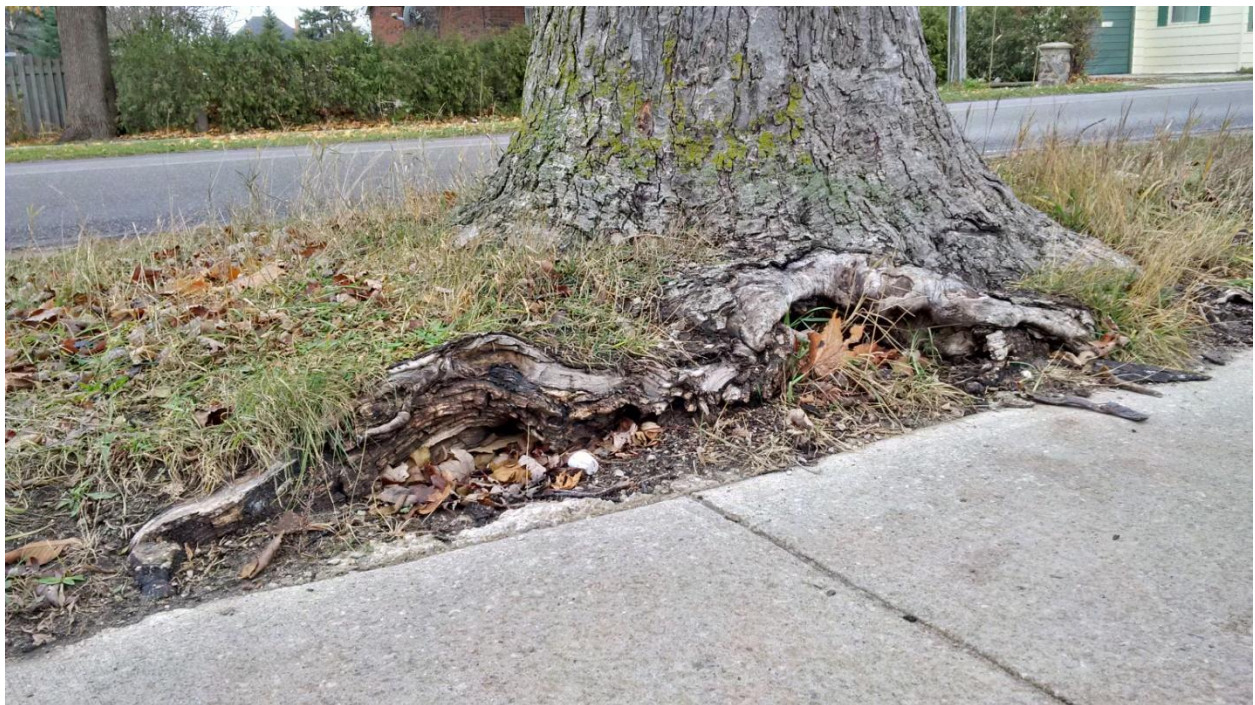
Roots and root flares are heavily impacted by sidewalk proximity and sidewalk snow clearing activity and have several cavities which are degrading the southern flare integrity (photos on page 6 and 8). It is one of these cavities that has allowed the spread of decay into the trunk in tree # 1 as shown by the heartwood analysis results on page 10. This cavity is over 40cm deep and leaves the southern lower side (at testing point) with no more than 4cm of trunk wall thickness.

Tree # 1 – Basal root flare along sidewalk showing decay – south side of tree

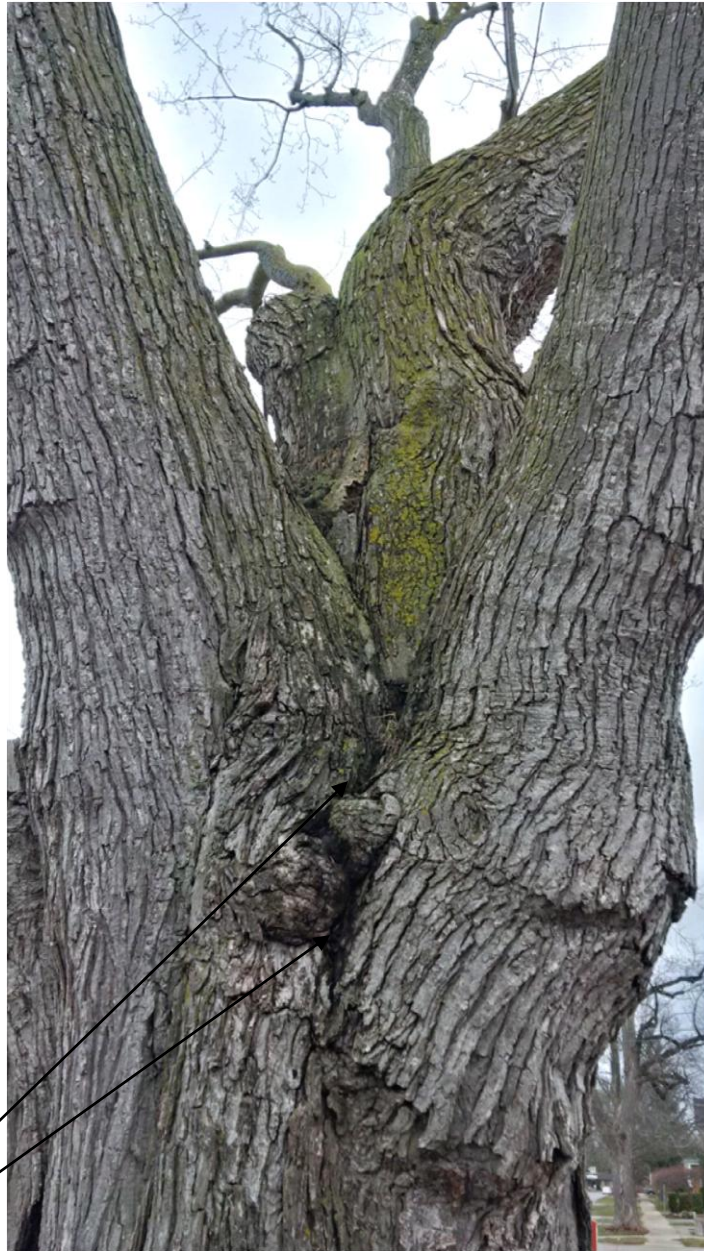
Tree # 2 – Eastern silver maple – poorly formed union with several stems sharing dominance

Included bark arising from stems of near equal size developing at low degree acute angles.

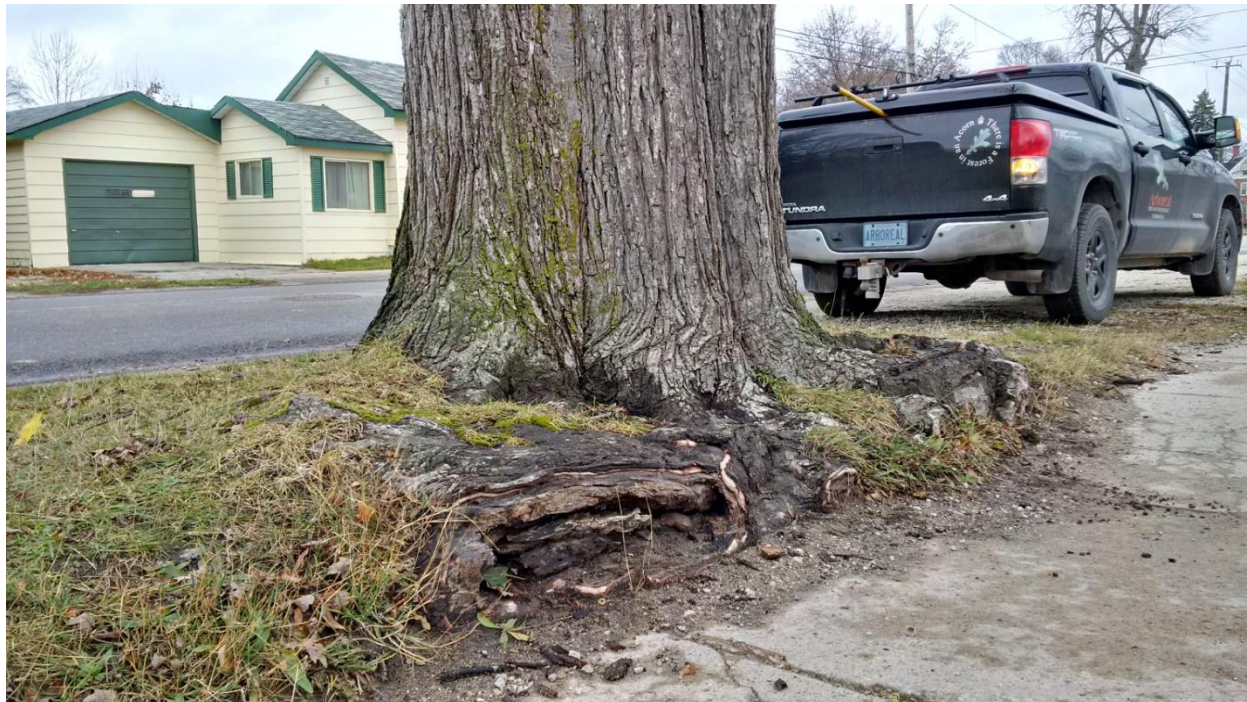
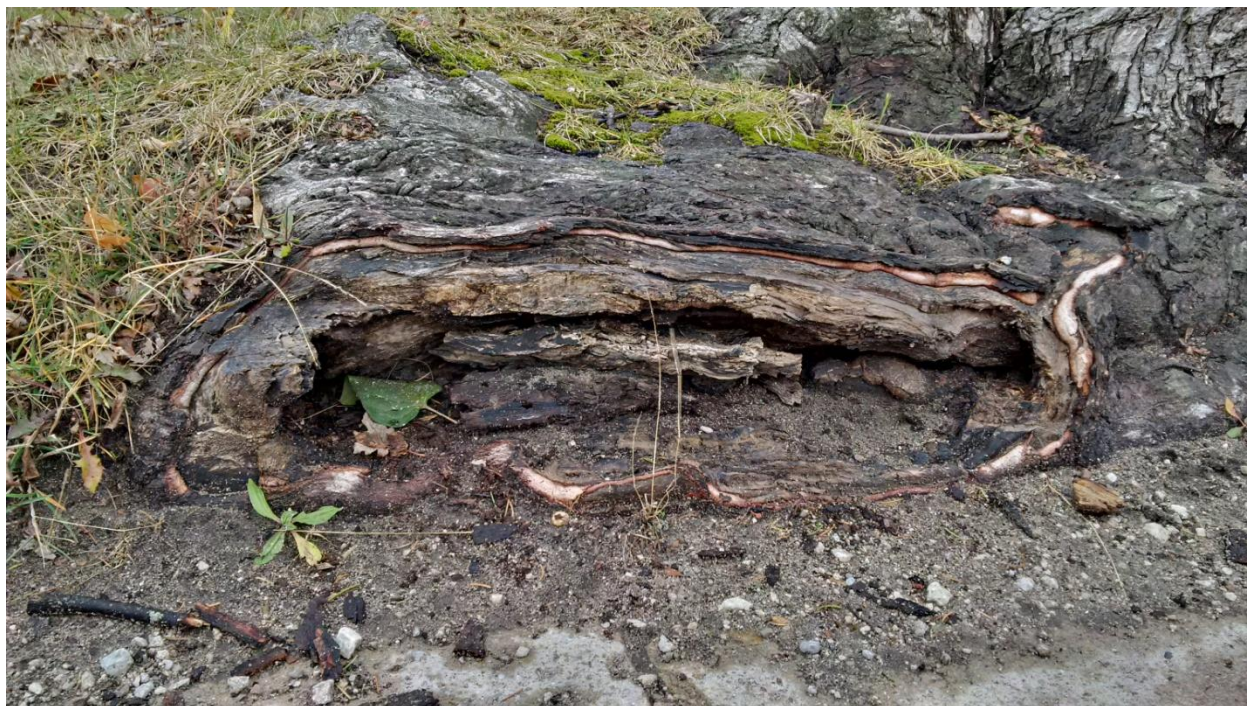
Tree # 2 - Basal root flare along sidewalk showing decay – south side of tree

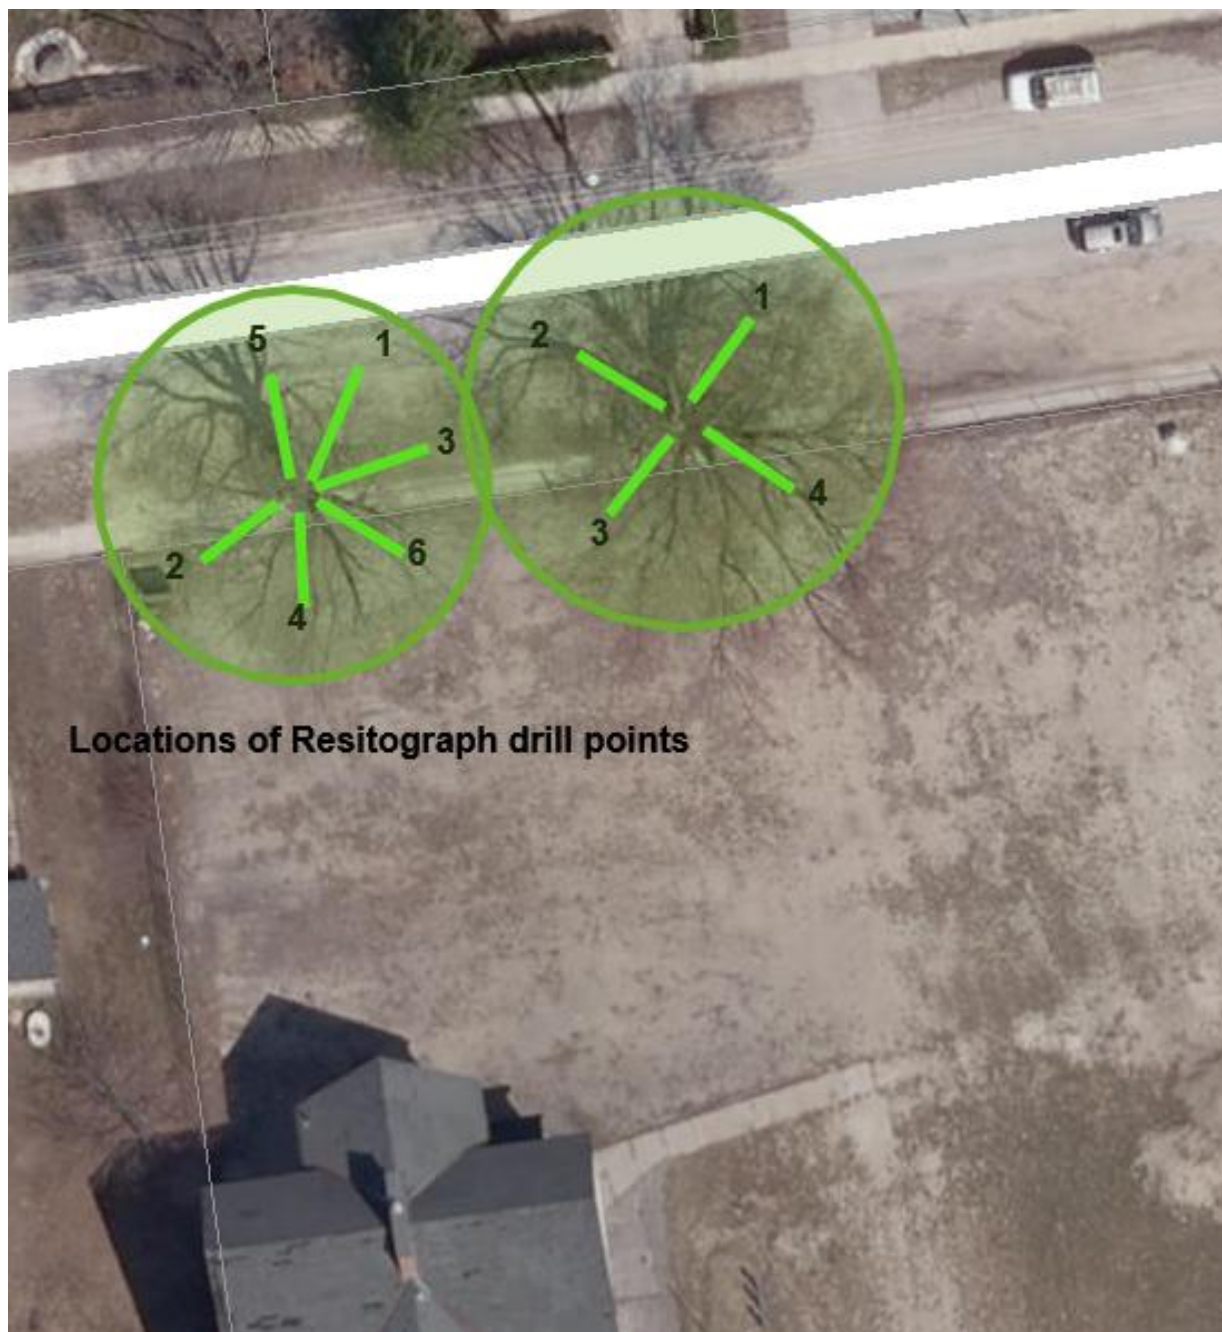
Heartwood analysis drill point locations – numbers correlate with field printouts from Resitograph

Cavity yes/no	Cavity size / comments	Drill point height from grade - cm
1	No	Test shows no defect	75
2	No	Test shows no defect	75
3	No	Test shows no defect	75
4	No	Test shows no defect	30
5	Yes	Wall (trunk) thickness only 3cm	30
6	Yes	Wall thickness only 4cm	30

Cavity yes/no	Cavity size / comments	Drill point height from grade - cm
1	No	Test shows no defect	100
2	No	Test shows no defect	100
3	No	Test shows no defect	100
4	No	Test shows no defect	30
