DESIGNATED SUBSTANCES AND HAZARDOUS MATERIALS SURVEY

**CITY OF COLLINGWOOD
COLLINGWOOD TERMINALS**

ECOH Project No.: 17384

May 2017

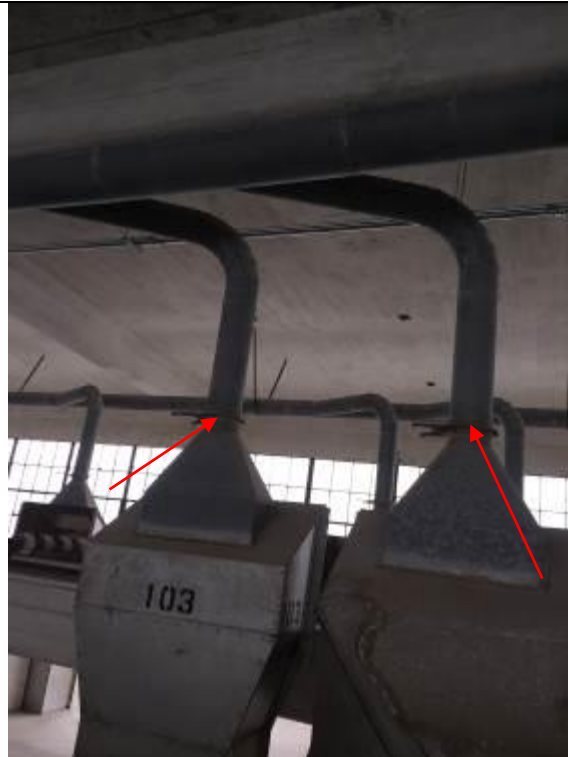
Grey mastic was observed to be present on ducts within the Bin Floor (2nd Floor) of the main terminal building. ECOH sampled this material and laboratory analysis determined this material is **asbestos-containing**.

Grey mastic on ducts, **asbestos-containing**.

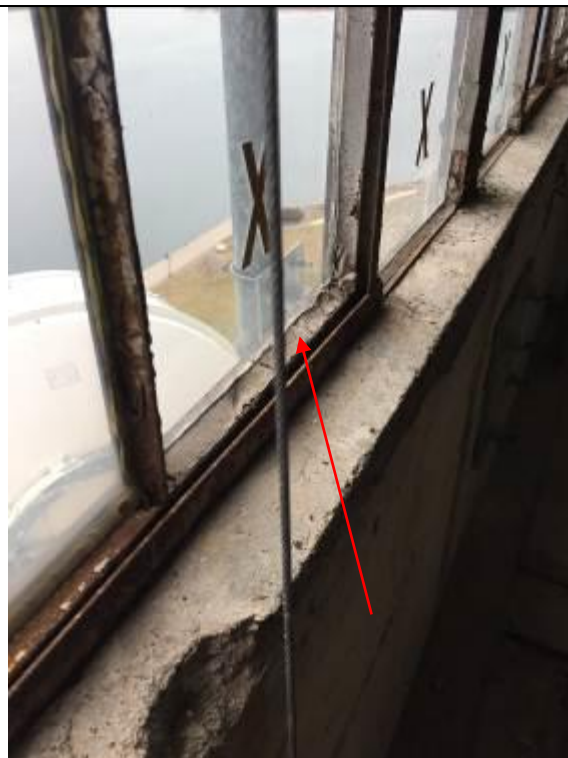
Photo No. 2.

- Grey caulking around windows was observed to be present around all windows throughout the Project Area. ECOH sampled this material from various locations and laboratory analysis determined this material is **asbestos-containing**.
- Grey caulking on the backside, between sheets of transite board was observed to be present in the stairwells of the terminals. ECOH sampled this material from the stairwells of the main terminal building and laboratory analysis determined this material is **asbestos-containing**. This material may be present in areas that are inaccessible.

Grey caulking around the
windows, **asbestos-containing**.

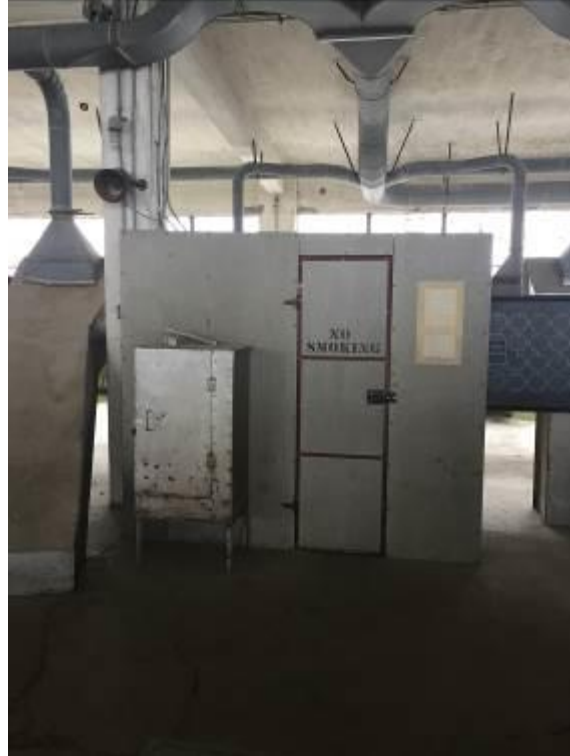
Transite cement board was observed in the stairwells of the main terminal building, on the walls and ceilings of the mini offices throughout the Project Area, and on the second-floor walls of the transformer room (red brick building). ECOH sampled transite cement board from various locations and laboratory analysis determined this material is **asbestos-containing**. Transite cement board is presumed to be present in other locations throughout the Project Area not mentioned above.

Mini office made from transite
cement board, **asbestos-**
containing.

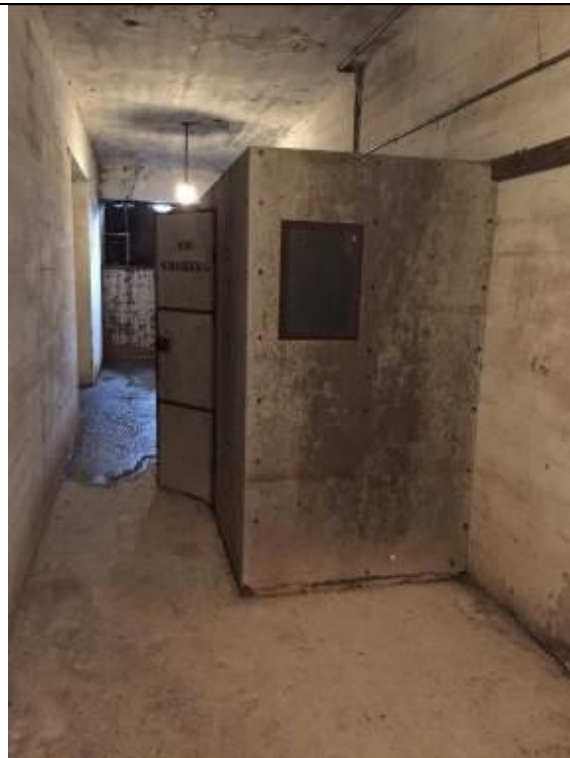
Photo No. 4.

Storage room made from
transite cement board, **asbestos-**
containing

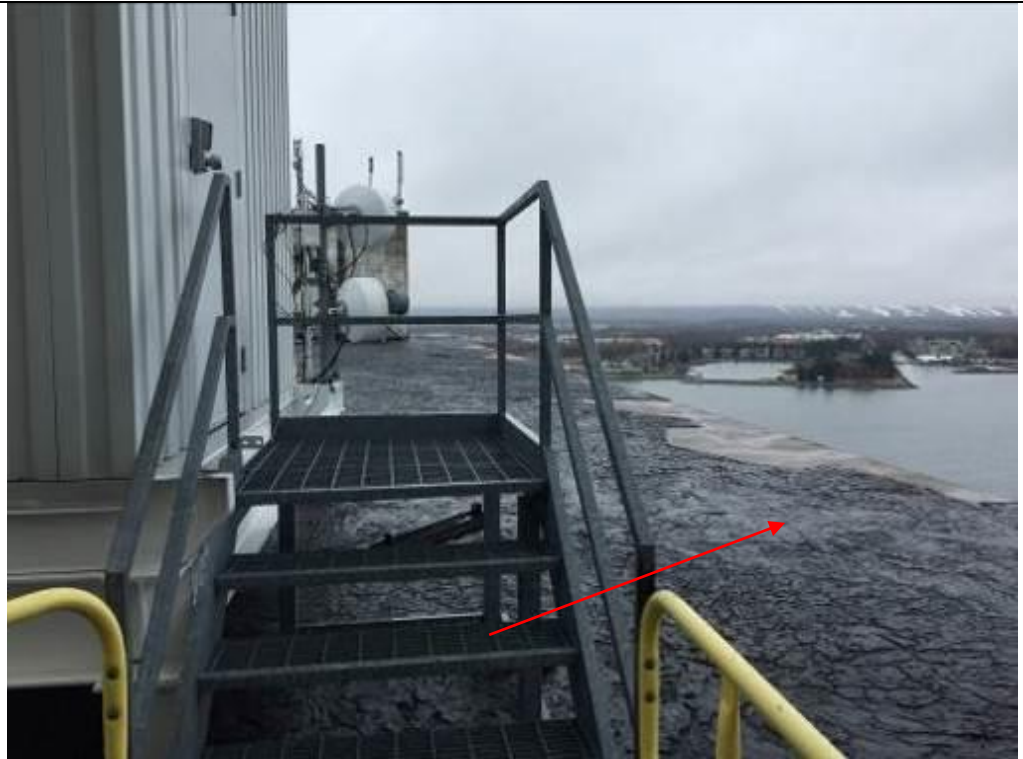
Black roofing materials were observed to be present on the roof of the Project Area. ECOH sampled this material and laboratory analysis determined this material is **asbestos-containing**,

Black roofing material,
asbestos-containing.

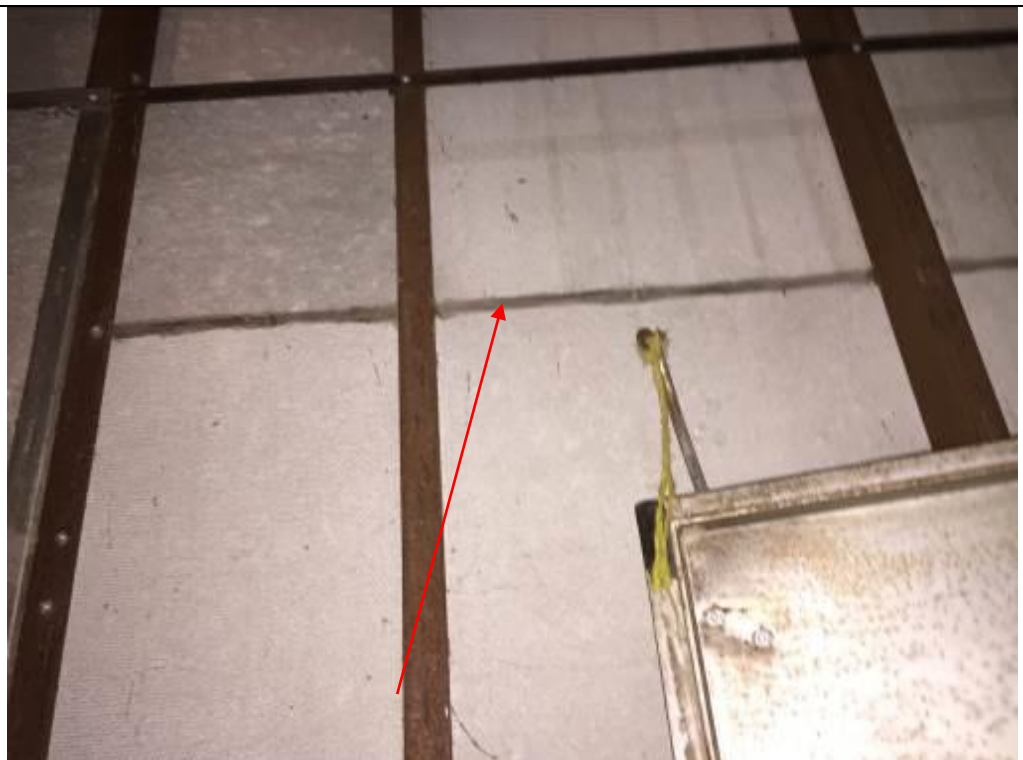
Photo No. 6.

Grey caulking on the backside,
between sheets of transite
board, **asbestos-containing.**

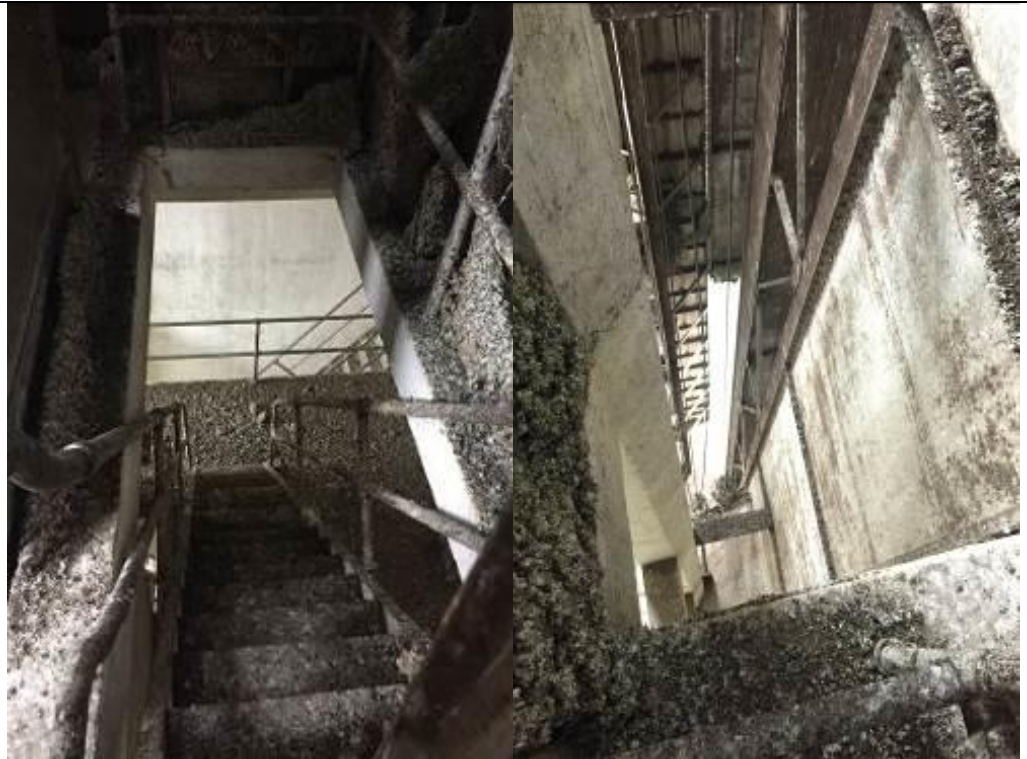
Bird droppings (varying in depth from several inches to several feet) were observed on all surfaces throughout the Marine Tower and associated areas. Many live birds inhabit this part of the project area.

Bird droppings present all
throughout the Marine Tower.

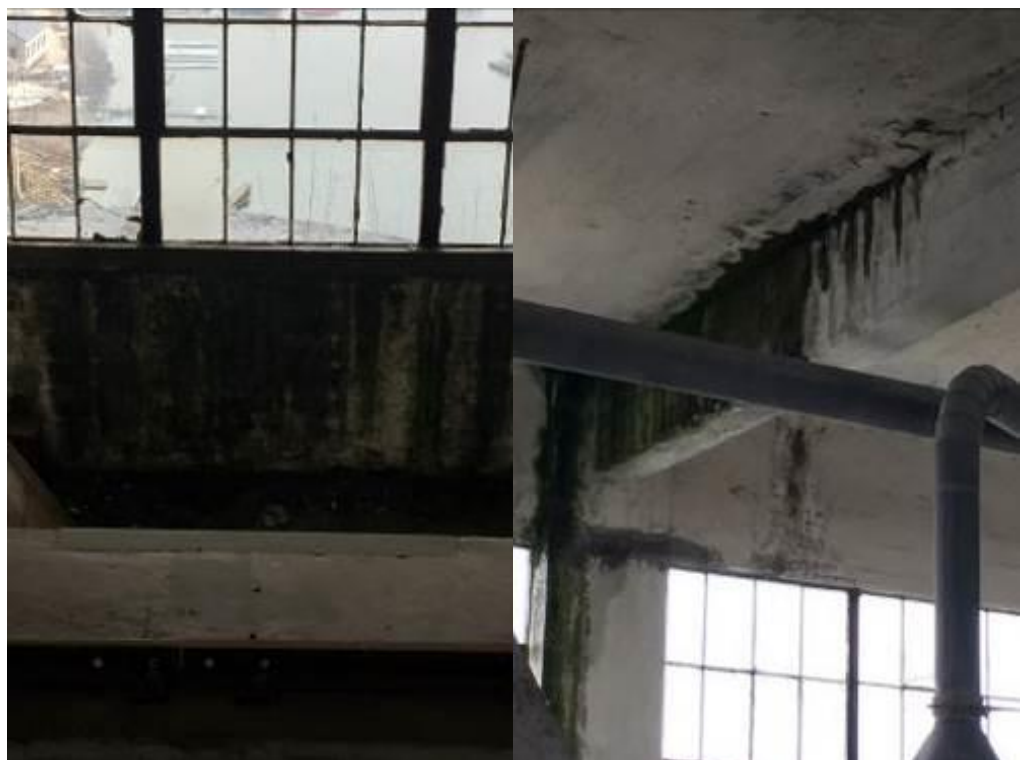
Photo No. 8.

Mildew observed on walls and
ceilings throughout the floor.

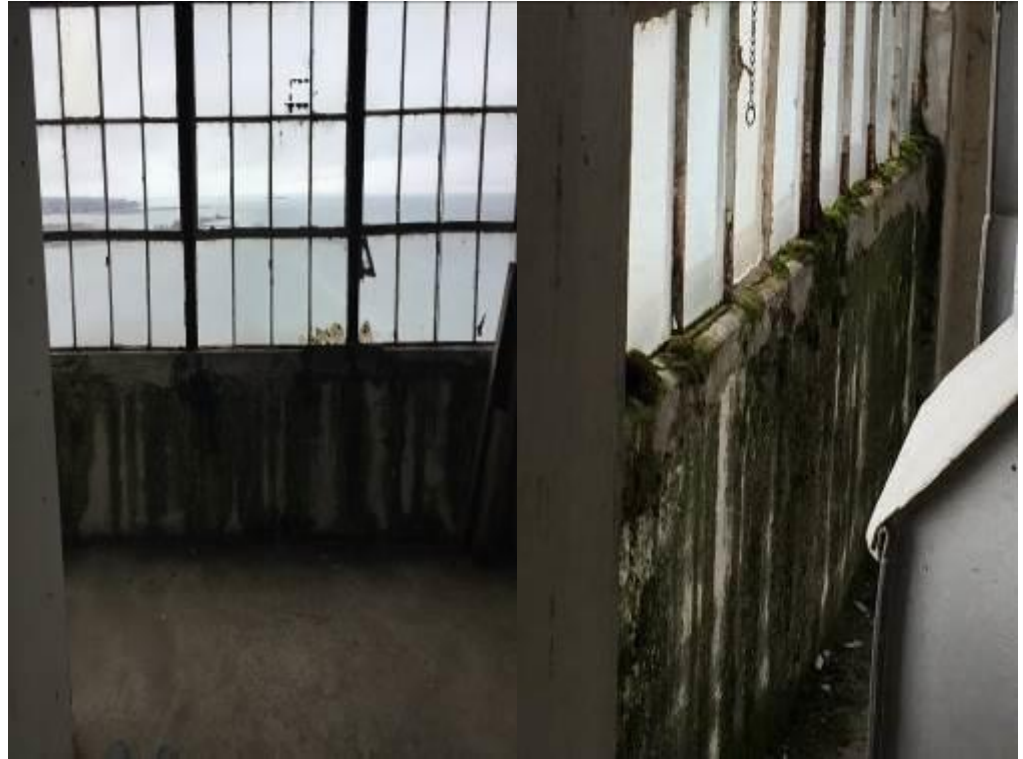
Mildew observed on walls and ceilings throughout the floor.

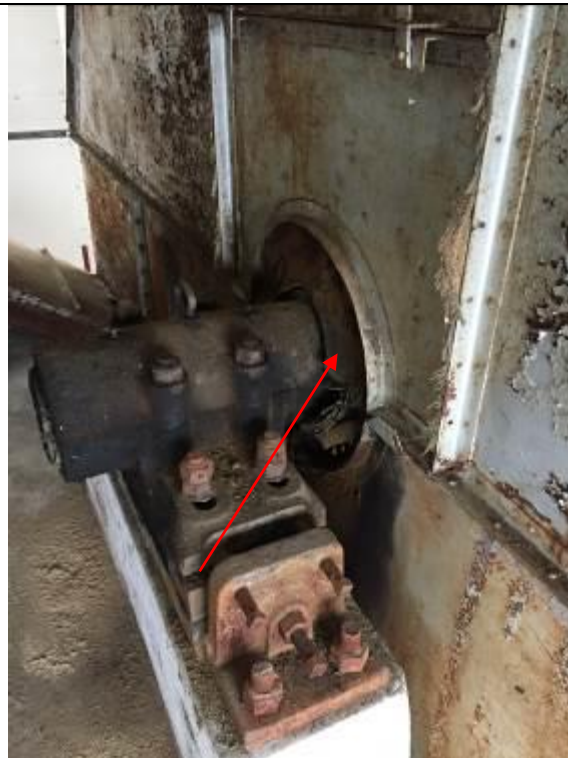
Photo No. 10.

Gaskets were observed on air handling units on the 4th floor mezzanine of the main terminal building. ECOH sampled this material and laboratory analysis determined this material does not contain asbestos.

Gaskets on mechanical equipment, does not contain asbestos.

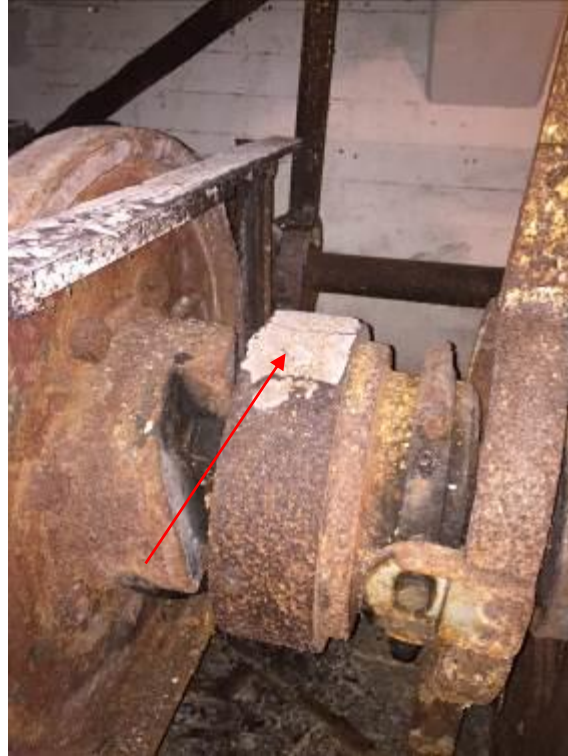
Unknown insulation material on
mechanical equipment, does not
contain asbestos.

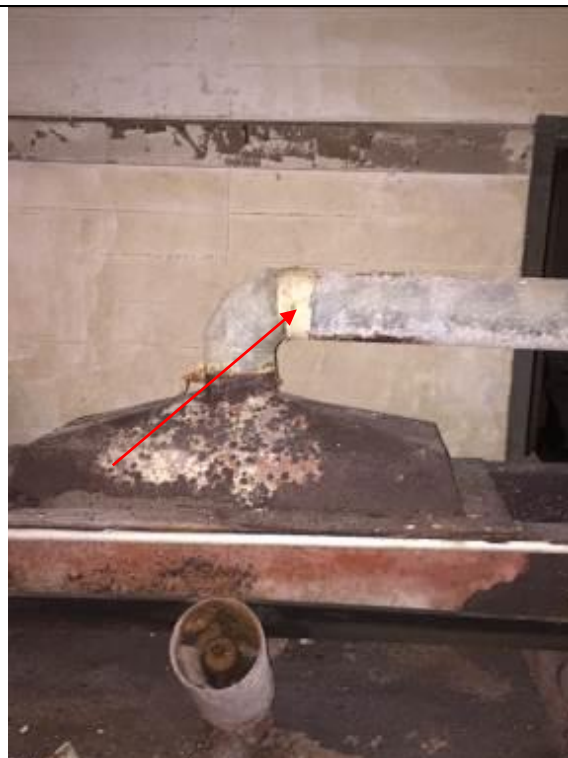
Photo No. 12.

Ducts observed throughout the Project Area were observed to be not insulated or insulated with non-asbestos materials (i.e. fibreglass, paper wrap, etc.). ECOH sampled paper wrap from duct work in the belt room (basement) and laboratory analysis determined this material does not contain asbestos.

Paper wrap on ducts, does not
contain asbestos.

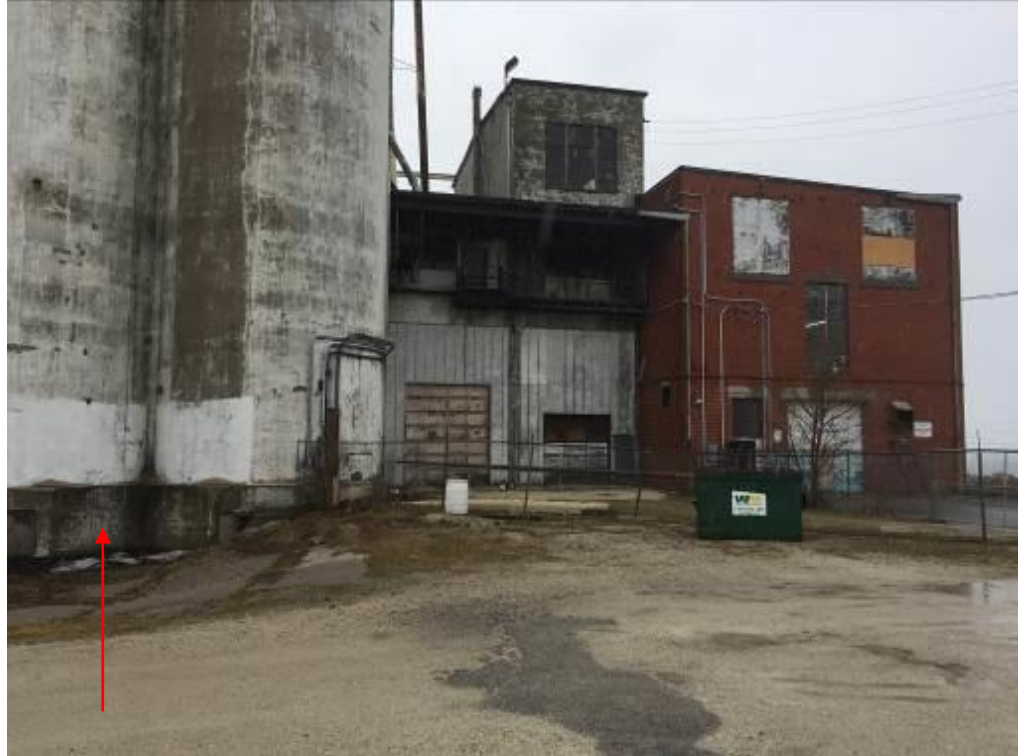
Tar was observed on the exterior base of the terminals. ECOH sampled this material and laboratory analysis determined this material does not contain asbestos.

Tar on the base of the terminals,
does not contain asbestos.

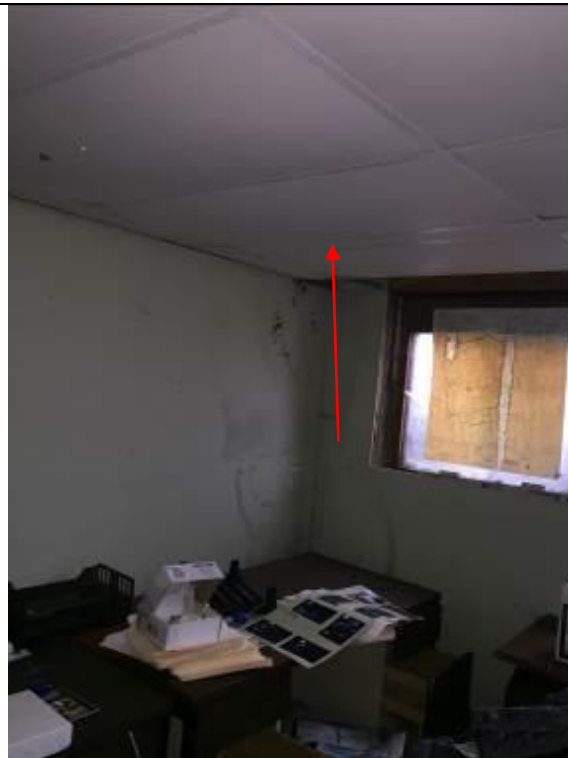
Photo No. 14.

One (1) type of acoustic ceiling tile (2'x4' White) was observed within the basement of the red brick building. ECOH sampled this material and laboratory analysis determined this material does not contain asbestos.

2'x4' White Ceiling Tiles, do
not contain asbestos.

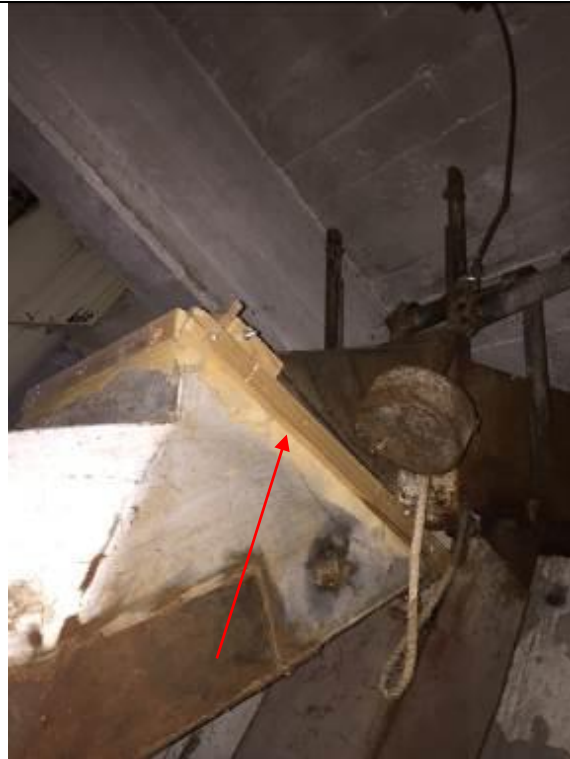
Flex duct connector, does not
contain asbestos.

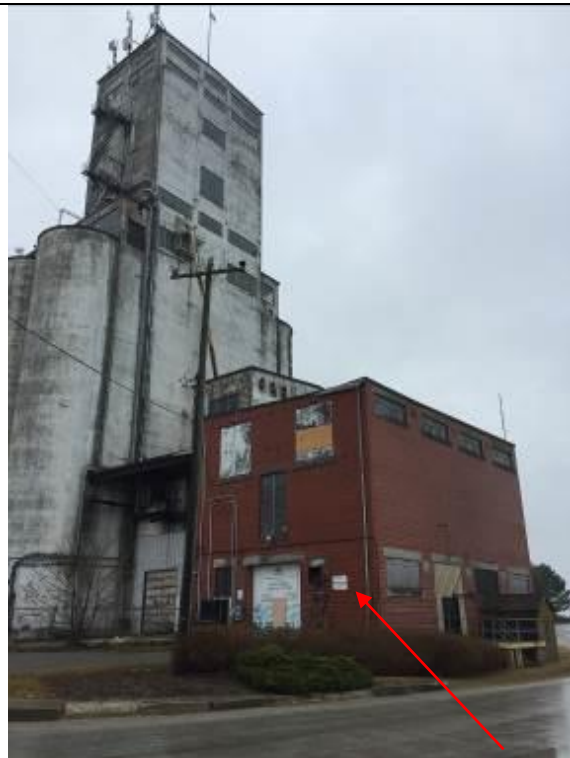
Photo No. 16.

Brick mortar was observed on the exterior and on some interior locations of the red brick building. ECOH sampled this material and laboratory analysis determined this material does not contain asbestos.

Brick mortar, does not contain
asbestos.

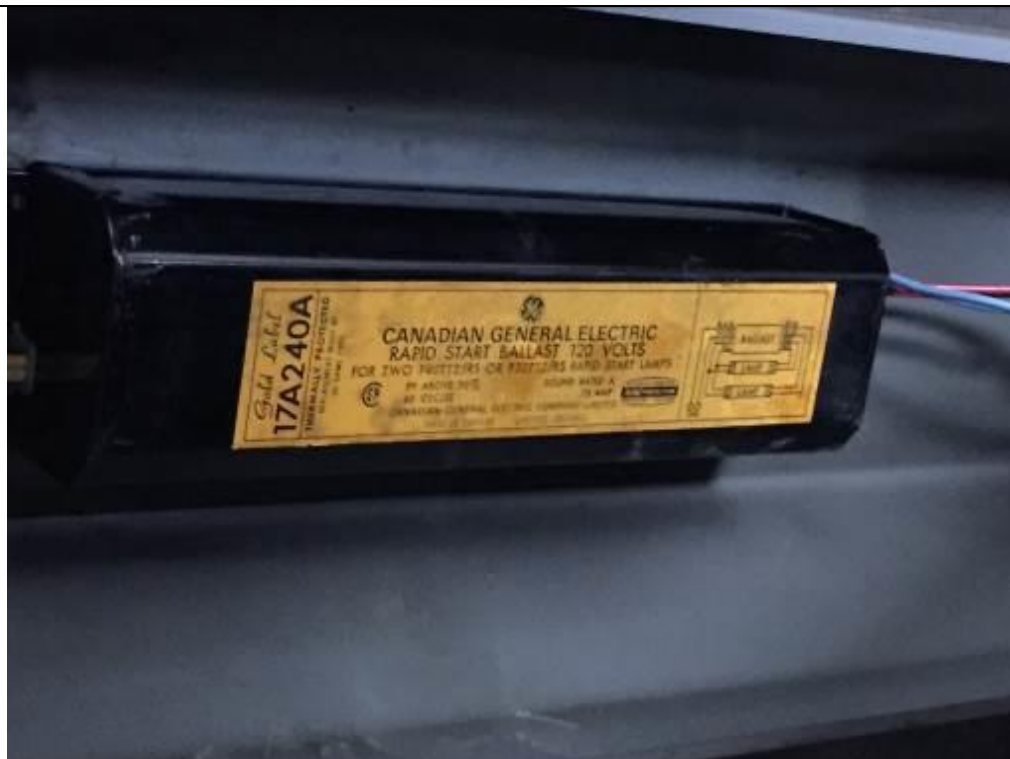
Light ballast, presumed to
contain PCBs.

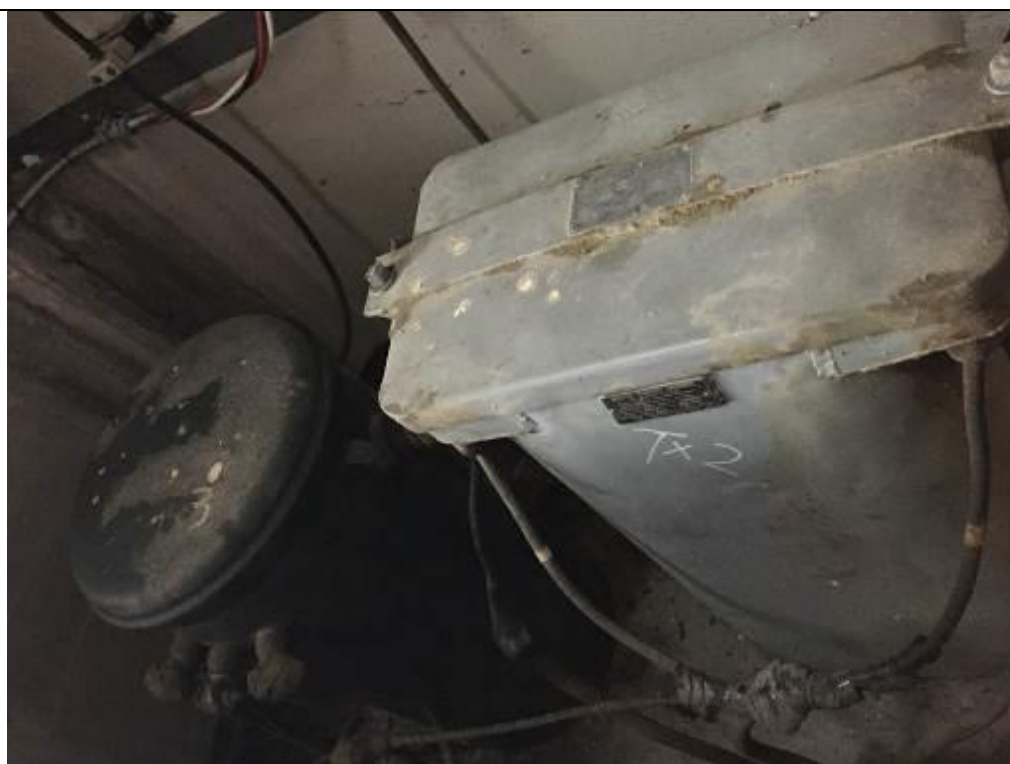
Photo No. 18.

Transformers, assumed to
contain PCBs.

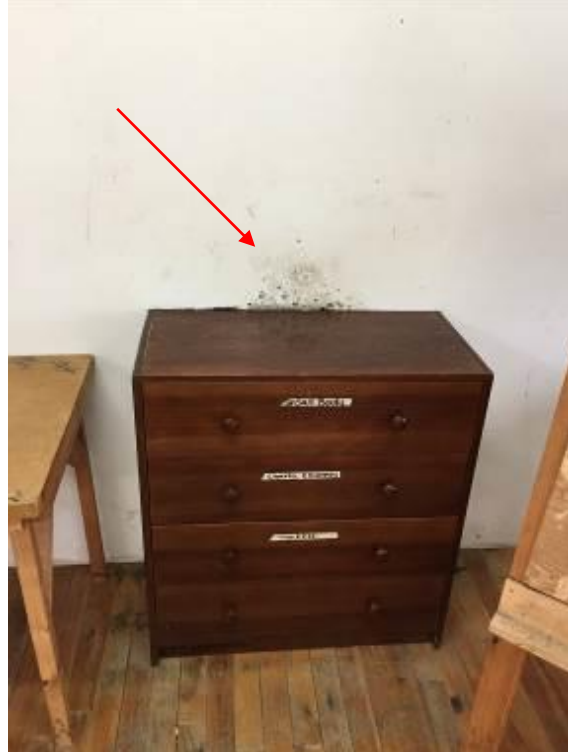
Mould-affected and water damaged building materials were identified in various locations throughout the Project Area at the time of assessment.

Mould affected and water
damaged drywall.

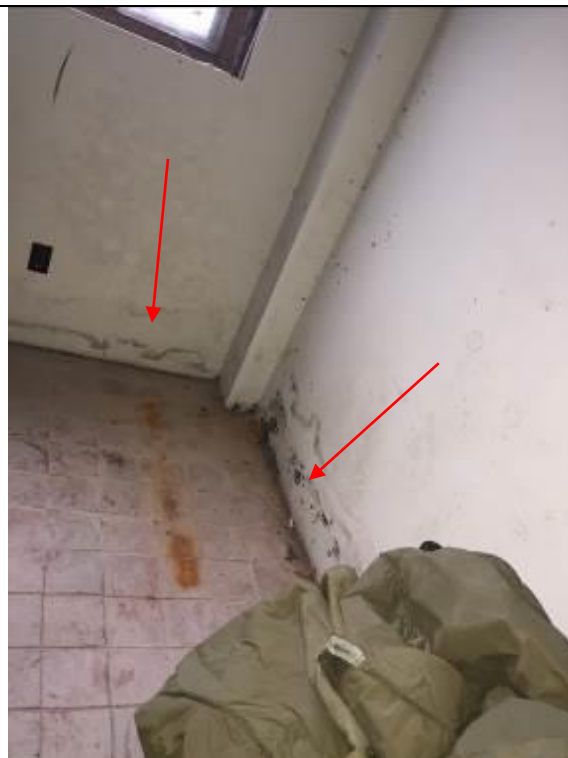
Photo No. 20.

Mould affected and water
damaged drywall.
