October 2, 2014

*Updated January 7, 2021*

**RE: LINKSVIEW DEVELOPMENT / BLUE MOUNTAIN GOLF & COUNTRY CLUB**

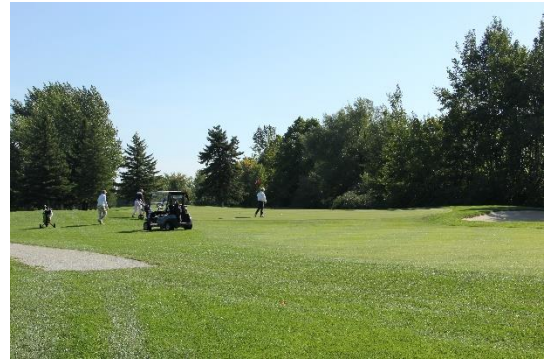
16<sup>th</sup> Green Near Property Line

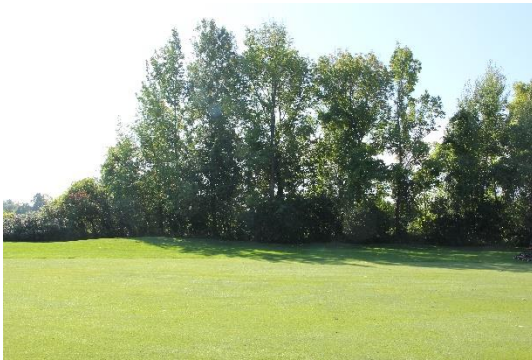
Hedgerow (typical)

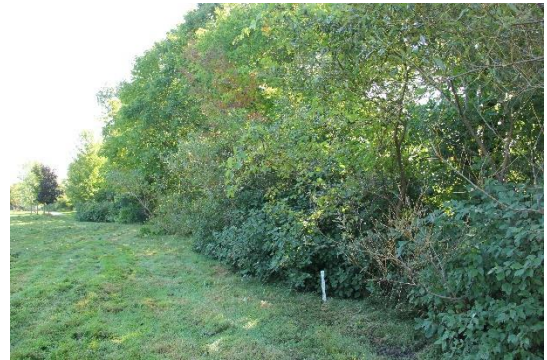
Dense Hedgerow Edge Near Tee

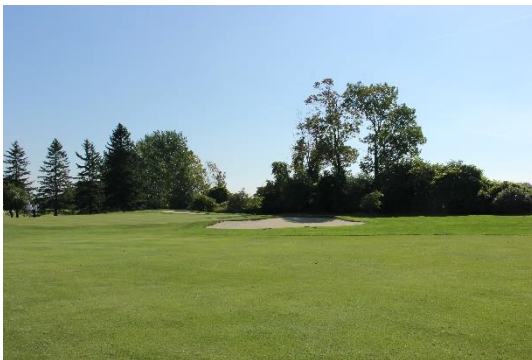
15<sup>th</sup> Green Near Property Line

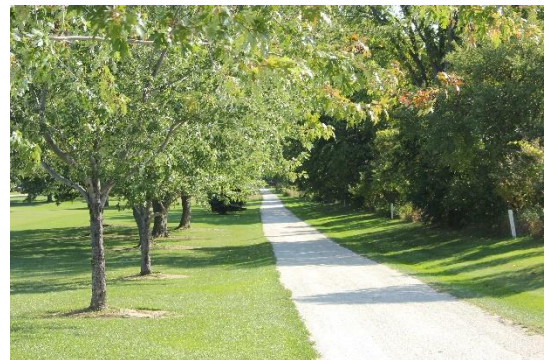
Additional Tree Planting on 18<sup>th</sup> Hole

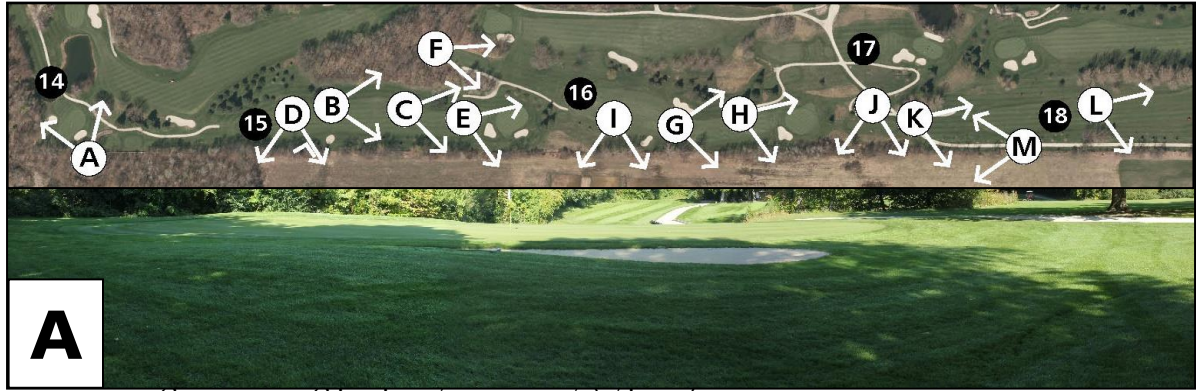
Lower hedge row adjacent to 15<sup>th</sup> green.  
 16<sup>th</sup> tee looking towards hedge row at landing area  
 16<sup>th</sup> fairway with intermittent hedge row at property line.

14<sup>th</sup> green looking back to the tee. Out of bounds at woodlot (behind).

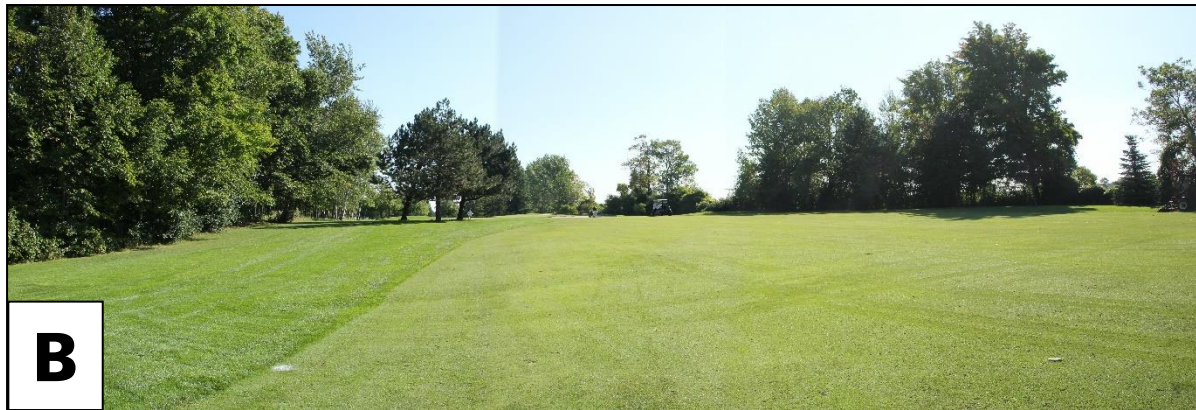
15<sup>th</sup> fairway at landing area looking towards green.

This hole plays parallel to the property line. The tee is located immediately adjacent to the woodlot which intercepts most errant shots towards the right side. The hedge row provides additional mitigation for most of the hole's length. The proximity of the fairway and the green to the south property boundary none the less still presents danger to the proposed residential lots.

*Recommendations:* The centre line of play from the tee should be directed further away from the property line. The fairway and green should be relocated approximately 60 metres away from the southern edge of the proposed buffer.

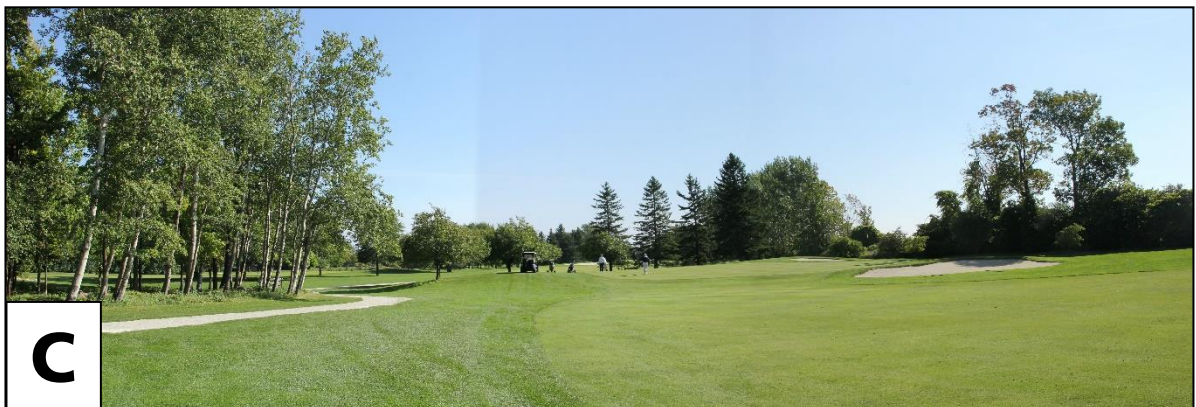
15<sup>th</sup> green, out of bounds right.

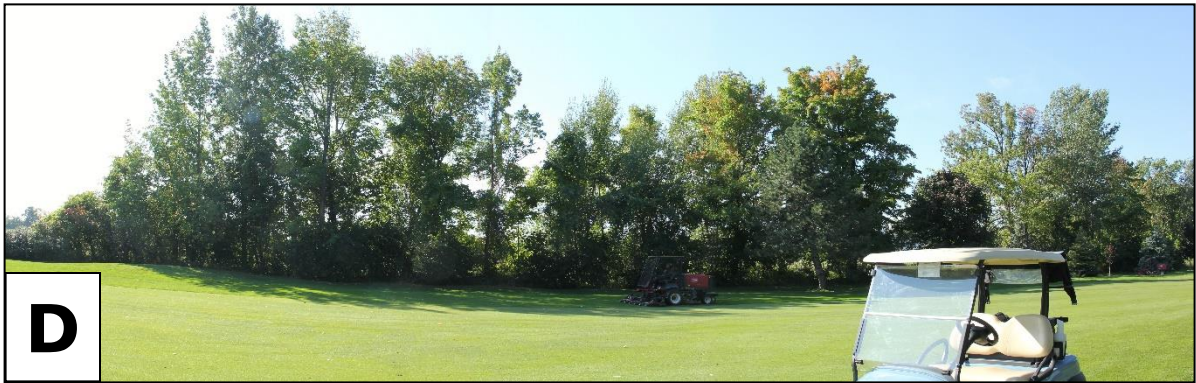
**D**

Mature hedge row along property boundary (typical).

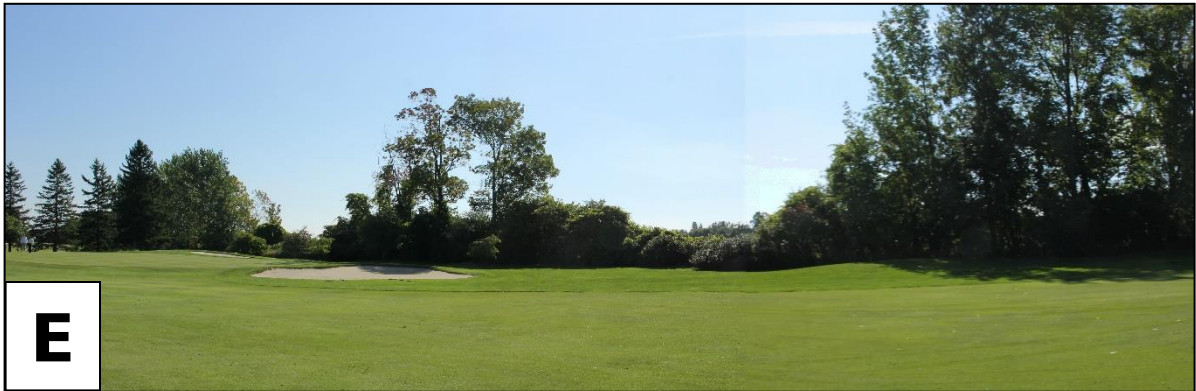
**E**

Lower hedge row adjacent to the 15<sup>th</sup> green.

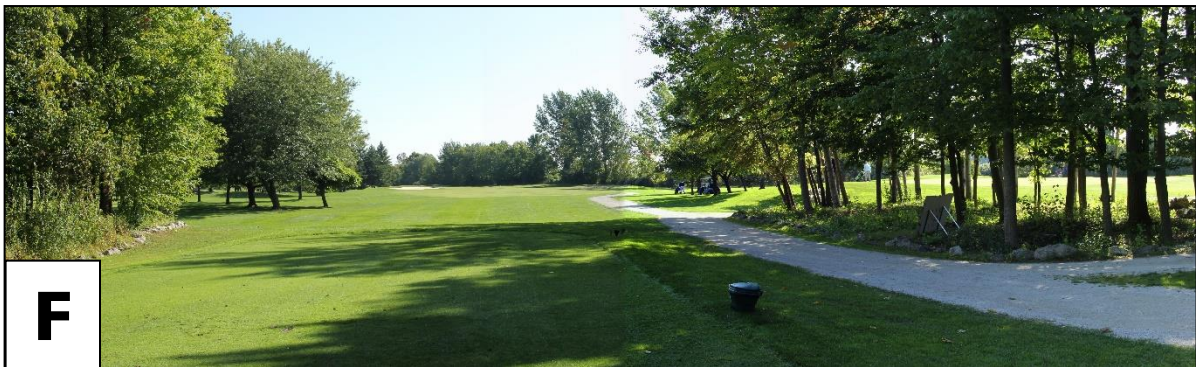
**F**

16<sup>th</sup> tee looking towards hedge row at landing area.

This hole plays diagonally towards the existing southern boundary of the property. The current landing area centre line is 22.7 metres from the property line. The centre of the green is 29.1 metres from the property line. The hedgerow at this point is sporadic, varying from low dense, thick shrubs to trees up to 12 metres in height.

*Recommendations:* The centre line of the hole from the tee should be moved left and the fairway redefined accordingly. The green and the centre line of the fairway should measure 60 metres from the southern edge of the proposed buffer.

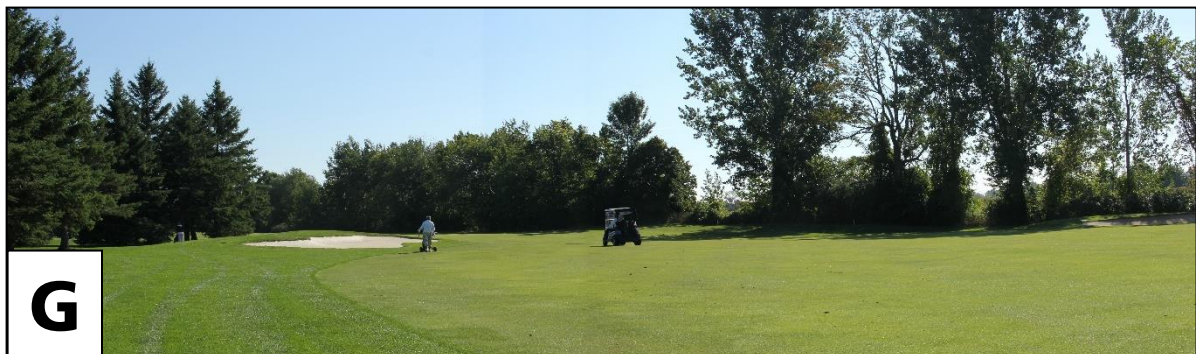
**G**

16<sup>th</sup> fairway with intermittent hedge row at property line.

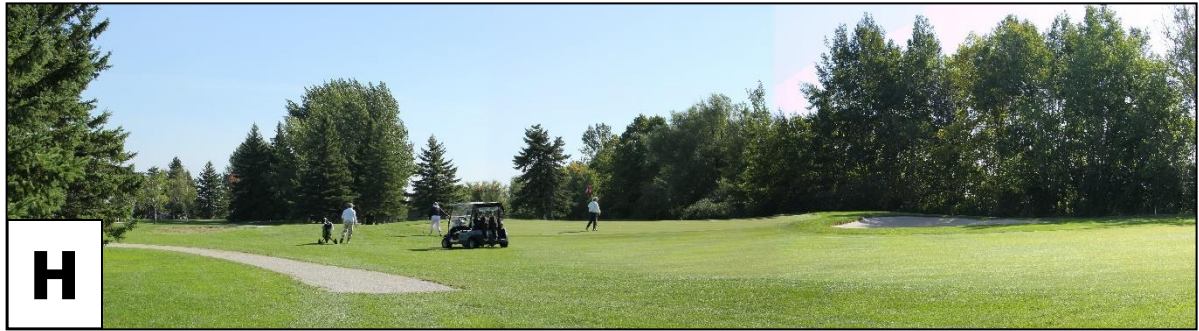
Dense hedge row at property line at 16<sup>th</sup> green.

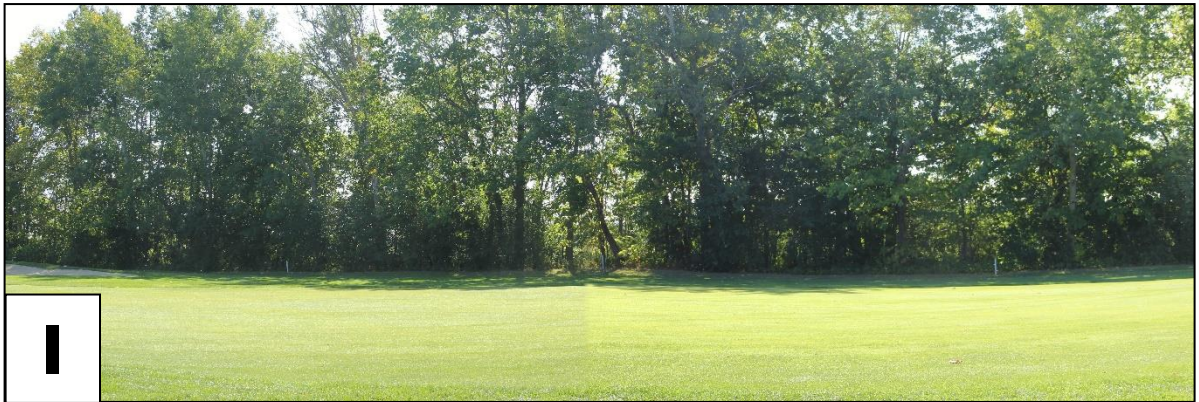
Thick hedge row near 16<sup>th</sup> green.

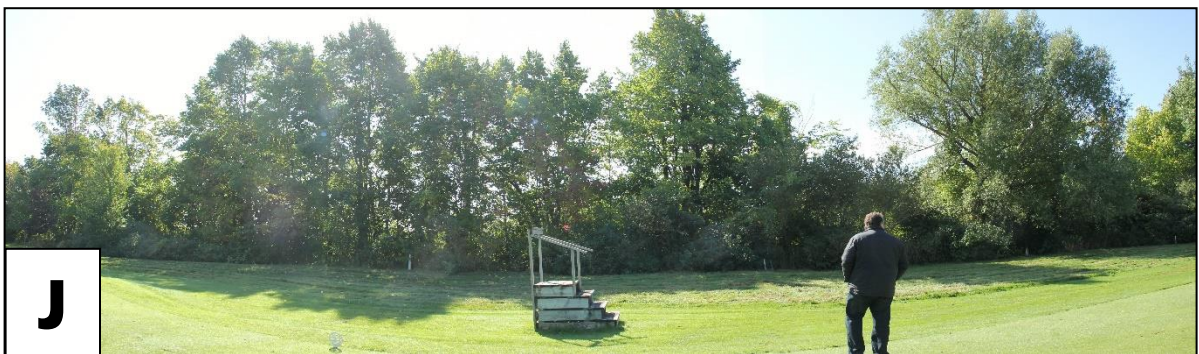
18<sup>th</sup> tee looking towards hedge row.

This hole is a long par 5. The tee and the centre line of play is 37.5 metres from the property line. From the first landing area the hole plays diagonally away from the property line. While the hedge row is sporadic, approximately 30 trees have been planted adjacent to the property line.

*Recommendations:* The tee should be relocated directly adjacent to the property line and the hole directed away from the property line. The centre line of play should be relocated 60 metres from the southern edge of the proposed buffer.

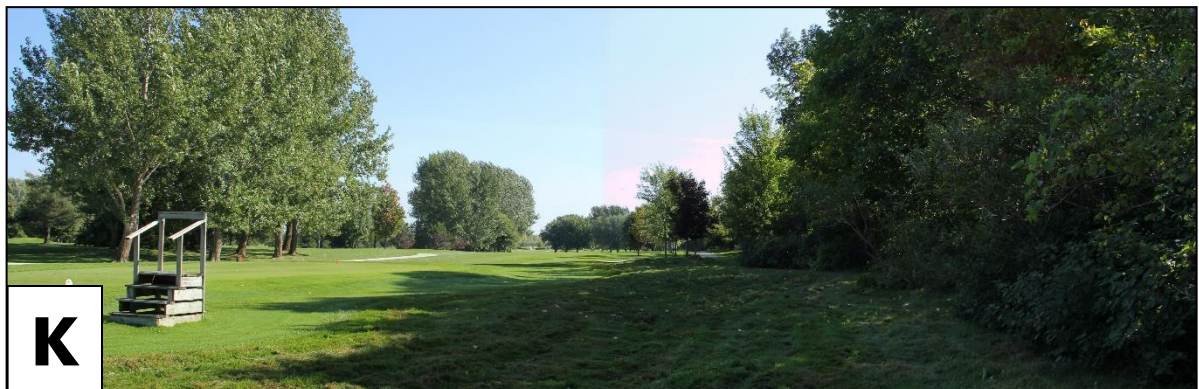
Right of 18<sup>th</sup> tee adjacent to dense hedgerow looking towards landing area.

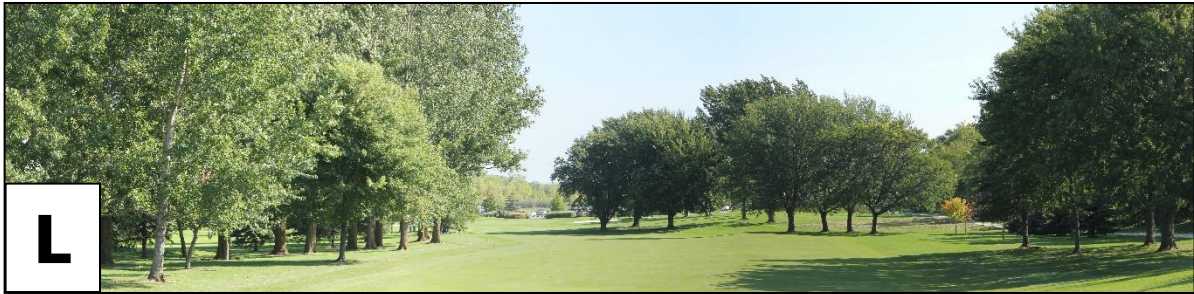
18<sup>th</sup> fairway moving away from property line. Additional tree planting on right.

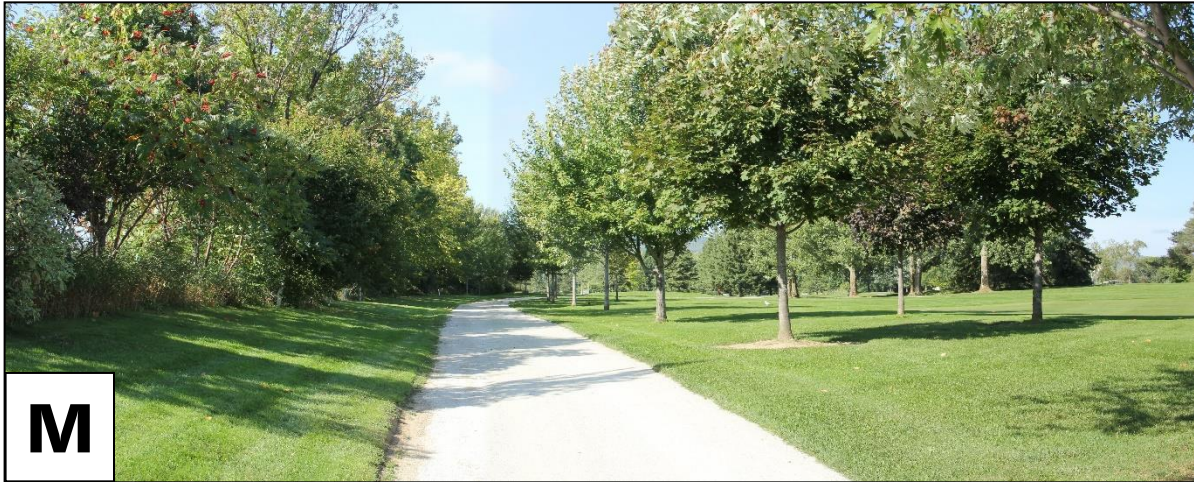
18<sup>th</sup> cart path looking back to the tee. Hedge row on left.
