# ARBORIST REPORT

11476 Highway 26  
Collingwood, Ontario

Prepared for

**INTEGRICON**

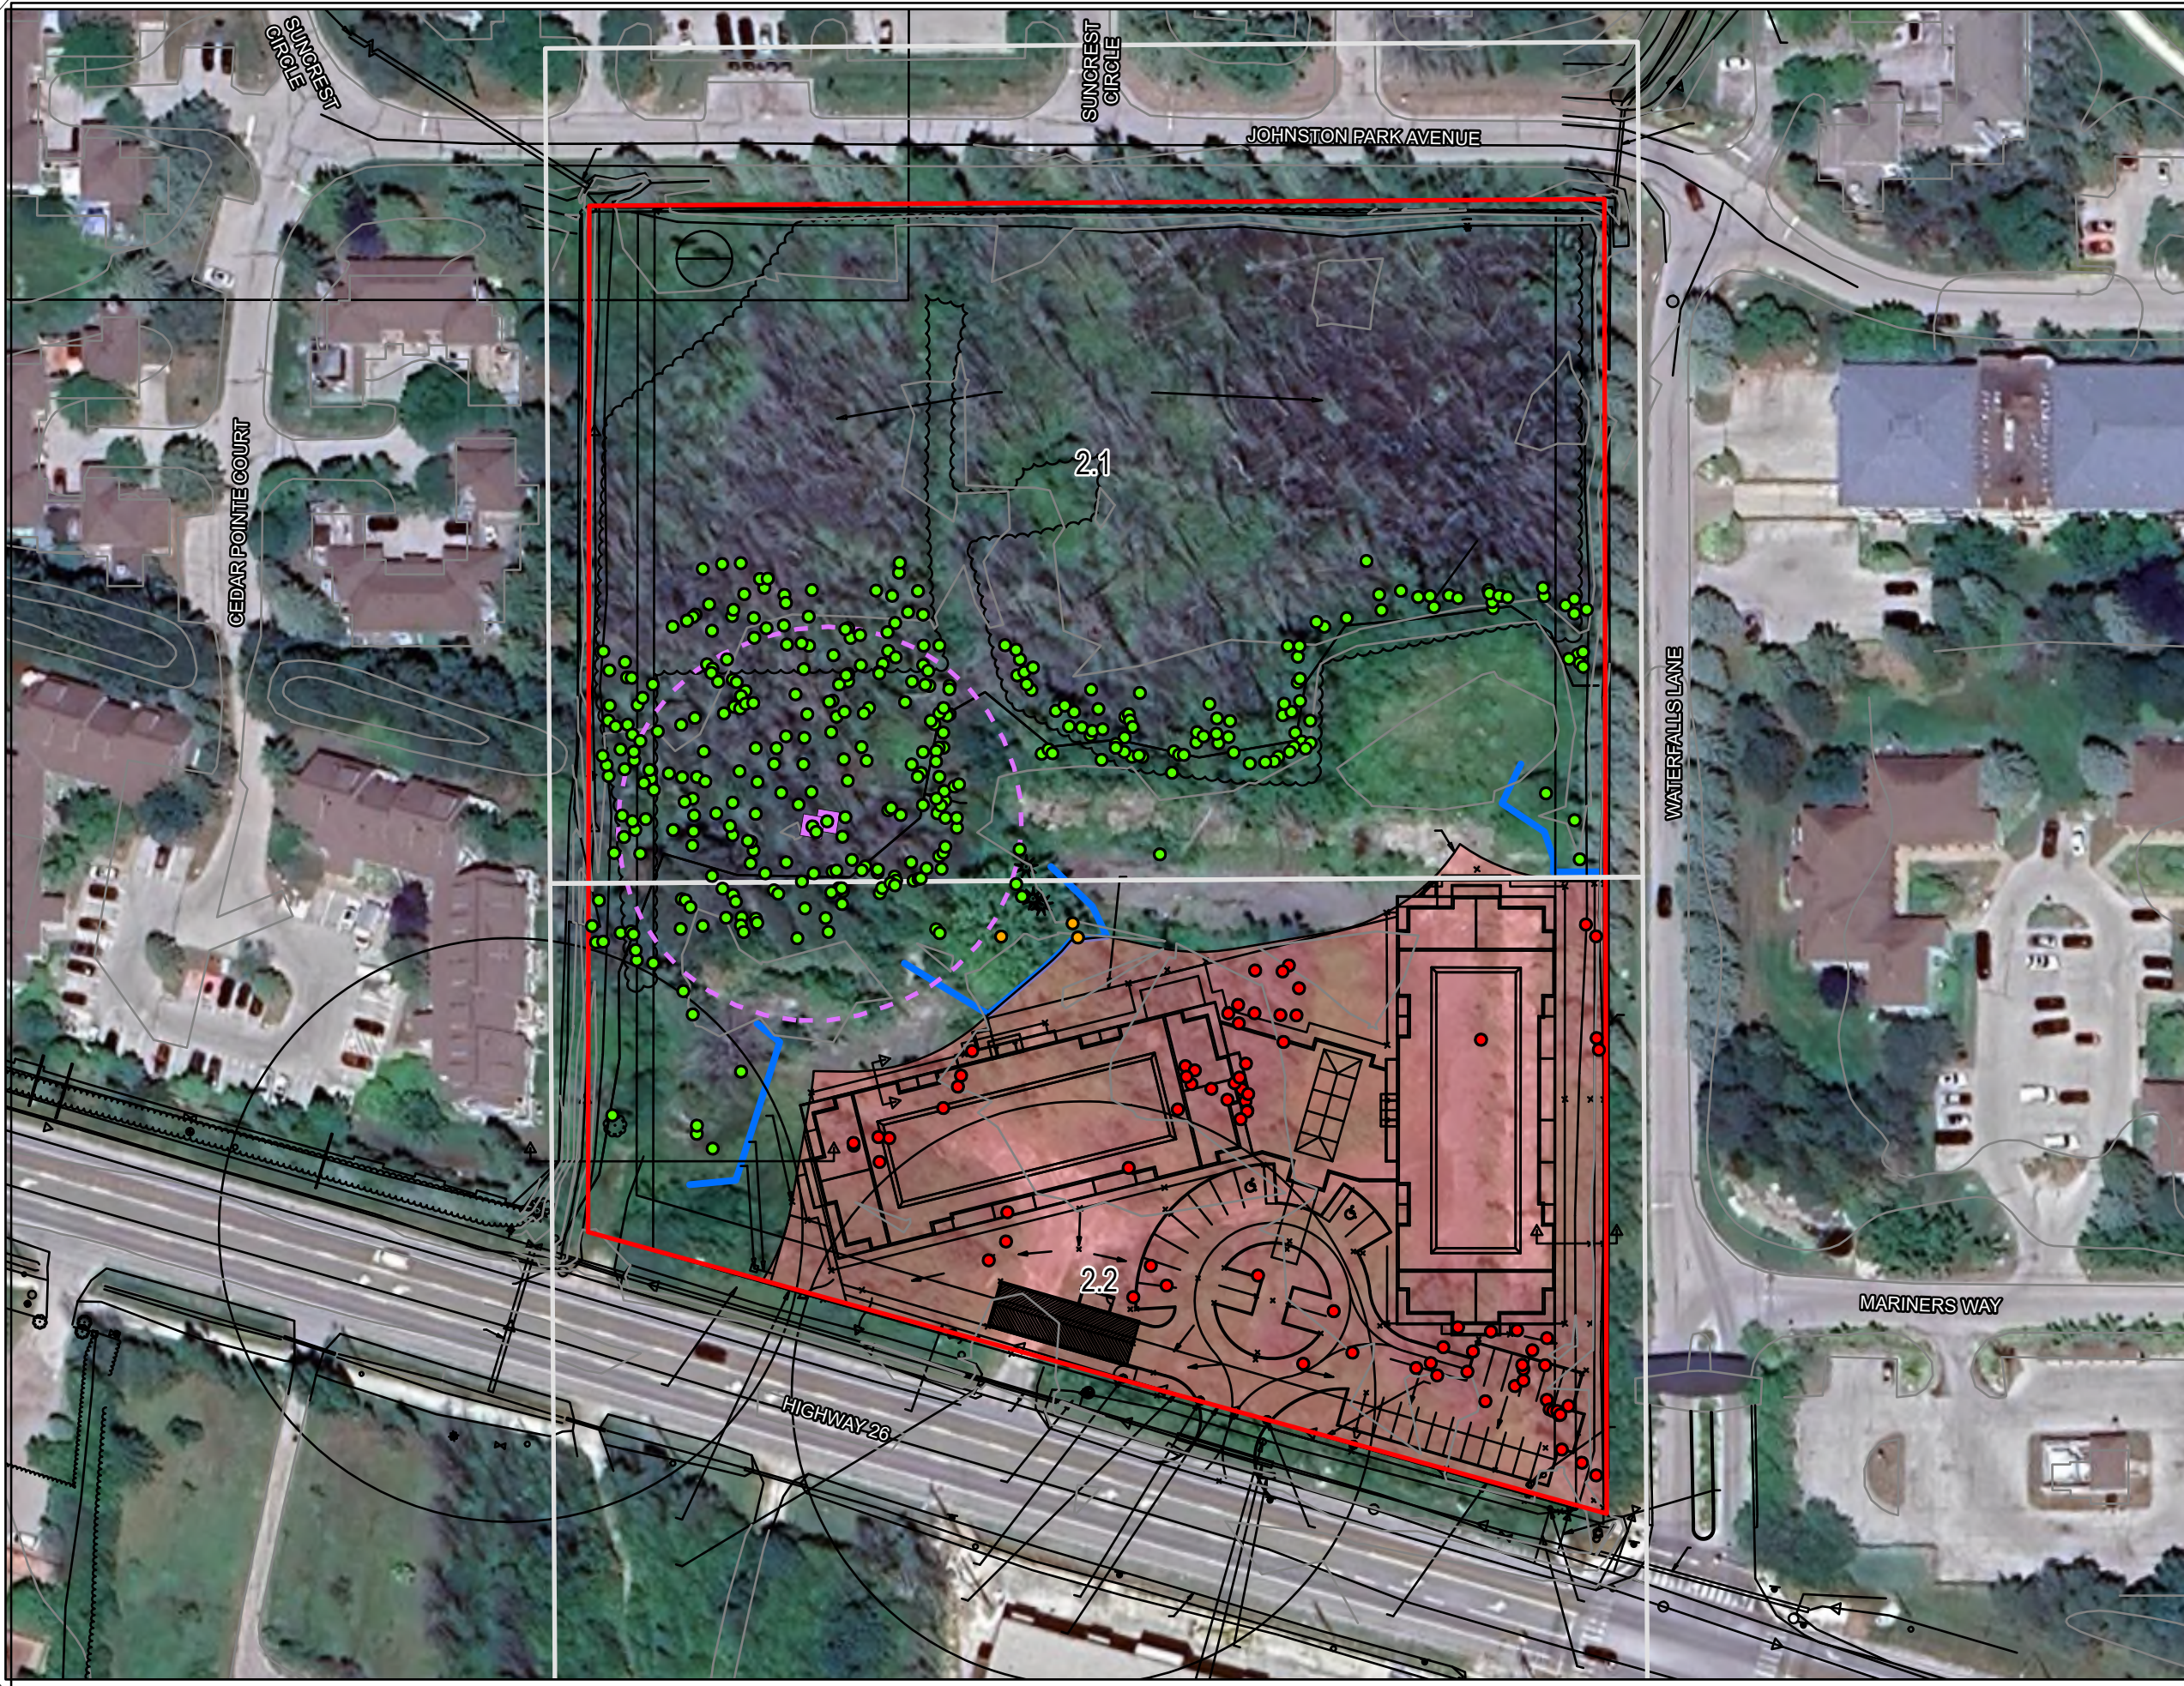
## 11476 Highway 26 Tree Resources

A total of 448 trees were identified and assessed within the Subject Property. Overall, trees within the study area range in size from 1 to 120 cm DBH and range in health from good to poor condition. Trees in poor condition displayed signs of a number of abiotic and biotic defects. In addition, ash trees throughout the Subject Property were generally in varying levels of decline which is likely a result of Emerald Ash Borer (*Agrilus planipennis*). A detailed summary of all trees surveyed are presented in the **Appendix A-Tree Inventory** and the locations of each tree (by identifier number) are presented in **Figures 2.0 to 2.2**.

As noted in **Section 5.0**, trees identified for removal include trees within the proposed disturbance limits and those trees outside of the disturbance limits where the amount of critical root zone that will be removed will likely cause significant and irreversible decline of the health of the tree. As such, a total of 79 trees have been recommended for removal as a result of the proposed development. Trees identified for removal and the reason for removal are listed in **Appendix A** and presented in **Figures 2.0 to 2.2**.

Trees identified for retention will not be adversely affected by the proposed development. A total of 366 trees have been identified for retention and listed in **Appendix A** and presented in **Figures 2.0 to 2.2**.
