Arborist Report and Preservation Plan Phase 1 Lands (Indig02) 452 Raglan Street Town of Collingwood

Prepared for Eden Oak (Raglan) Inc.

AEC Project No. 17-169 | February 2026

Re: **Arborist Report and Tree Preservation Plan, Phase 1 Lands (Indig02),
452 Raglan Street, Town of Collingwood, County of Simcoe**

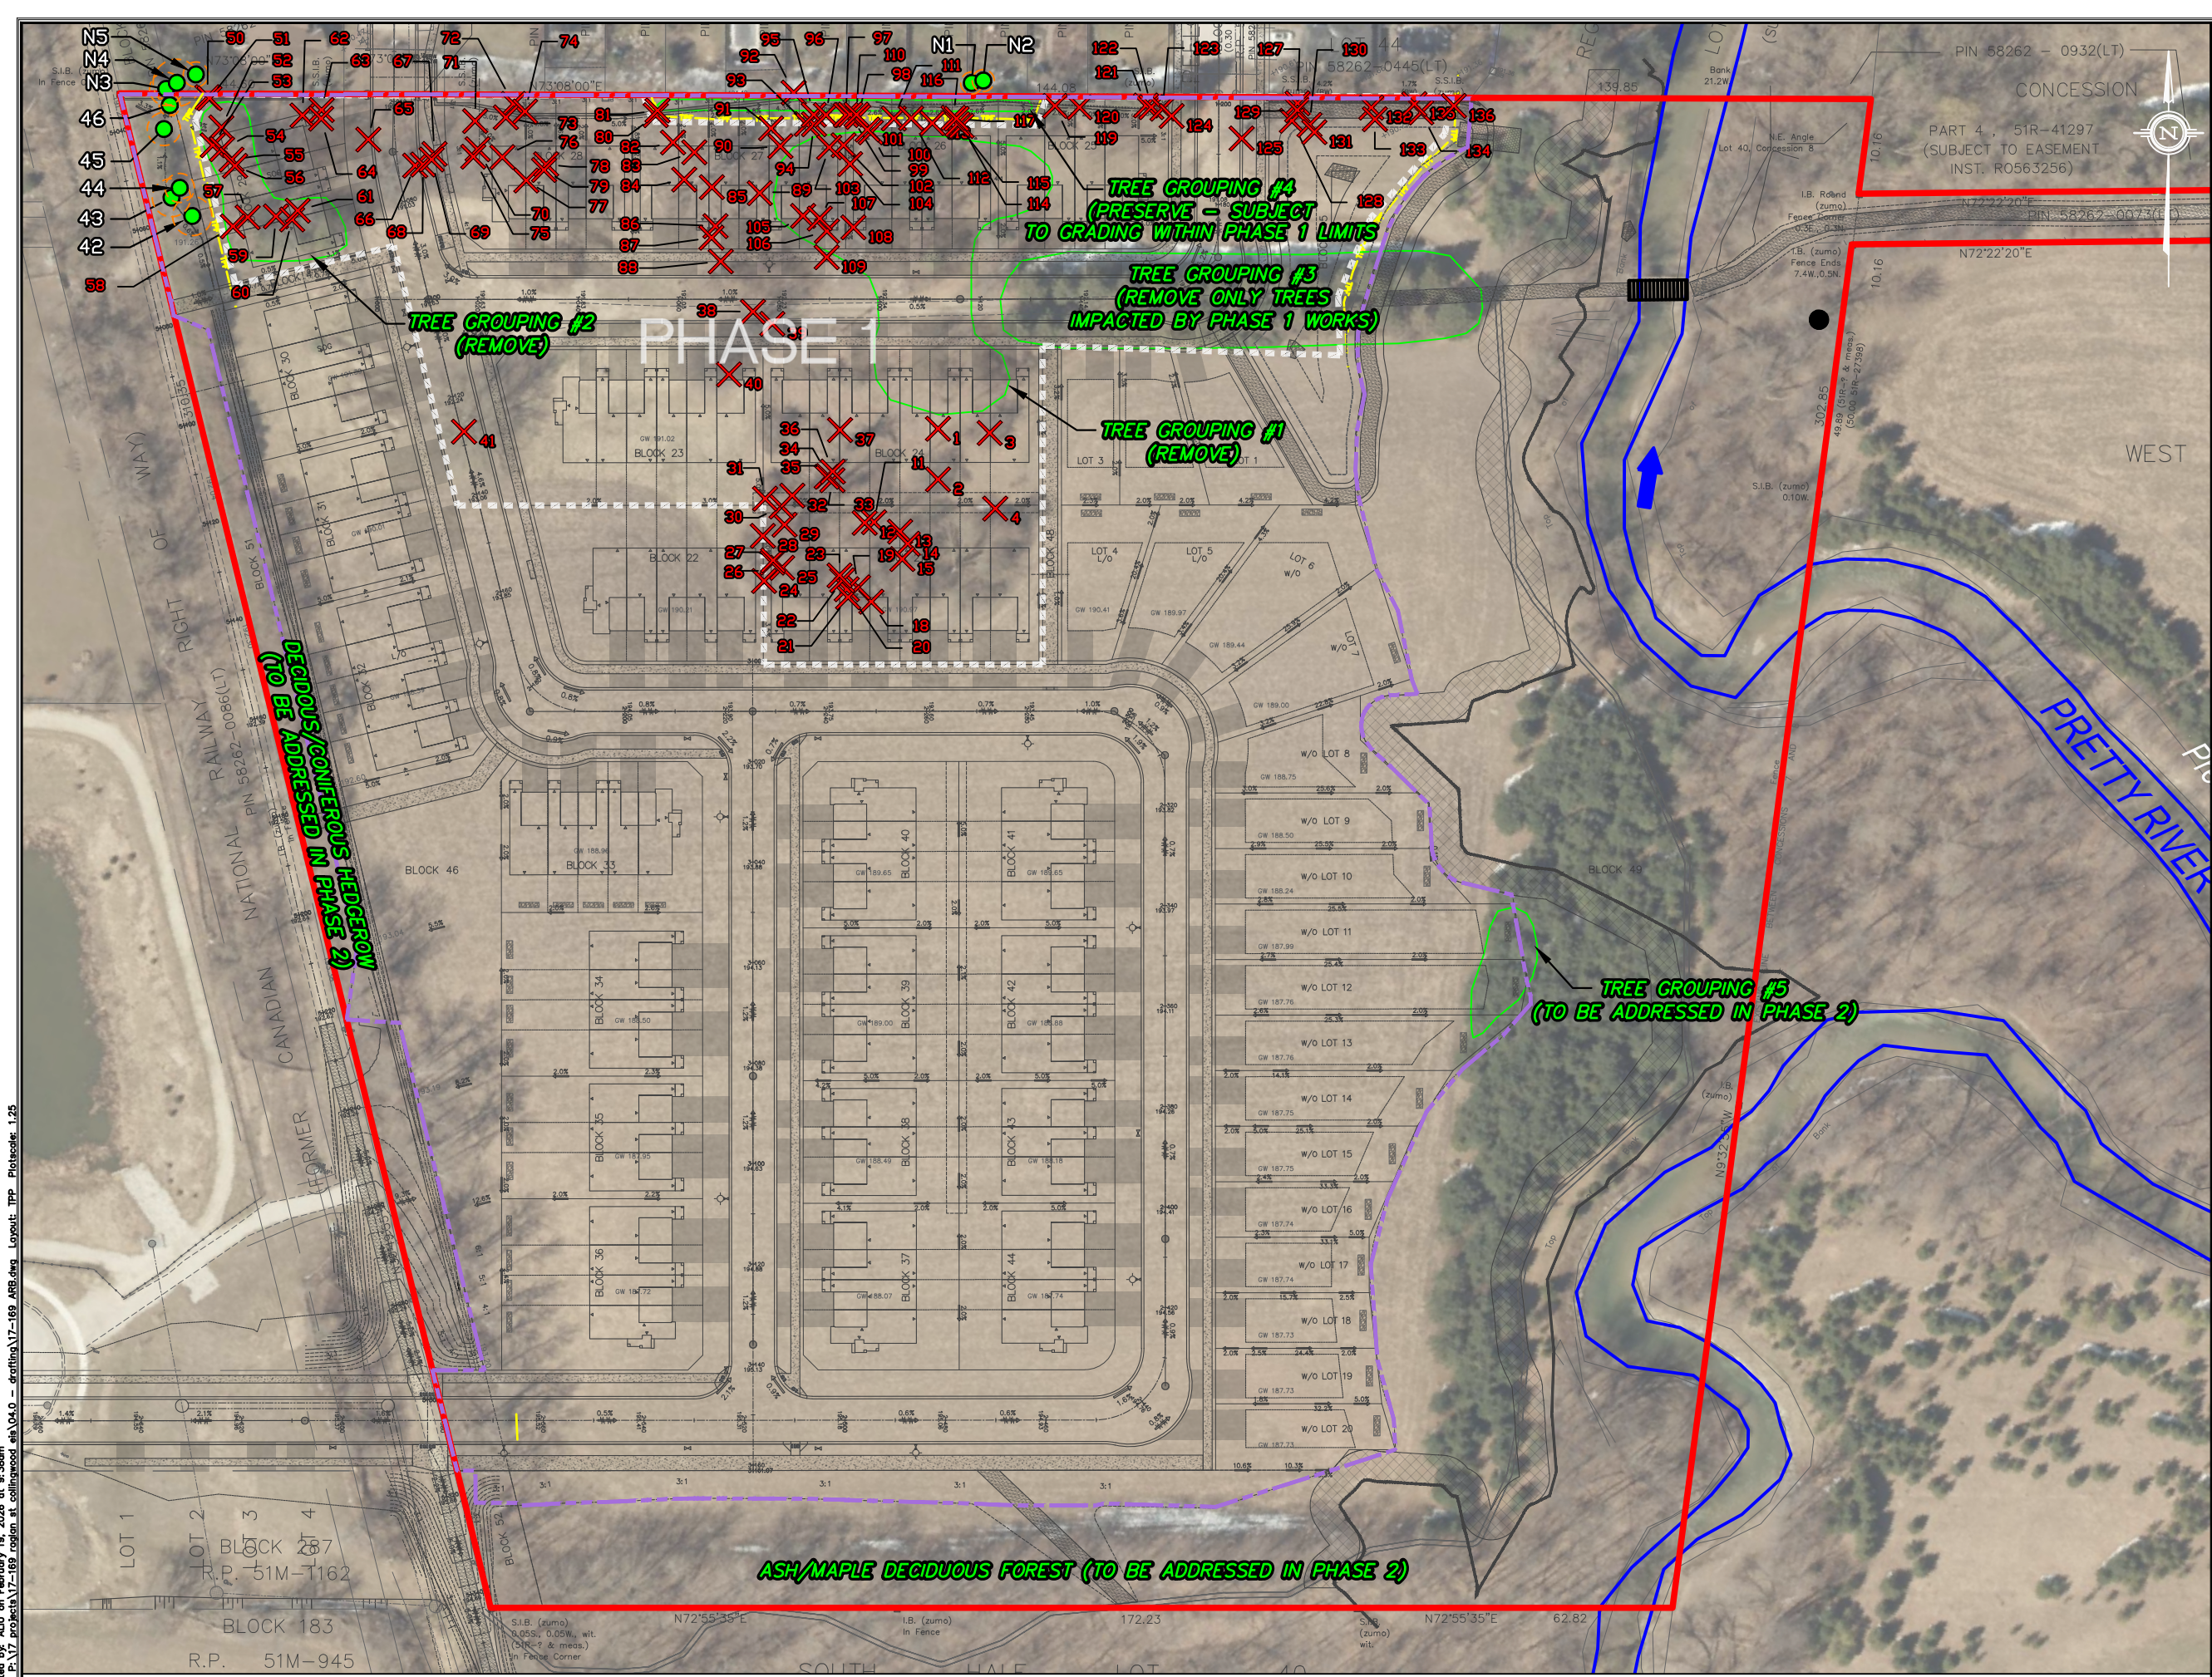
As can be seen in Figure 2, development associated with Phase 1 accommodates the preservation of trees within woodland, valleyland and hedgerow features on the property. The long-term preservation of trees appears feasible within woodland and valleyland features

The Tree Preservation Plan (Figure 2) illustrates all individual trees and tree groupings proposed for removal as a result of the Phase 1 site works, as well as the recommended locations for tree protection fencing for Phase 1 site works. At this time, all trees and tree groupings marked on Figure 2 to be addressed in Phase 2 are considered temporarily preserved. These trees, as well as any additional trees identified within 5m of the comprehensive limits of development, will be reviewed as part of the Arborist Report and Tree Preservation Plan for Phase 2; in the interim, impacts to these trees will be avoided. Where Phase 1 works are proposed in close proximity to temporarily preserved trees, tree protection fencing has been recommended as depicted on Figure 2. This fencing should consist of tree hoarding as detailed in the Town of Collingwood Standard Drawing (STD No. 1110; see Appendix A). The tree protection fencing will prevent inadvertent encroachment into the temporarily preserved trees, protecting the root zones and canopies of the retained tree resources, until such time as the Phase 2 assessment can account for the comprehensive impacts of the full limits of development.

Part of Tree Grouping #3 and all of Tree Groupings #4 and #5 are also recommended for temporary preservation. Tree Protection Fencing has been proposed to protect the edge of the dripline (at minimum) of Tree Grouping #4 where it abuts Phase 1 works, and as such this feature is not expected to be impacted during phase 1 works. Tree Protection Fencing is also proposed at the limit of Phase 1 to protect the remaining trees in Grouping #1 from impacts. Grouping #5 is located >30m from Phase 1 works and would not be expected to be impacted by these works.

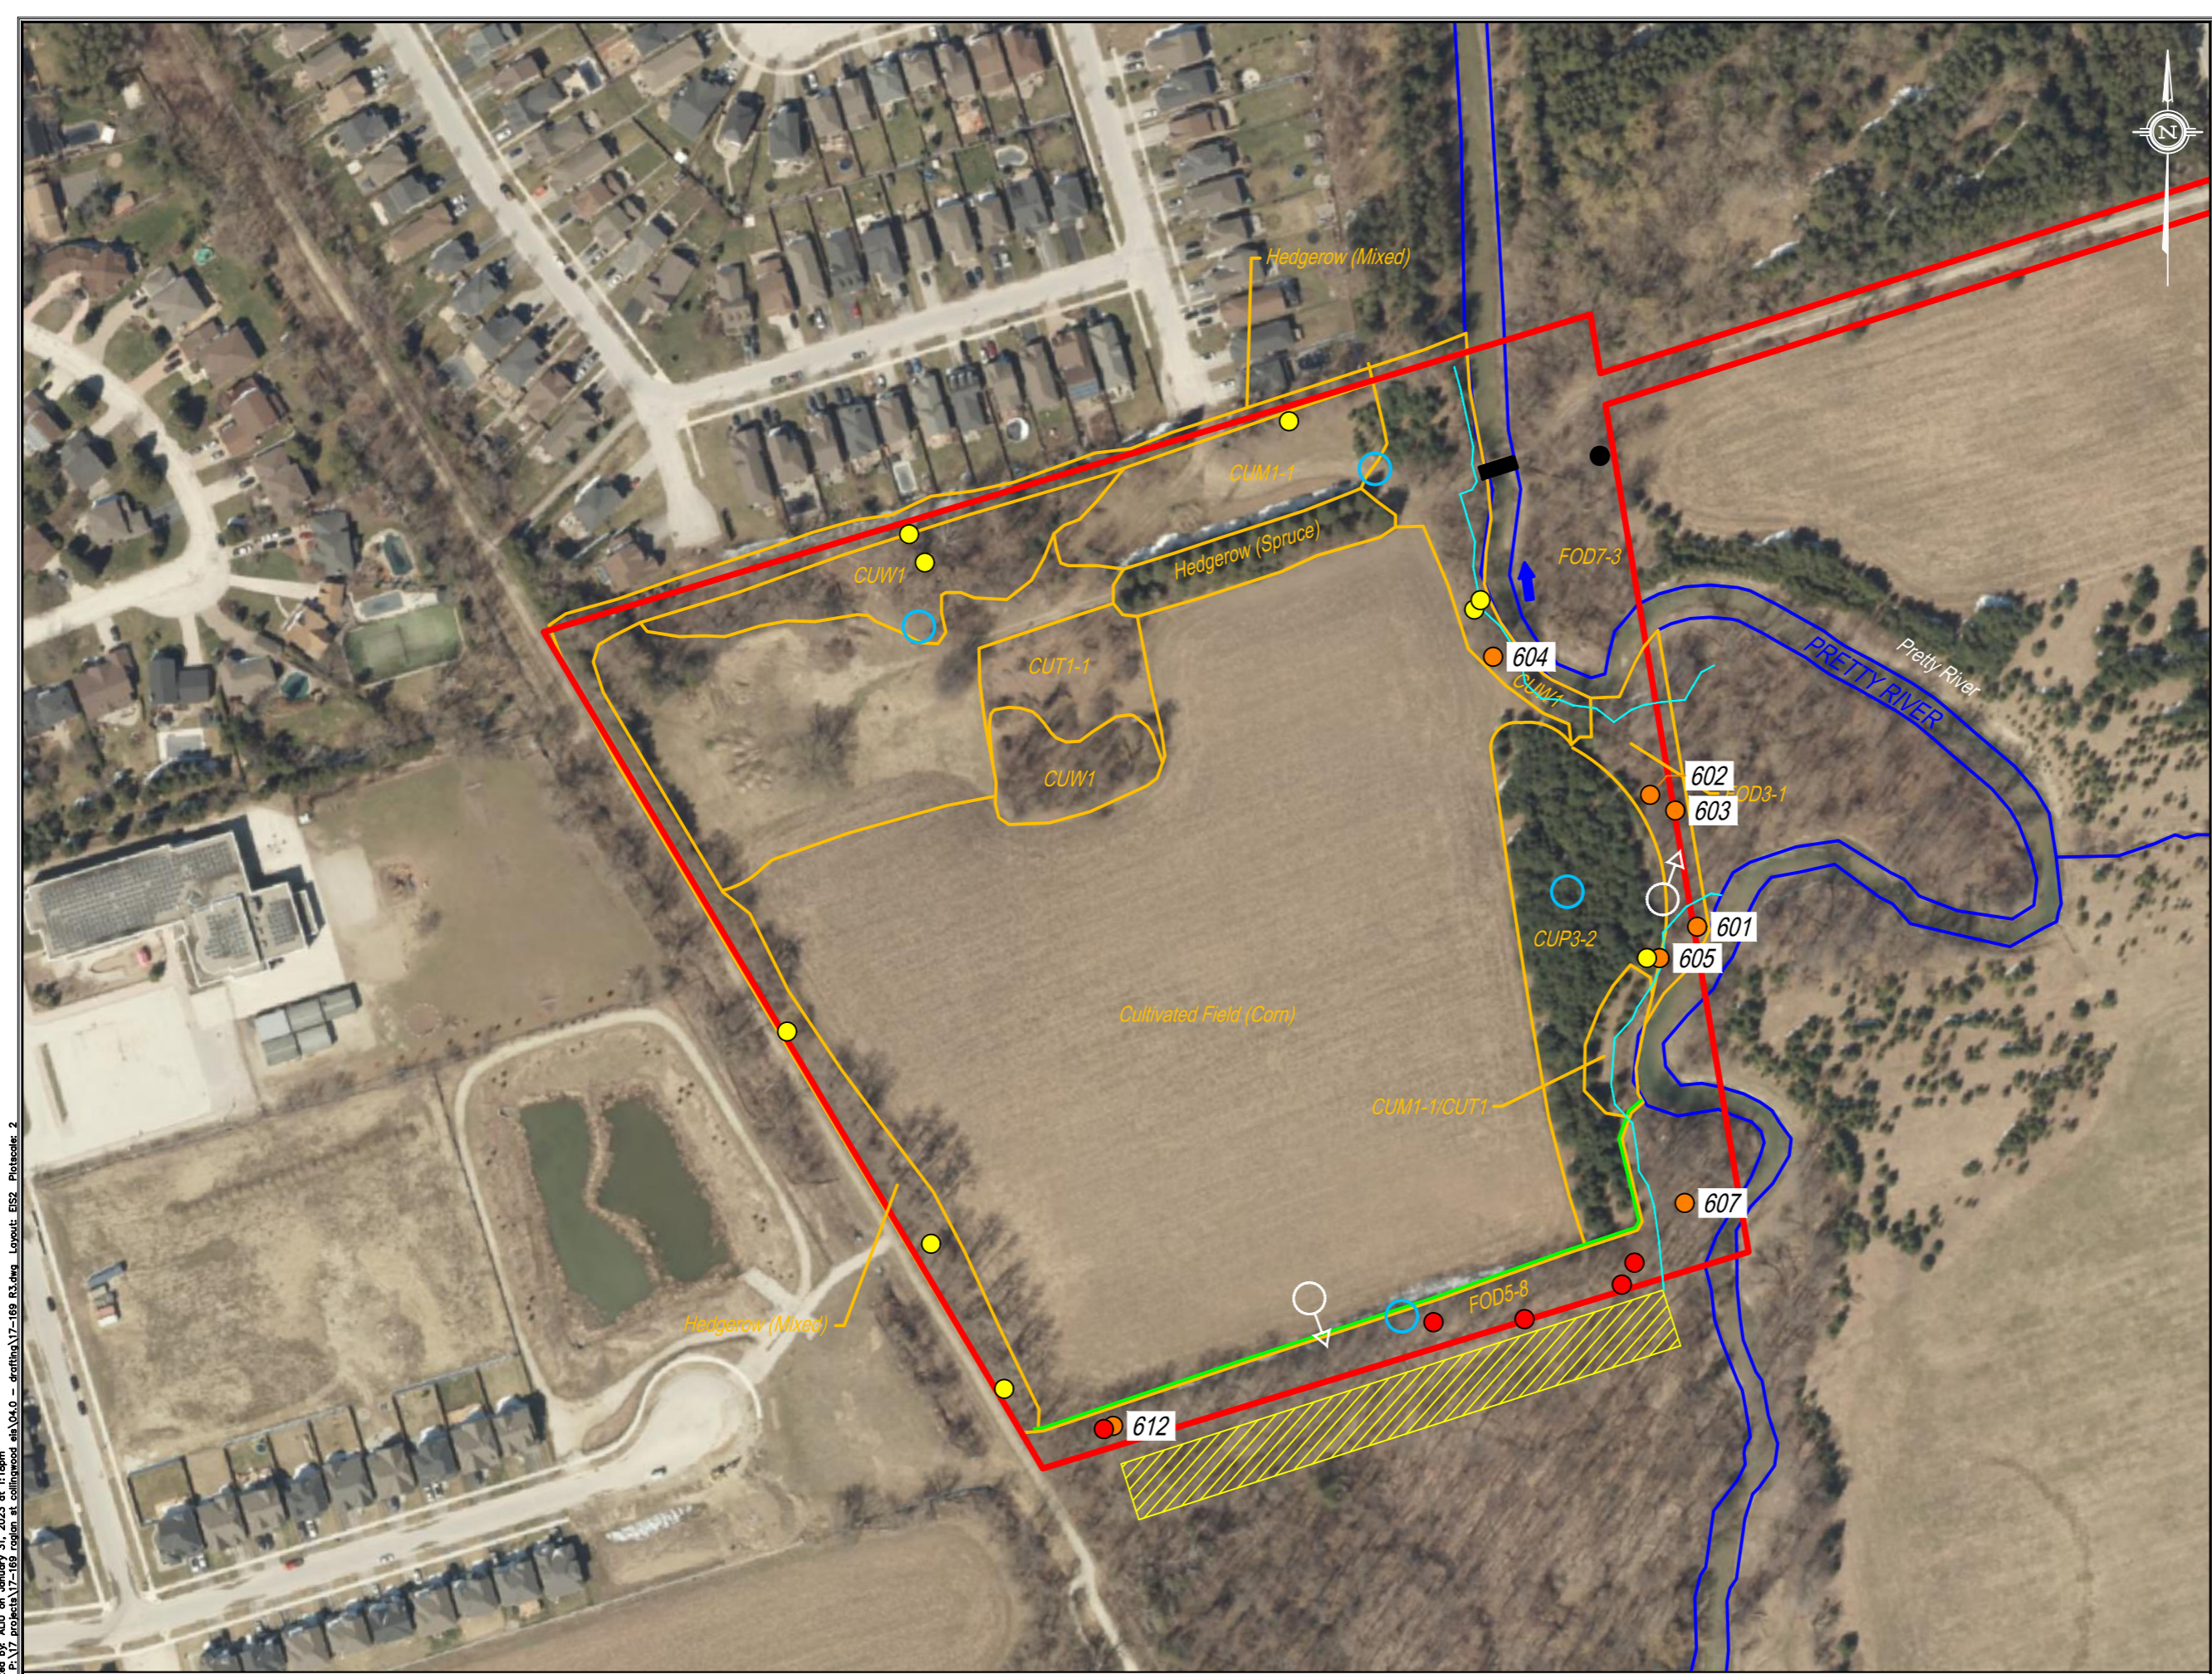
Figure 2, 452 Raglan Street, Town of Collingwood (IndigO2), Scoped Environmental Impact Study, Addendum Letter (Azimuth, 2023b)

Three (3) of the above-noted Butternut were documented within proximity to the Phase 1 lands, all evaluated as Category 1 (removable), and all associated with the north edge of the property (Appendix C). These include Butternut #616 (1cm DBH), Butternut #617 (15cm DBH) and Butternut #618 (14cm DBH). Discussion relating to these Butternut was originally deferred to the EIS documents, which were submitted in tandem with Azimuth's arborist reporting for this property. However, it should be noted that since the MECP did not elect to reach out to audit these BHAs within the 30-day post-submission waiting period, all three of these Butternut are no longer considered protected under the *Endangered Species Act, 2007*.
