Design Report

THE SHIPYARDS - COLLINGWOOD Outfitting Dock and Launch Basin (West & South Sides)

FRAM Building Group / Slokker Canada Corp.

Prepared by: Shoreplan Engineering Limited

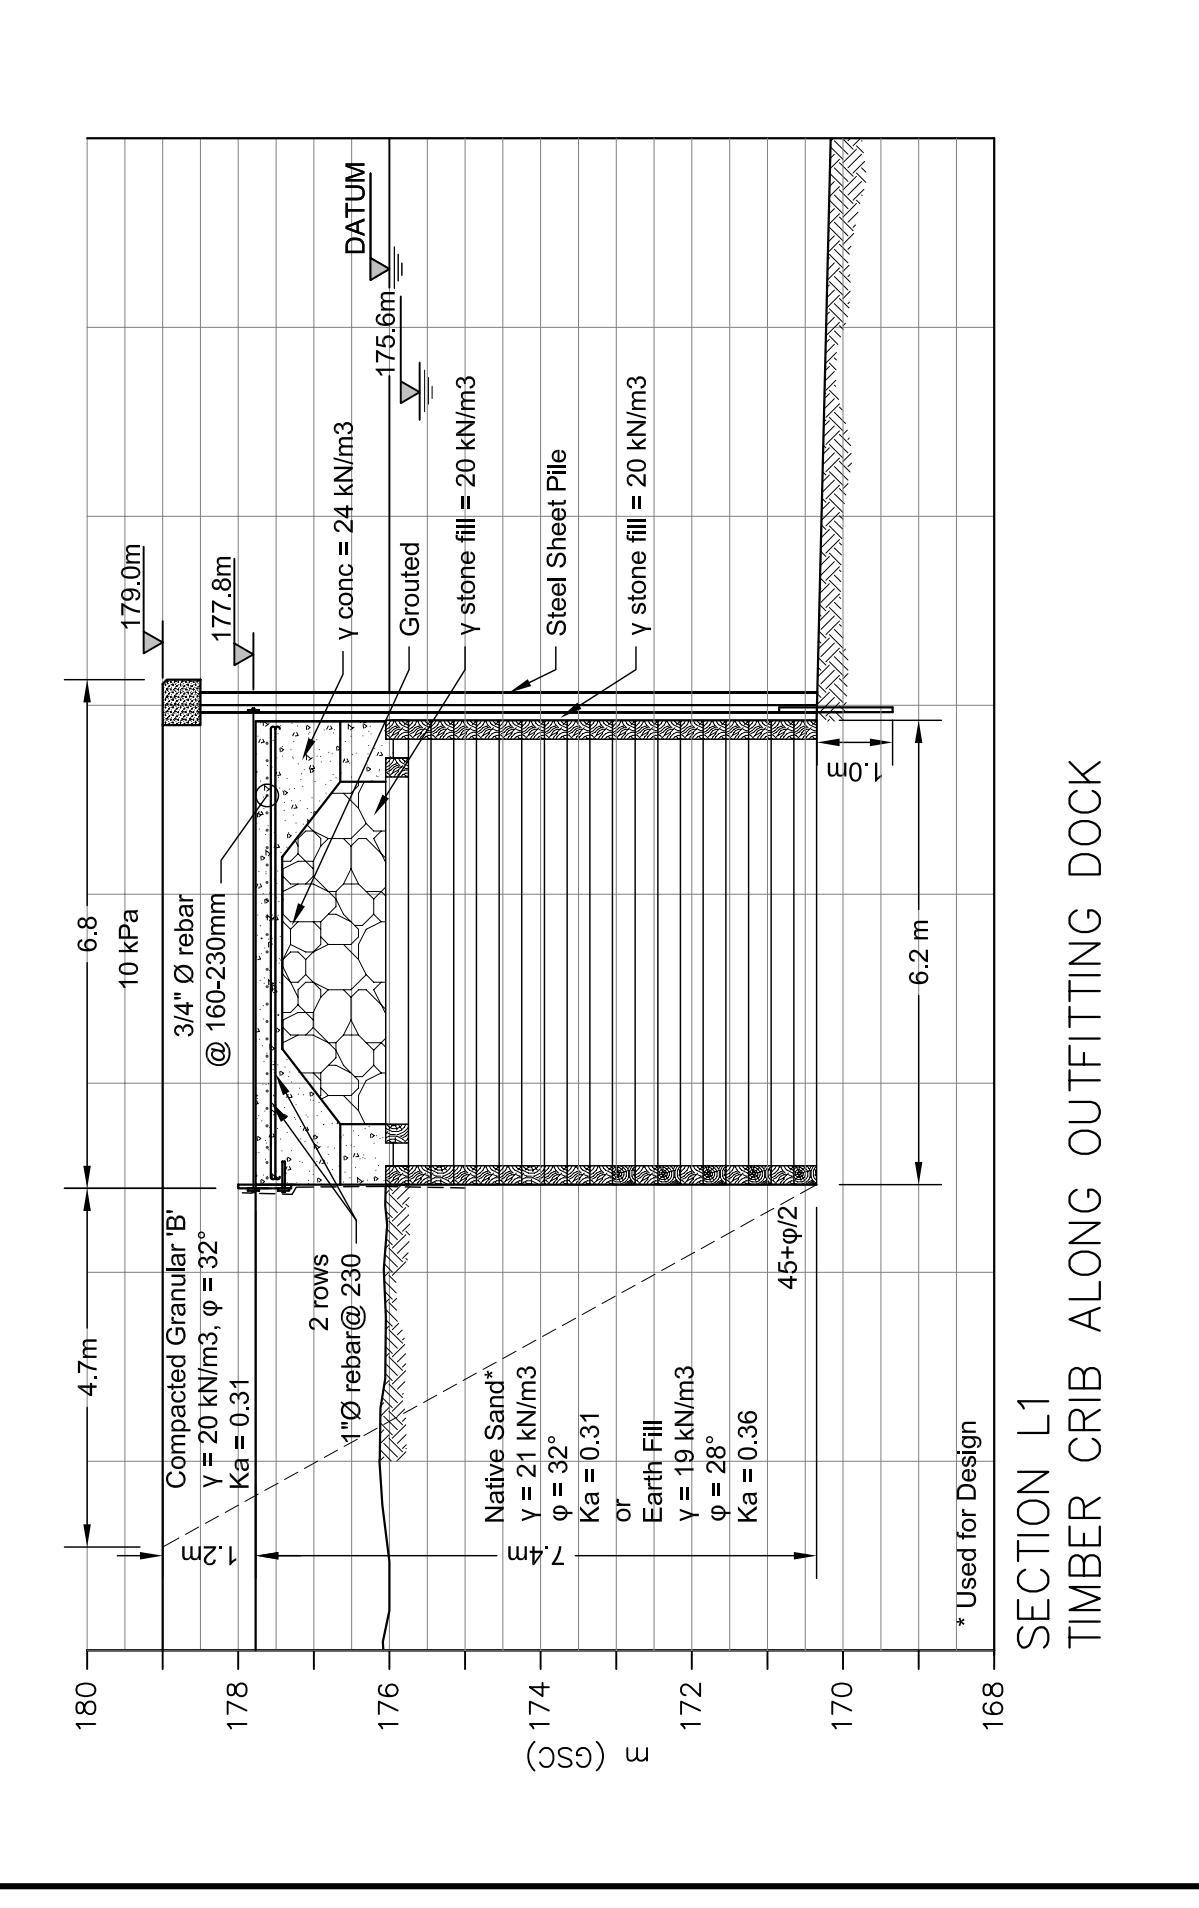
Figure 3.1 Design Loads Outfitting Dock Collingwood Shipyards Launch Basin

The existing reinforced concrete cap was analysed to determine if it could support the proposed load. The existing cross section of the concrete cap is as shown in Figure 3.1, Section L1. The slab varied in thickness. Therefore the slab was analysed with a minimum thickness of approximately 350 mm. Our observations at the south end of the slab indicate that there are two layers of reinforcement each with 25.4 mm diameter spaced at approximately 230 mm with bent ends. The same spacing was confirmed at other locations where the bars could be observed due to local breakage or spalling. Details of the design loads acting on the slab and reinforcement in the cap are shown in the Figure 3.1. The analysis indicates that the slab will support the applied load as shown in Table 3.3. However, the subsequent decision to grout the void will result in greater support to the concrete slab.

Where the concrete cap is missing at the south end of the reach (Section L2), the top of the steel sheet pile wall will be anchored to a cast-in-place continuous concrete anchor. The toe of the wall will be pinned as described above. The gap between the existing structure and steel sheet pile wall will be filled with tremie concrete and clear stone. Granular 'B' backfill will be placed and compacted behind the wall to the grades specified on the drawings. Figure 3.2 Section L2 shows a typical section where the concrete cap is missing and the design parameters and loads used for the design of the wall at this location.
