**Built Heritage Assessment  
Collingwood Terminals  
Part Lot 44, Concession 8, Water Lot in Front of Lot 44, Concession 8, Water Lot K40  
Geographic Township of Nottawasaga  
Simcoe County  
Town of Collingwood, ON**

HR-346-2021  
*ARA File# 2021-0253*

**01/12/2021**

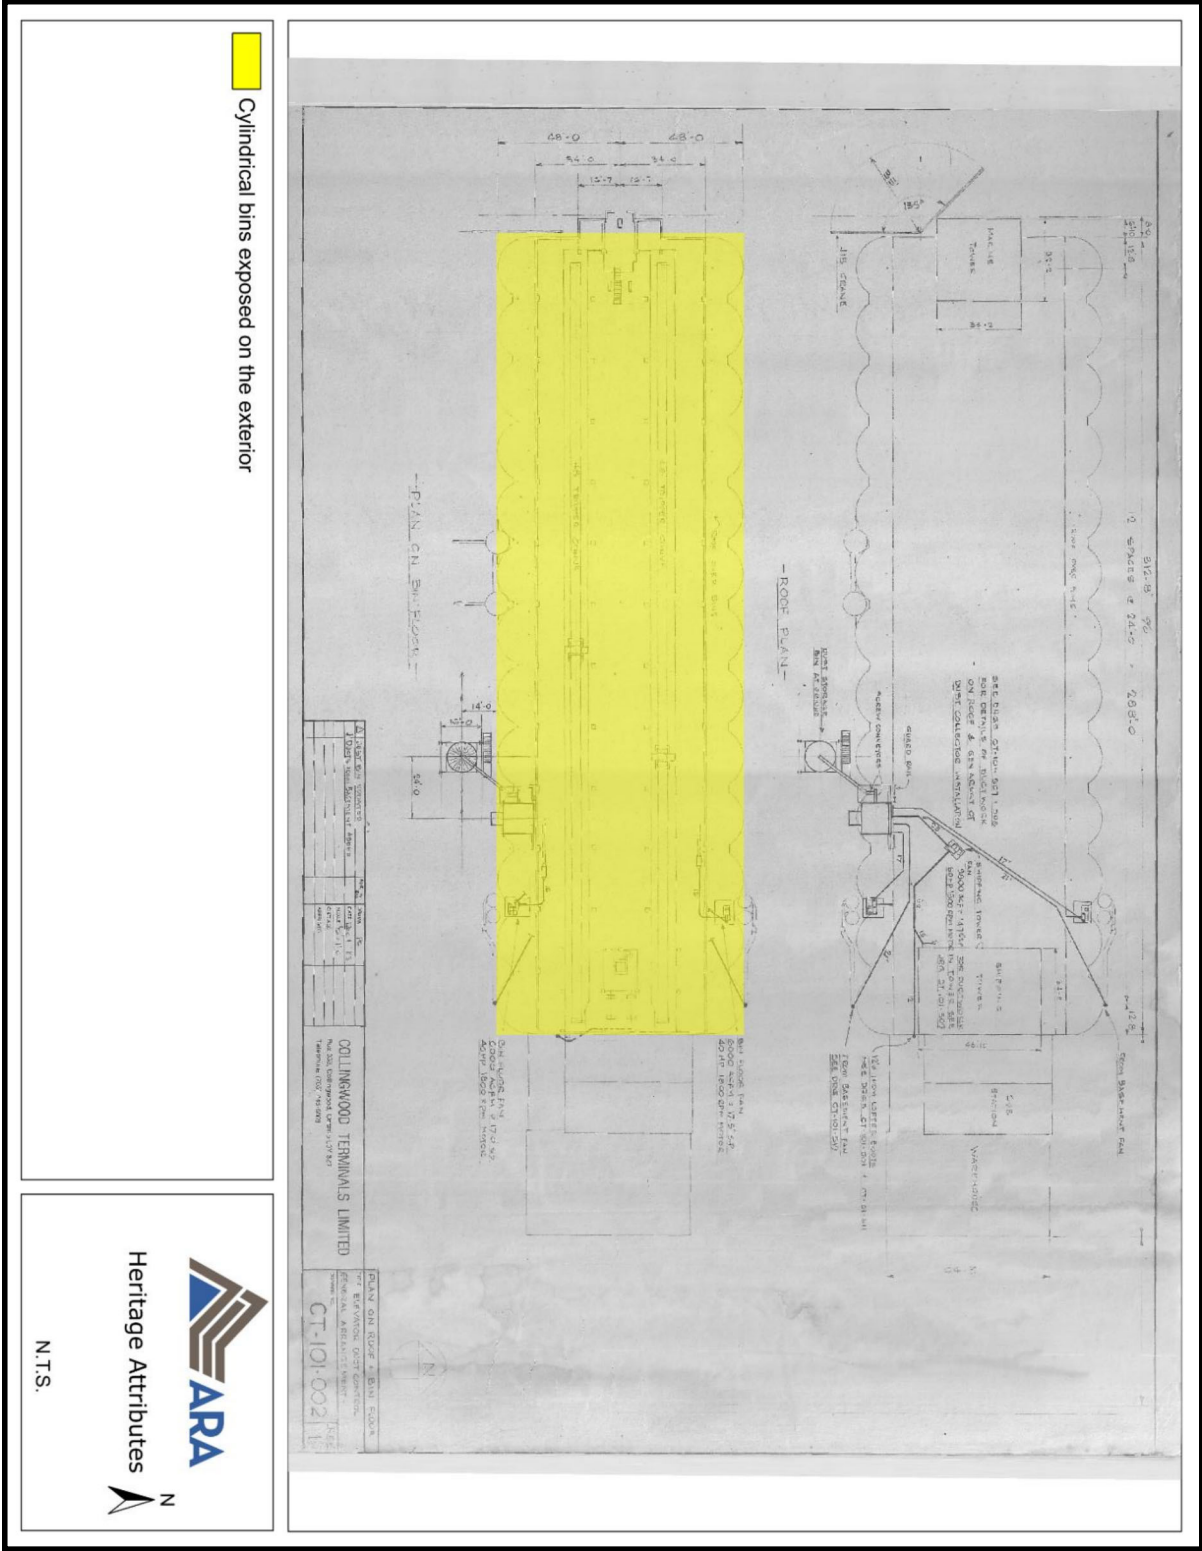
Map 5: Heritage Attributes Represented on Plans

The following maps (see Map 4–Map 6) display the property boundary and heritage attributes as outlined in Section 6.2 above.

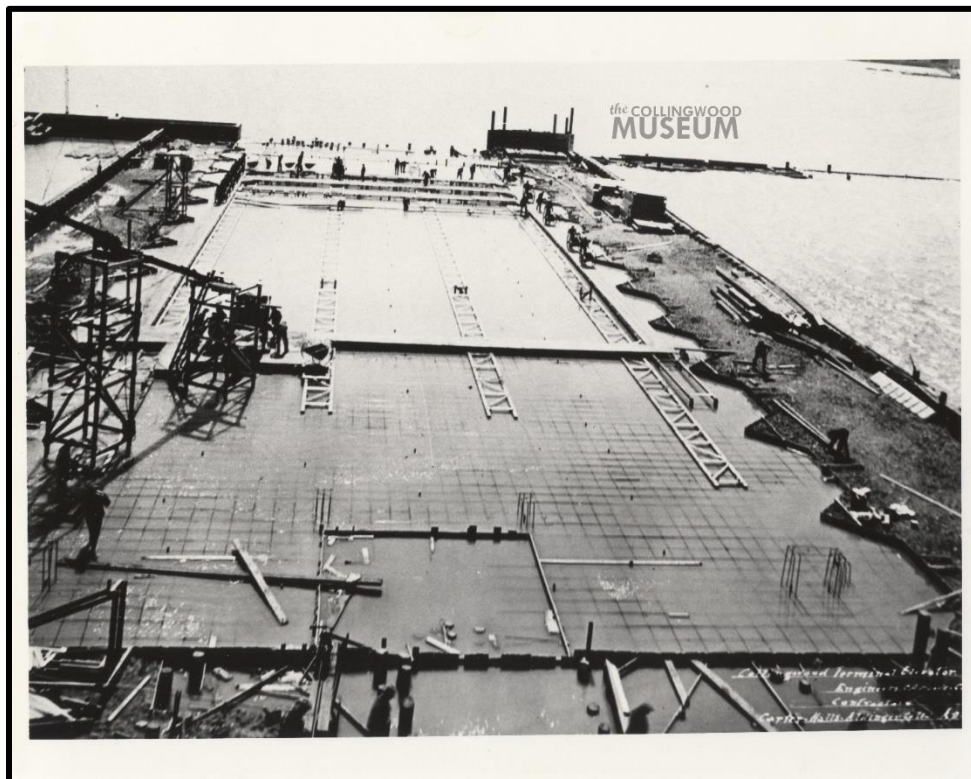
**Plate 20: Pouring Basement Floor of Terminals, 1929**  
(Facing Southwest; Provided by the Town of Collingwood)

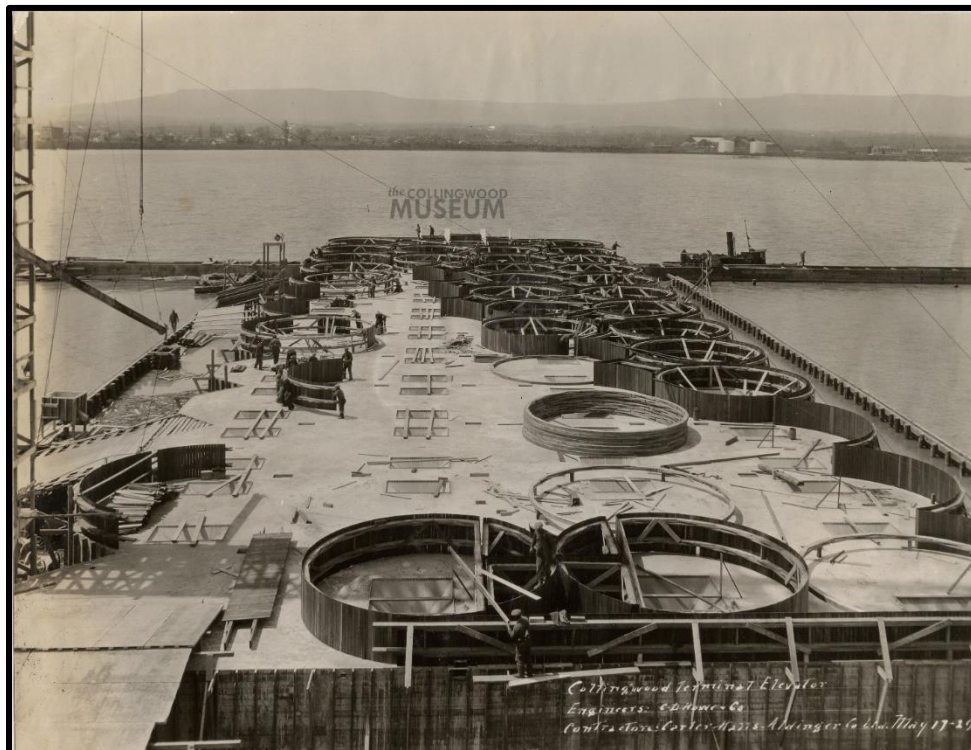
**Plate 31: Collingwood Terminals During Concrete Pouring Showing Cylindrical Cribbing, May 17, 1929**  
(Facing Southwest; Provided by the Town of Collingwood)

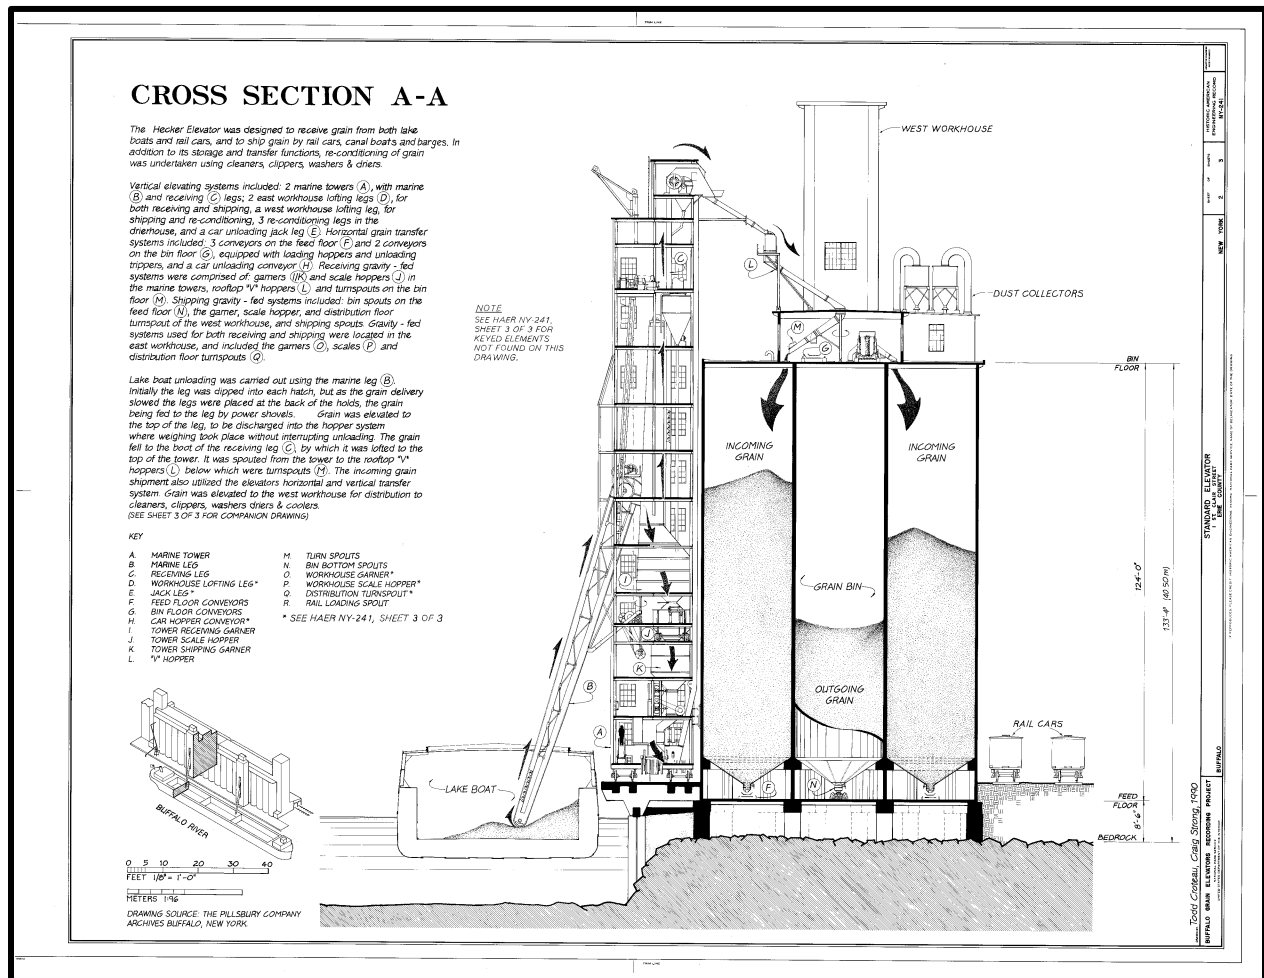
**Plate 49: Cross-Section of a Typical Concrete Elevator, Dockside View  
(LoC 1990)**

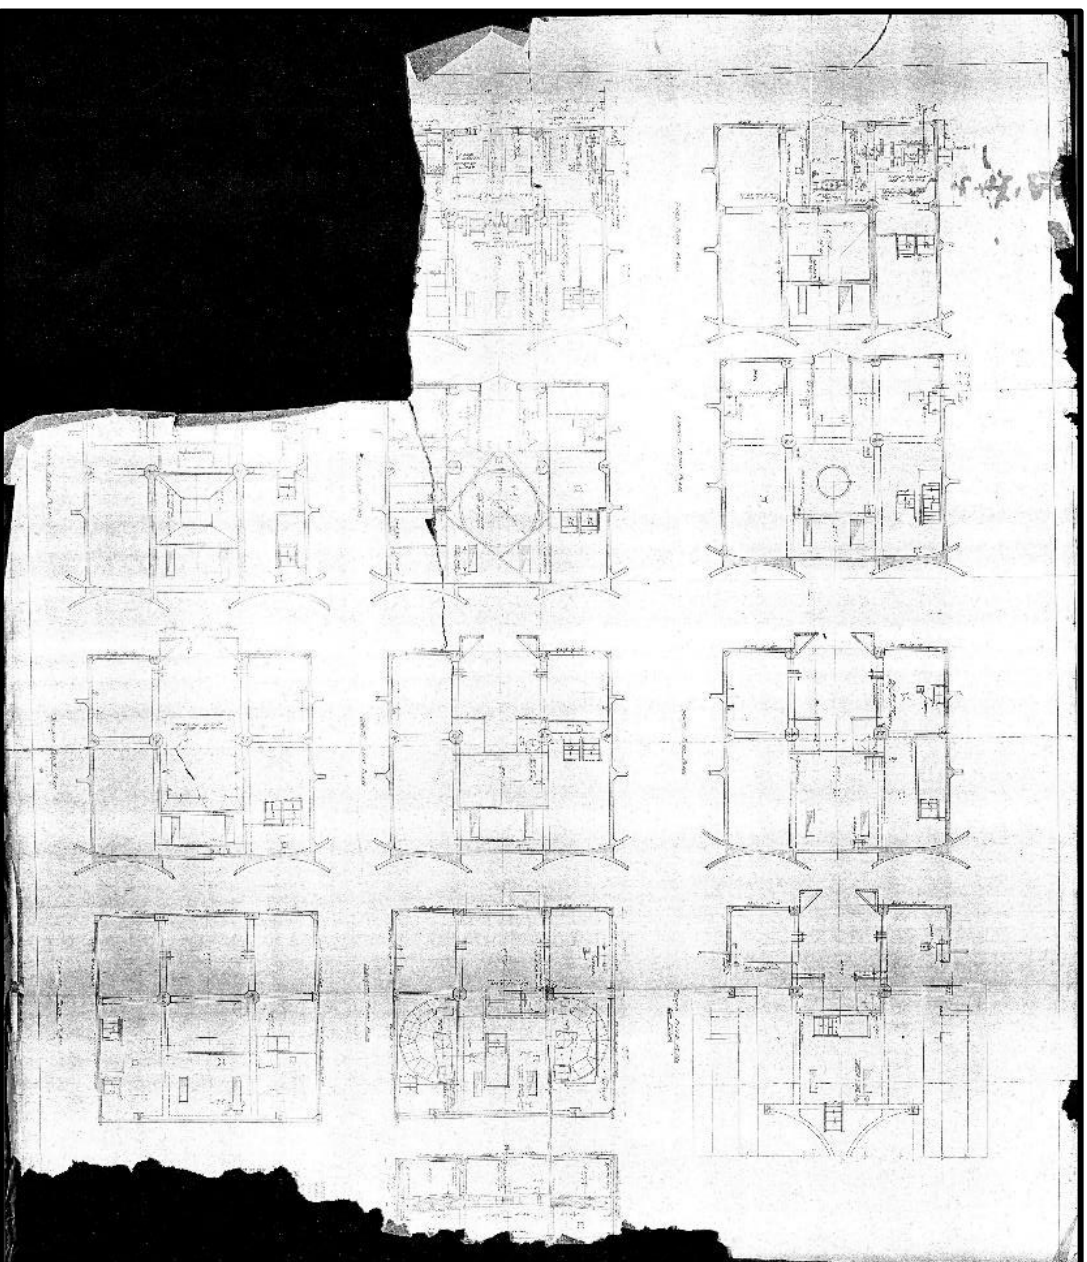
**Figure 7: Floor Plan of Collingwood Terminals, n.d.**  
(Provided by the Town of Collingwood)

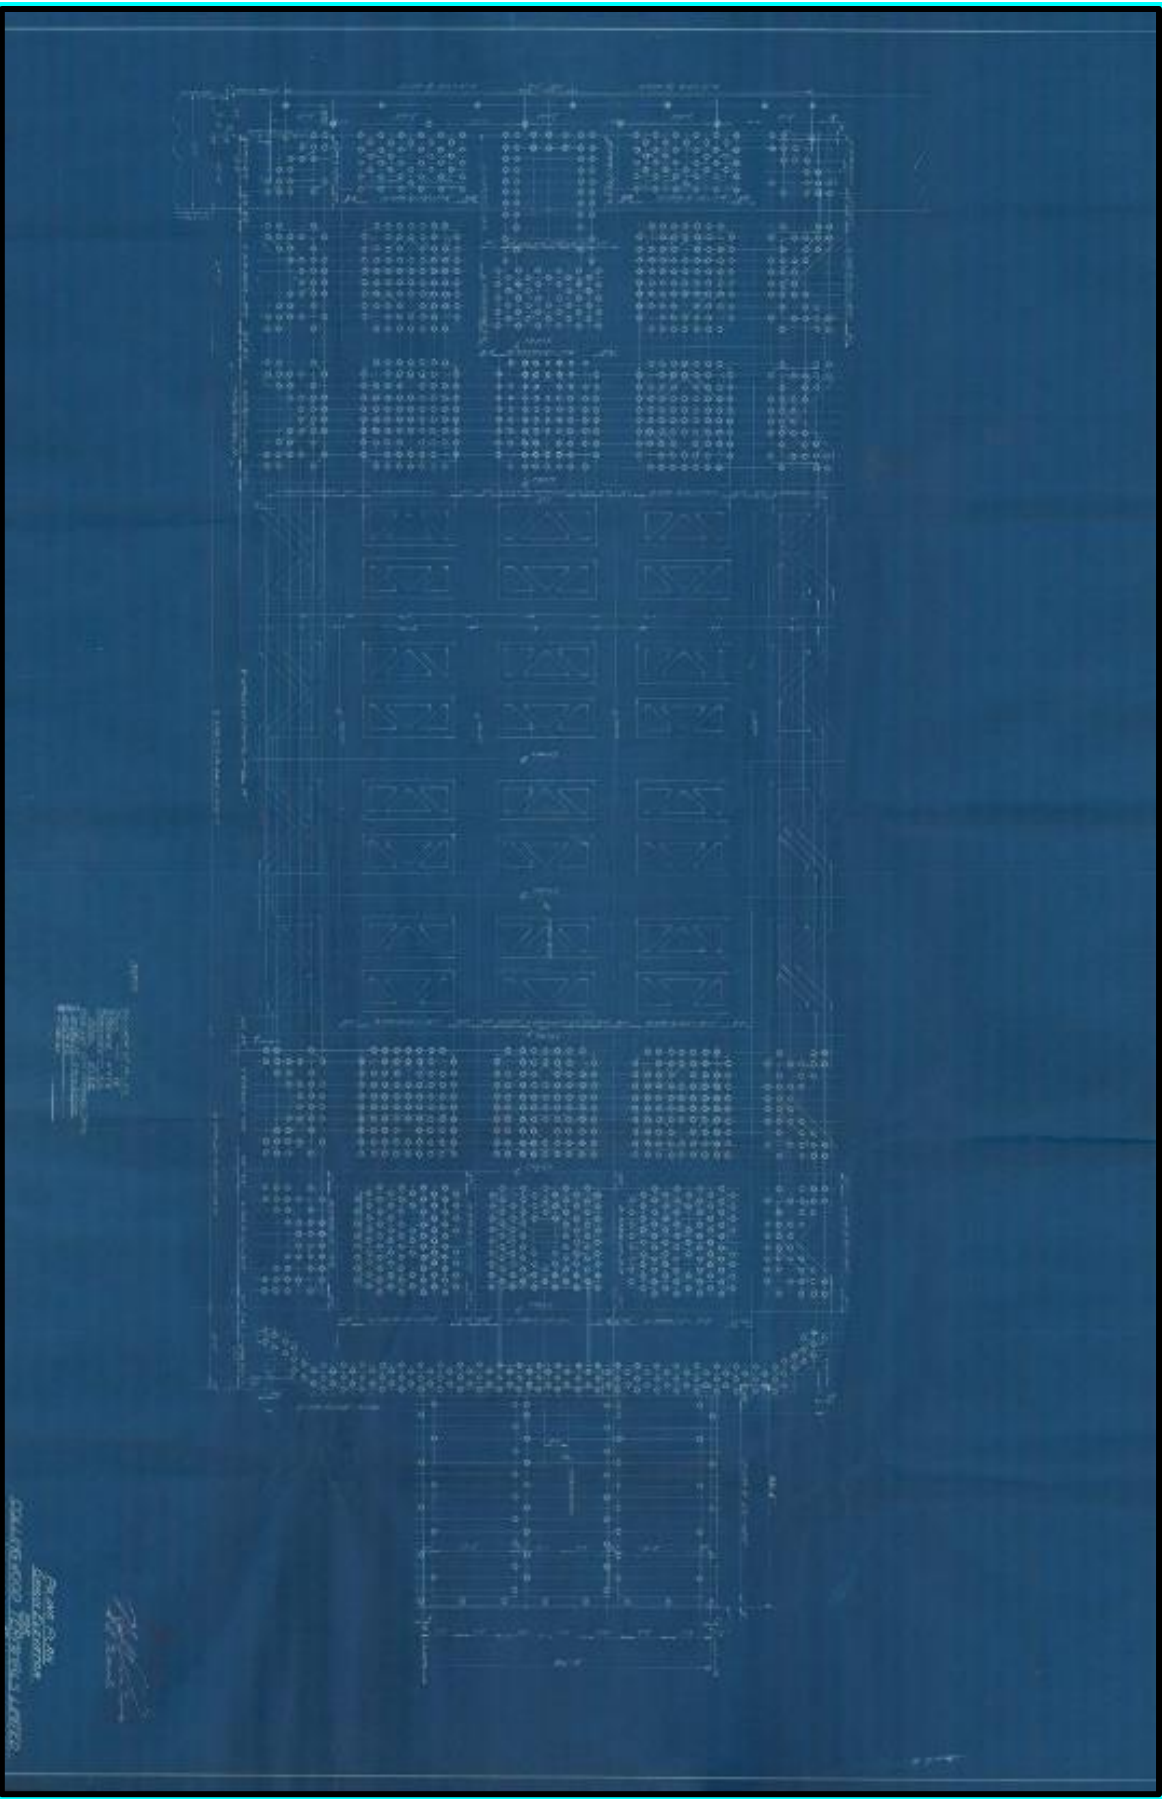
**Figure 9: Piling Plan, circa 1929**  
(Provided by the Town of Collingwood)

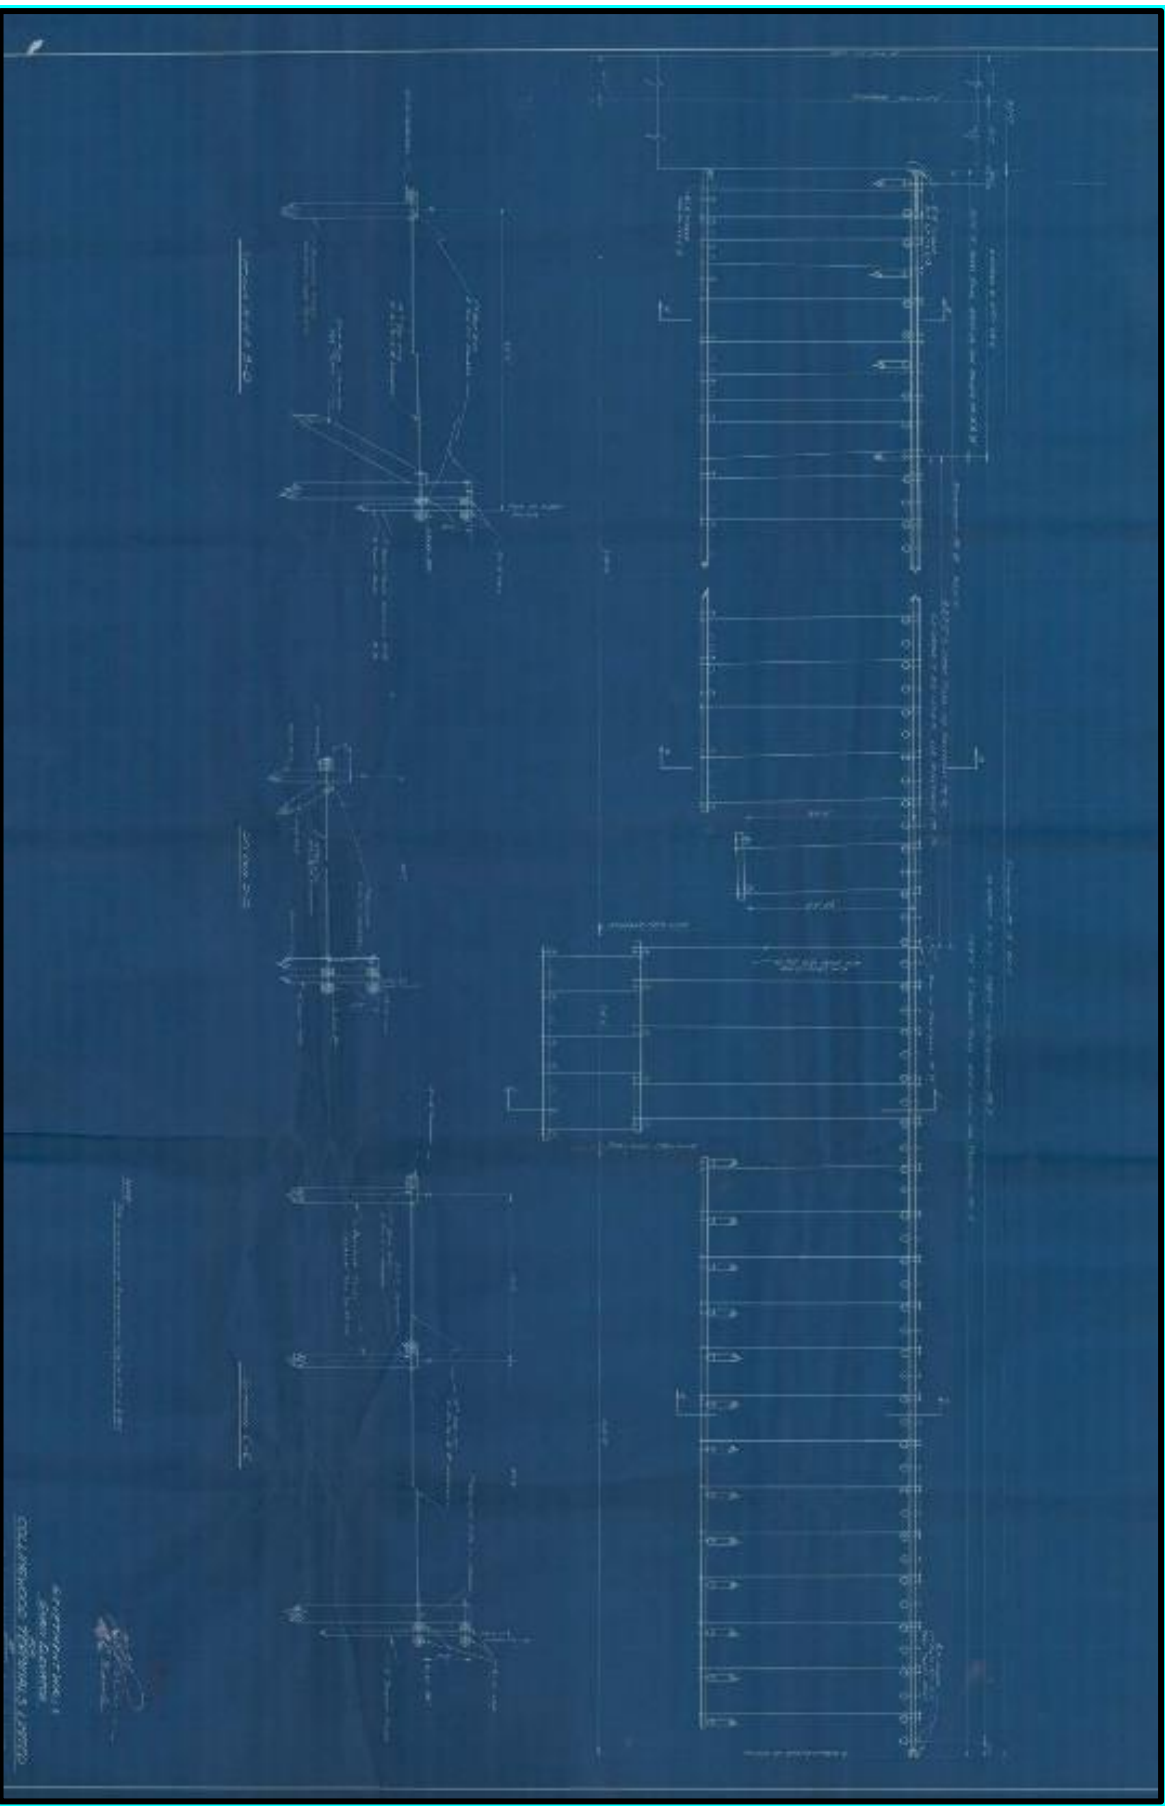
**Figure 10: Revetment Walls Plan, circa 1929**  
(Provided by the Town of Collingwood)

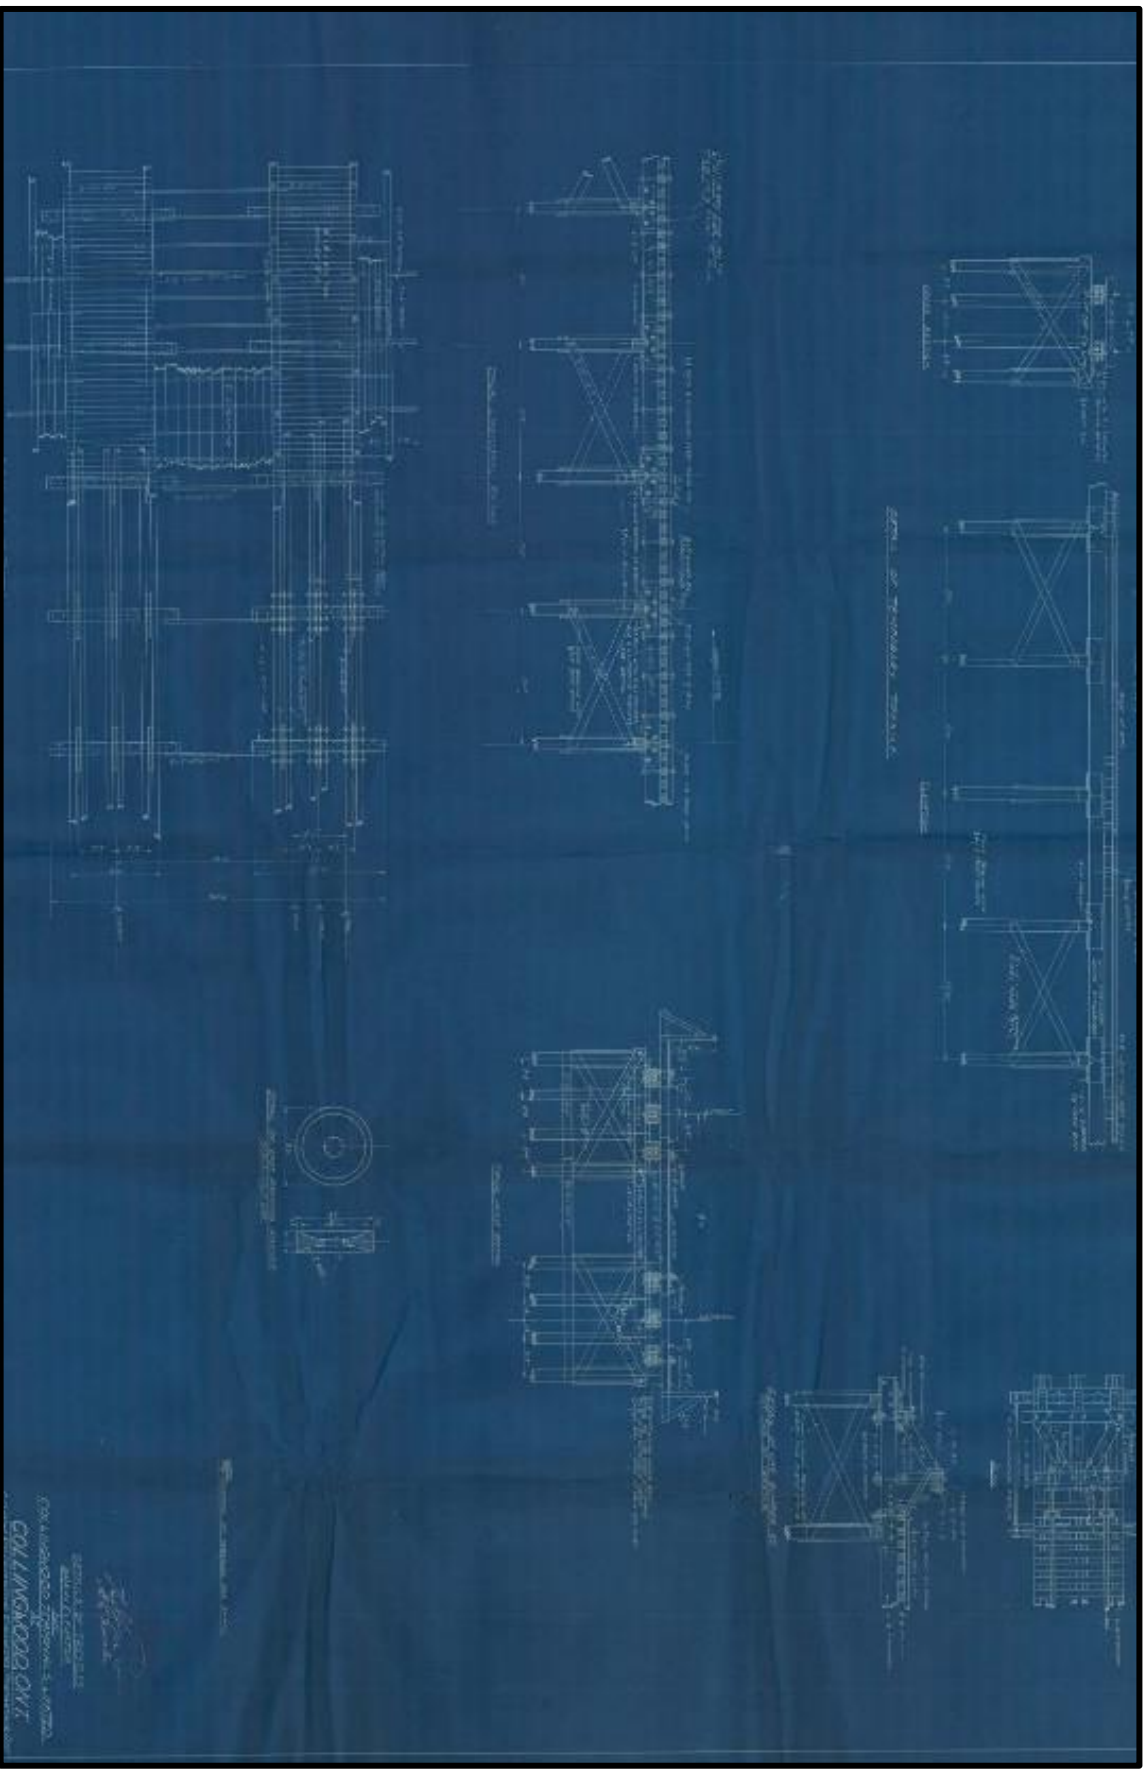
**Figure 12: Details of Trestle, circa 1929**  
(Provided by the Town of Collingwood)
