**HYDROGEOLOGICAL REPORT**

**LINKSVIEW DEVELOPMENT**

**TOWN OF COLLINGWOOD  
SIMCOE COUNTY**

**MARCH 2022**

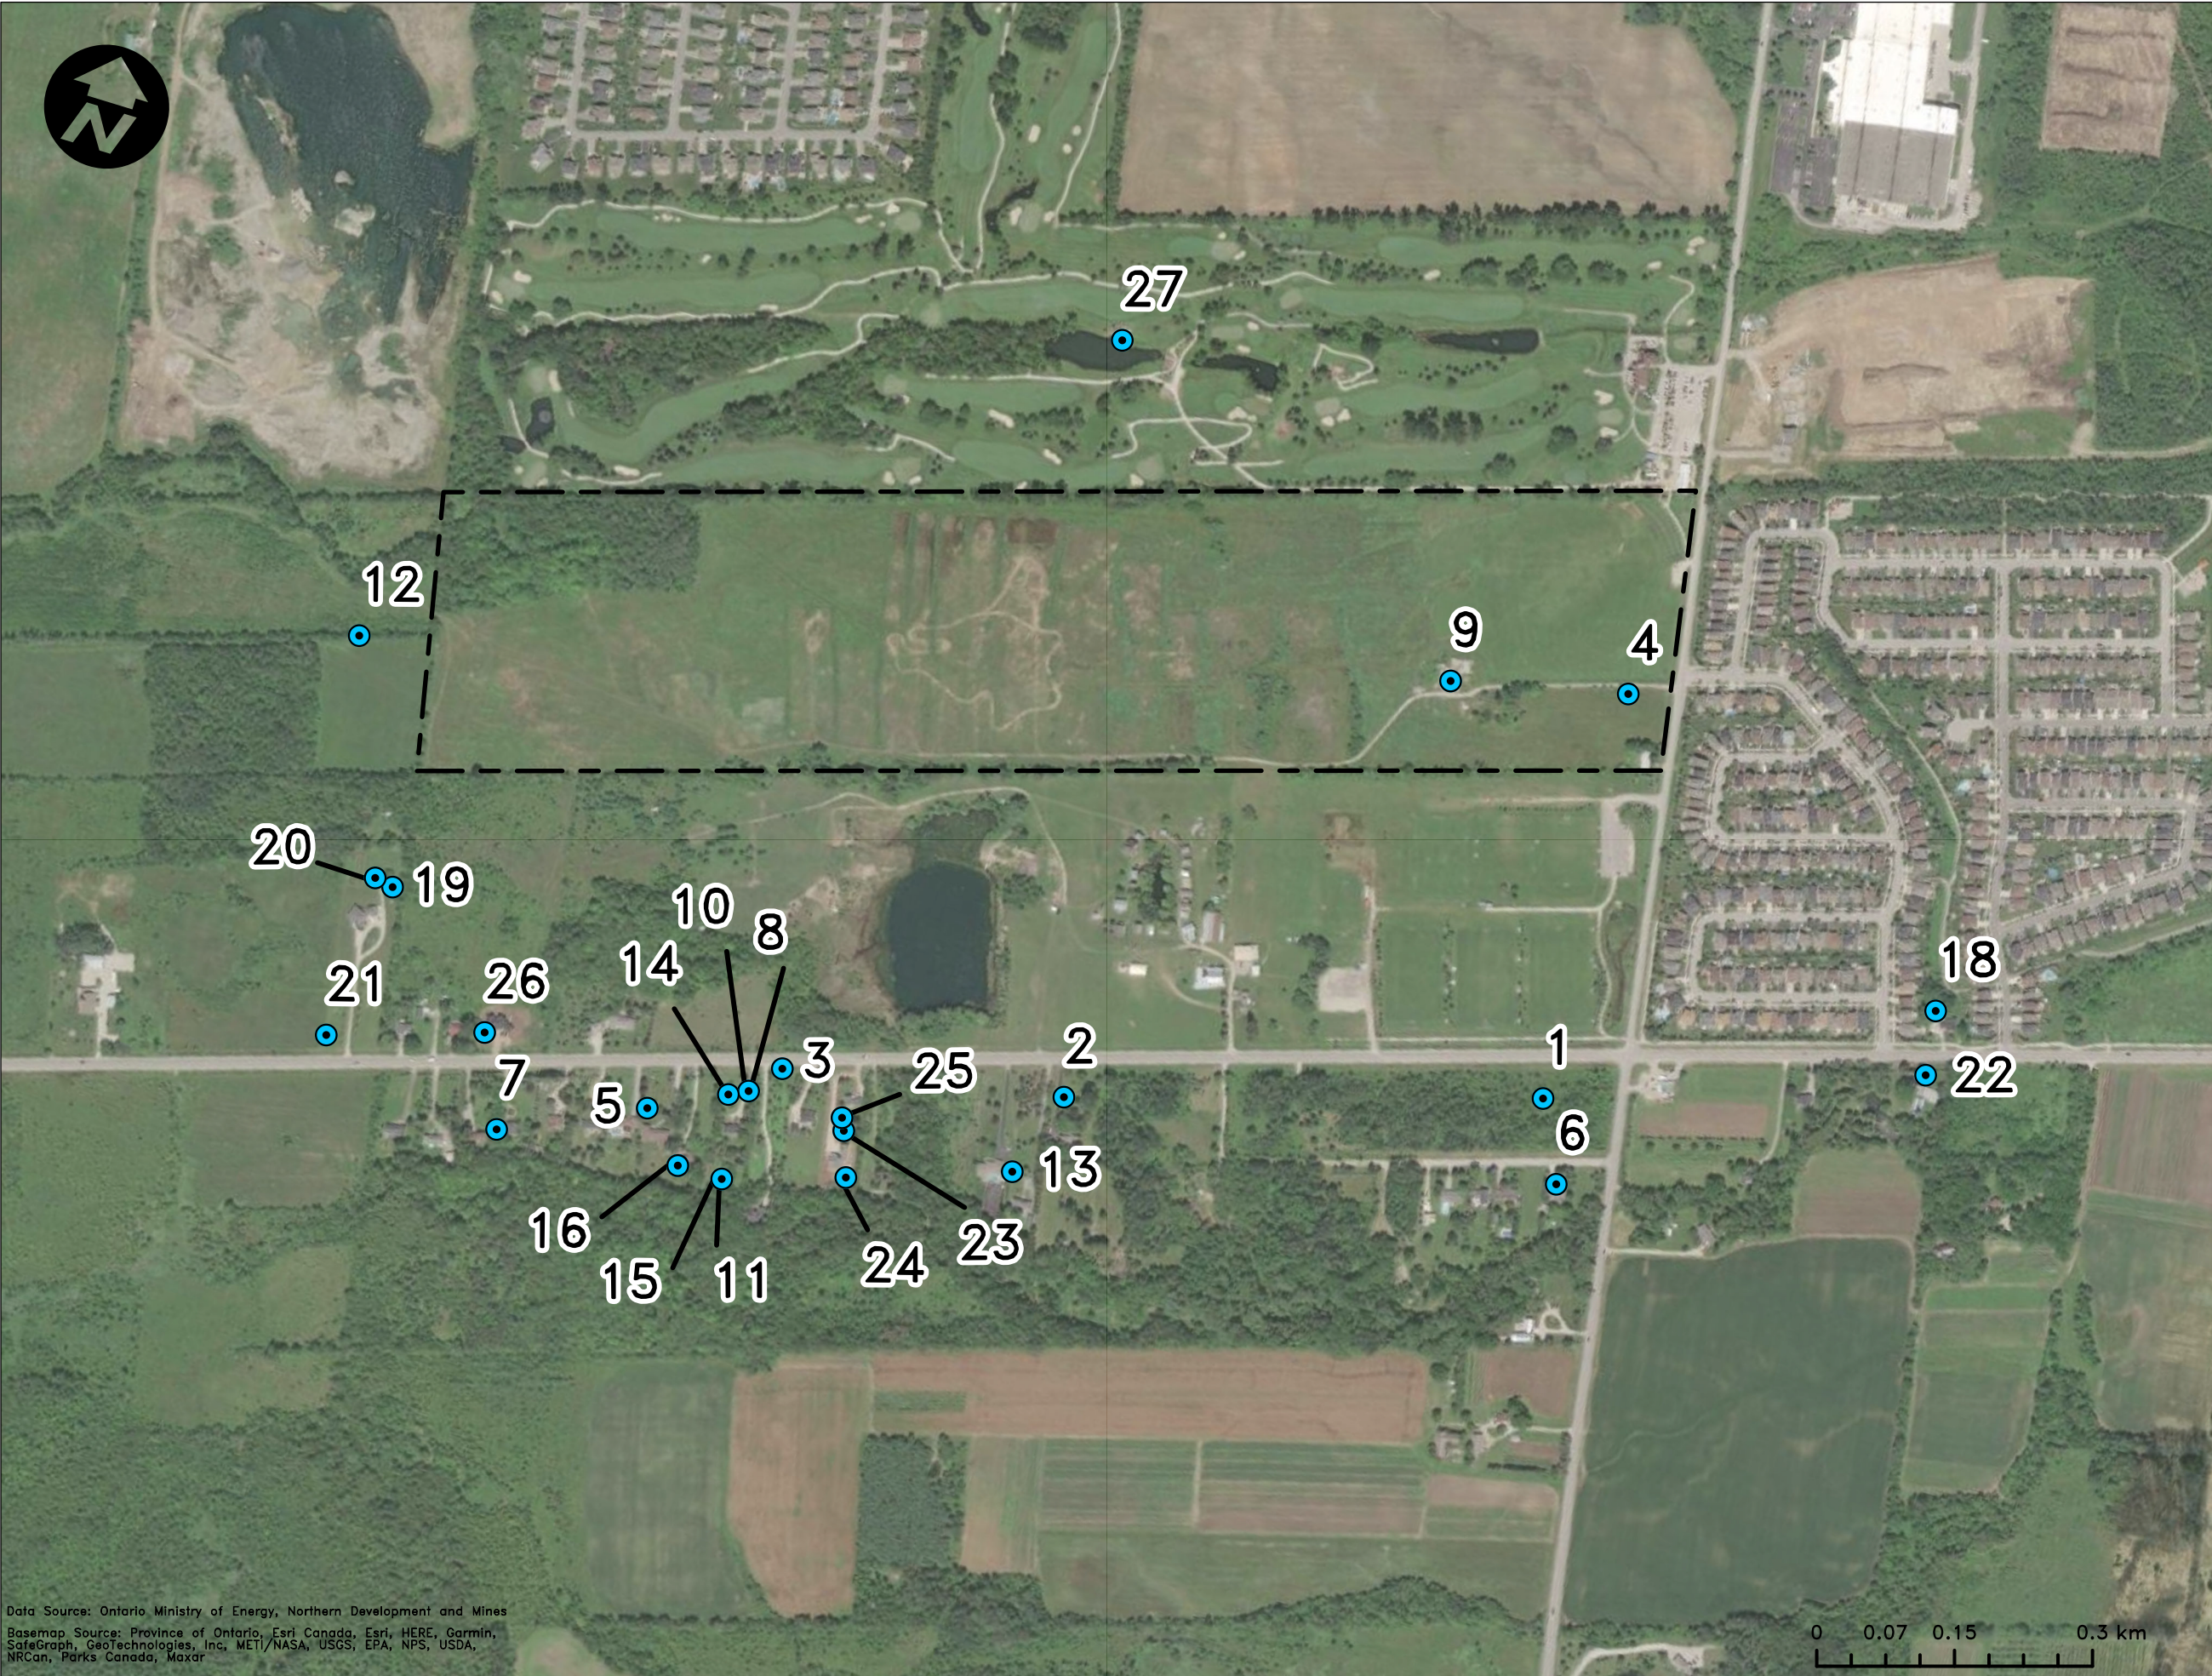
| | | | | Dwg. | FIG. 3 |

- LEGEND**
- Property Limits
  - MECP Wells
  - Key Number - See Appendix B

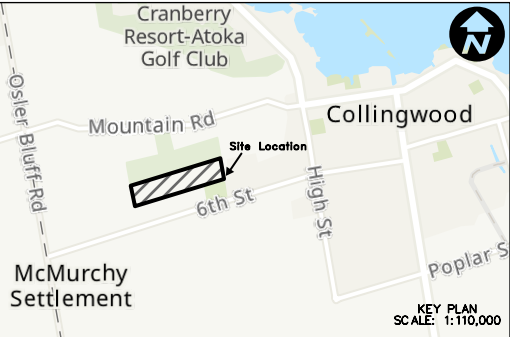
Stratigraphy described within the MECP well records was in agreeance with previous studies. A summary table of the MECP wells can be viewed in Appendix B. Refer to Figure 3 for the MECP well location plan and the spatial distribution of historical wells around the site.

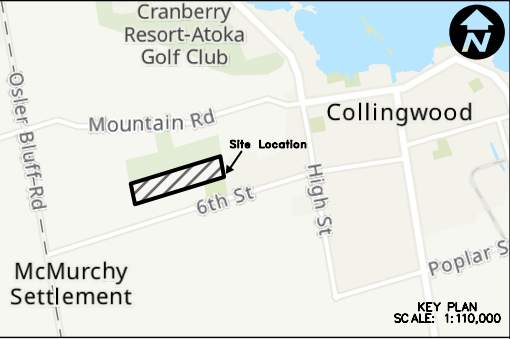
| | | | | Dwg. | FIG. 4 |

Refer to Figure 4 for the surficial geology in the study area.

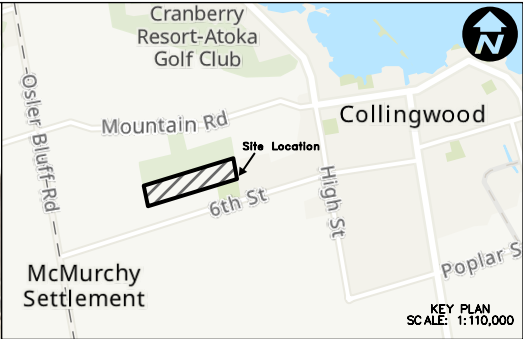
| Date 2022-03-28 | Projection EPSG:26917 | Scale 1:5,000 Dwg. FIG. 5 |

Figure 5 is a well location plan showing all wells, boreholes and testpits at the site including wells previously installed as part of the Peto MacCallum Geotechnical Investigation.

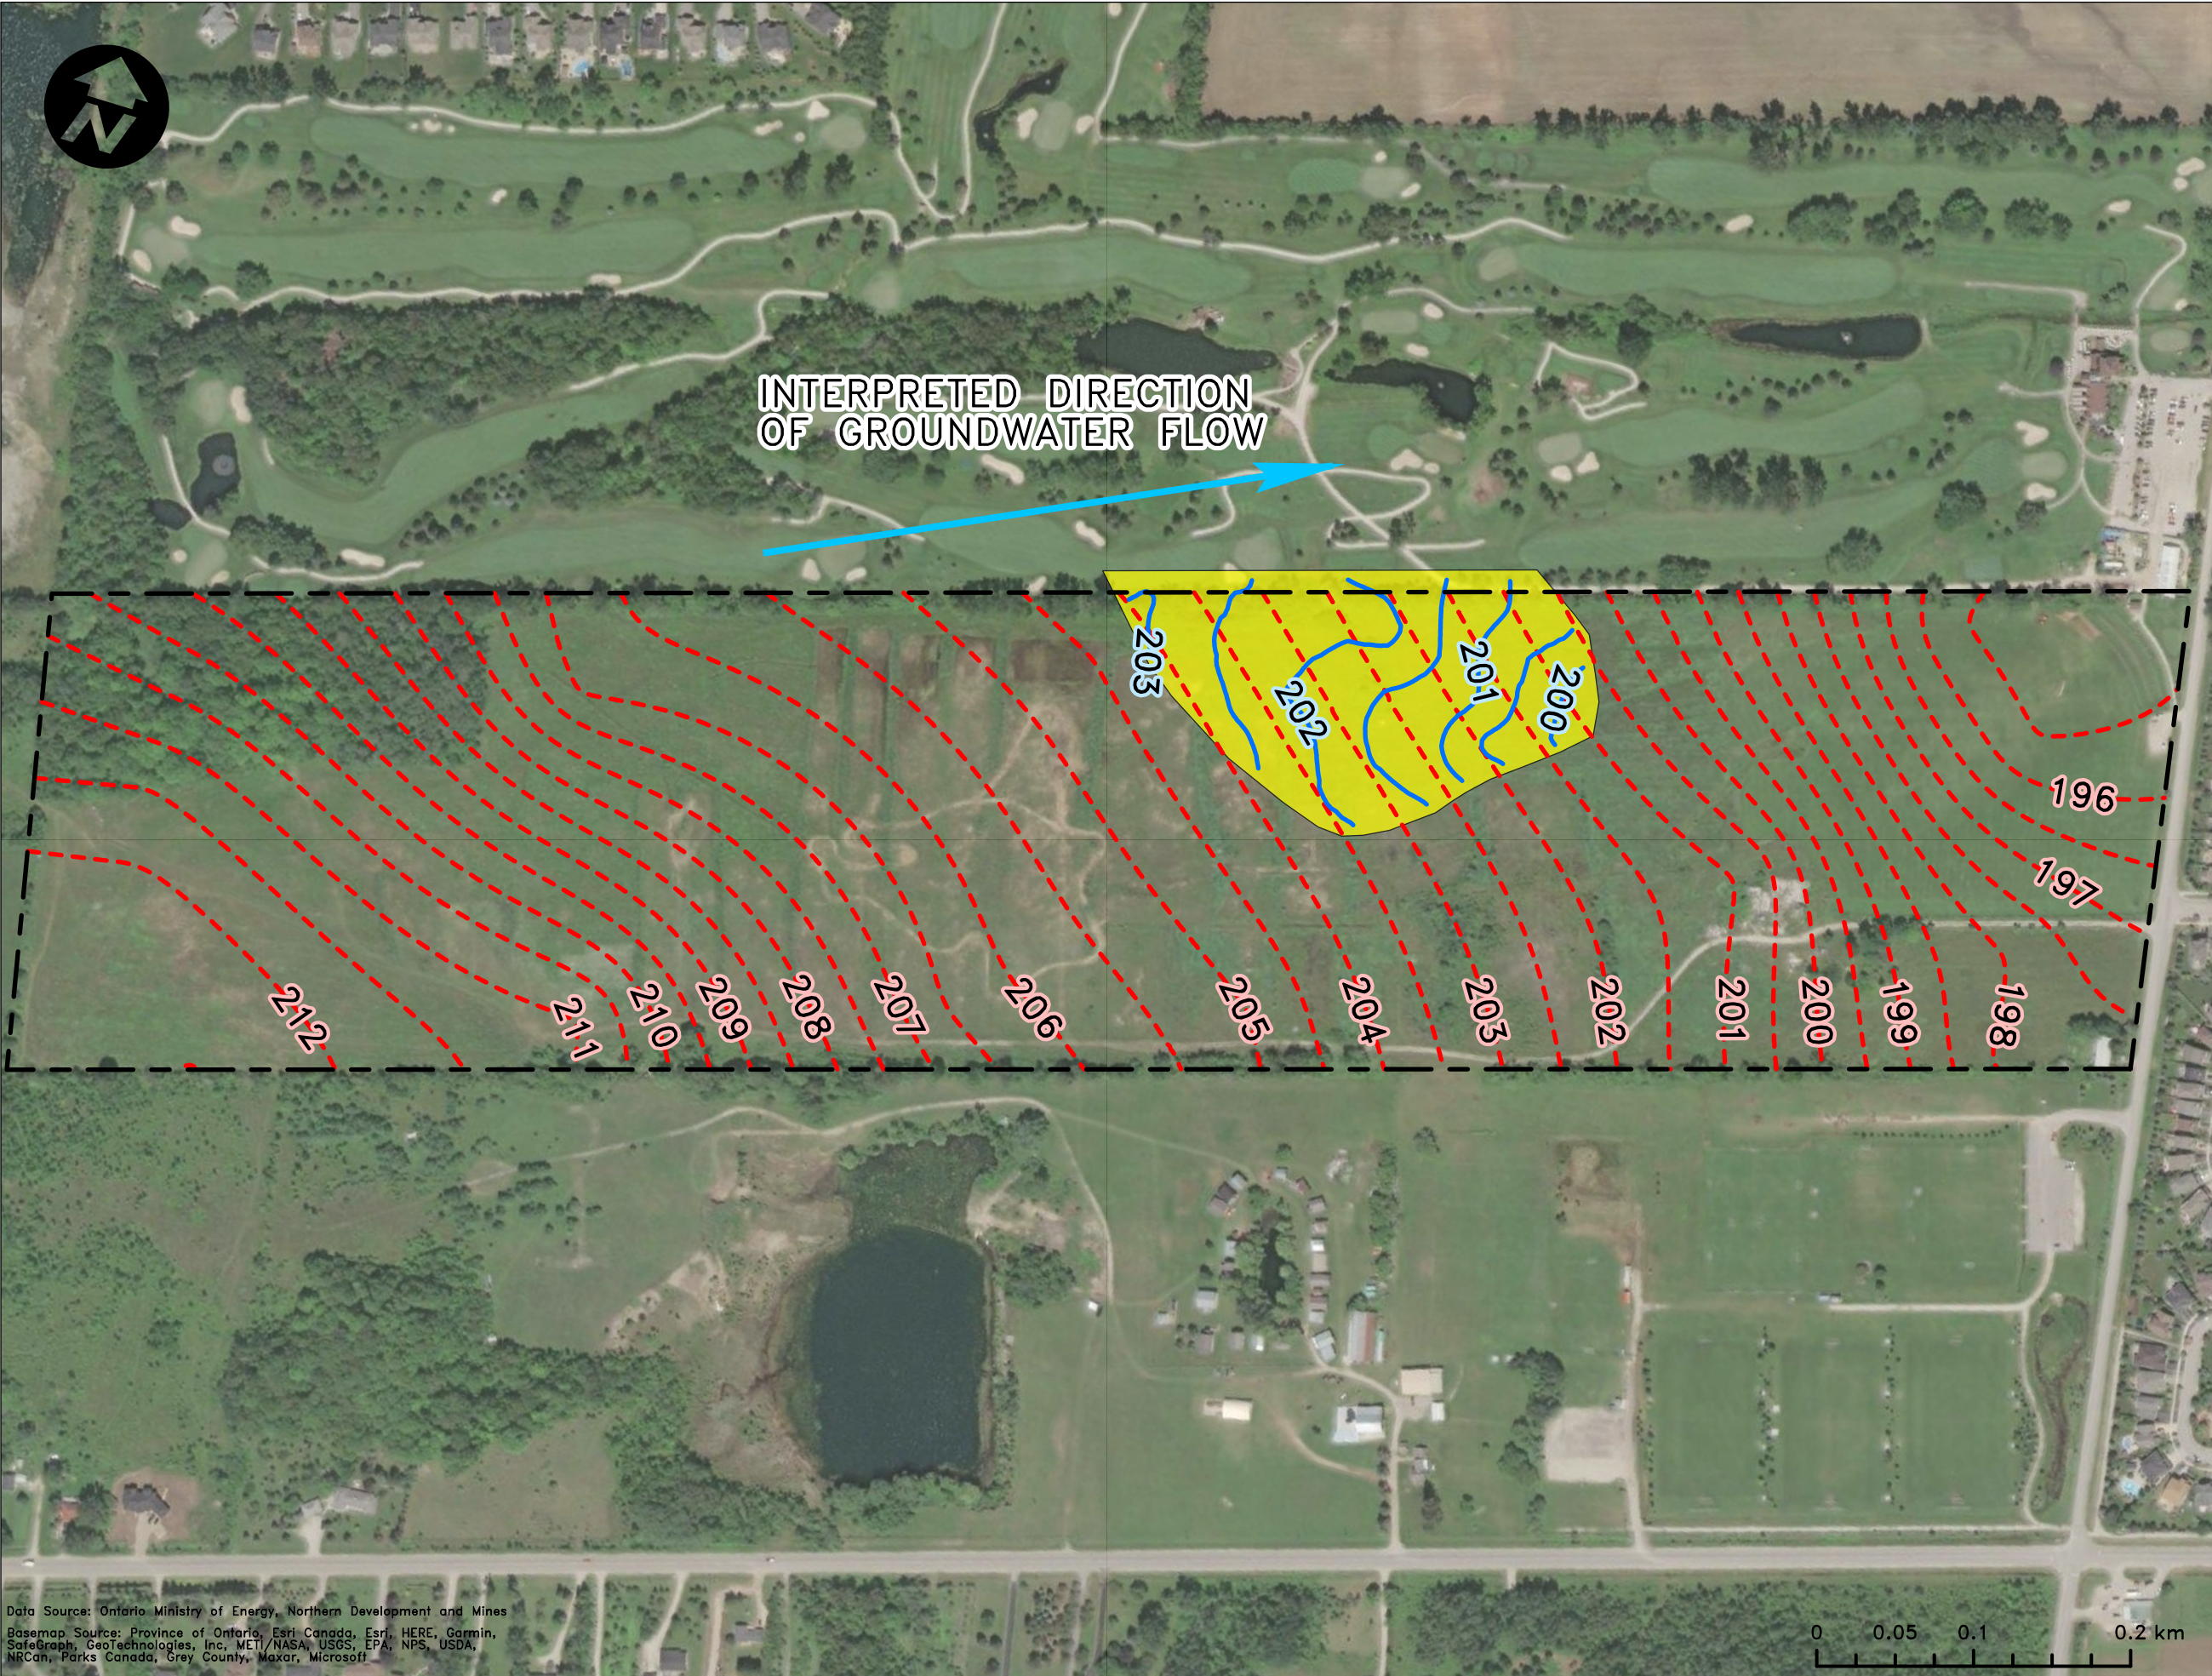
- Property Limits
- Top Unit Groundwater Contour (0.5m)
- Groundwater Contour (0.5m)
- Area of Potential Artesian Conditions
- 200 Top Unit Interpreted Groundwater Elevation (masl)
- 200 Interpreted Groundwater Elevation (masl)
- Interpreted Groundwater Flow Direction

Groundwater contour mapping (Figure 6) was created with the water level data from previous monitoring along with the additional water level data obtained as part of the 2020 and 2021 investigations. Given the presence of potential artesian conditions around BH11, the data was adjusted to respect the elevation of the confining layer and present a surface representative of actual groundwater elevations. This information indicates that groundwater flows from west to east at the site.

Figure 6 also shows an area around BH11 where the potential would exist for artesian conditions. If excavation during construction were to extend below the confining layer, there is the potential for artesian conditions to occur during seasonally high groundwater periods.
