# Phase I Environmental Site Assessment 780 & 788 Tenth Line Collingwood, Ontario

Prepared for: Linksview Development Corporation

> Prepared by: Azimuth Environmental Consulting, Inc.

Re: Phase I Environmental Site Assessment Critique 780 & 788 Tenth Line, Collingwood, Ontario

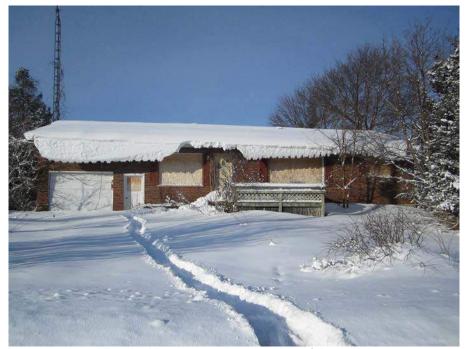
Photograph 1: View looking west at the east side of the existing residential dwelling located at the southeast corner of the Site (788 Tenth Line).

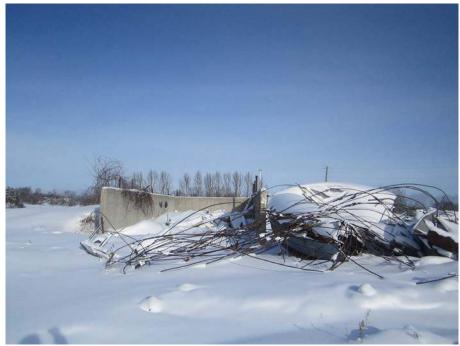
Photograph 3: View looking northwest at the concrete foundation and metal debris piles located in the central portion of the Site.

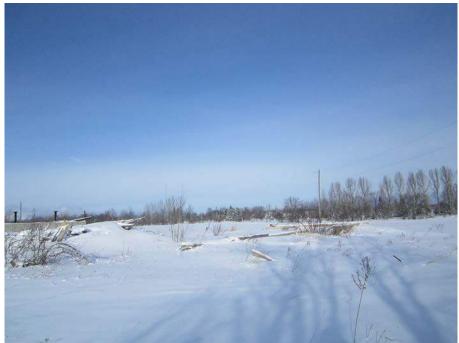
<u>Photograph 4:</u> View looking north at the foundation of former barn located at the central portion of the Site.

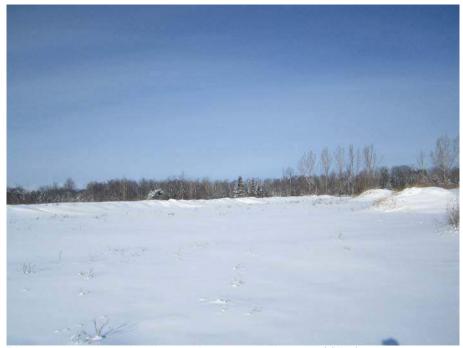
<u>Photograph 5:</u> View looking northwest at the berms of fill of unknown quality in the central section of the Site.

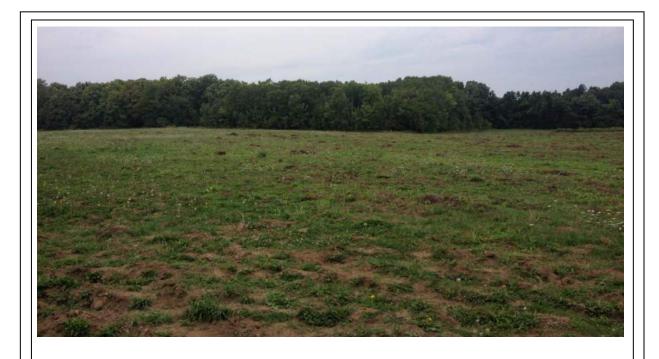
Photograph 1: View facing north of the agricultural area at the western side of the property taken on September 10<sup>th</sup> 2014.

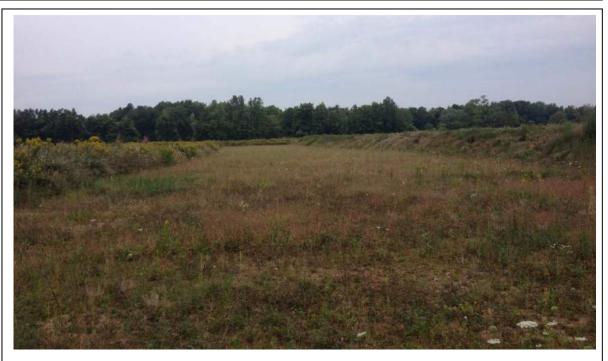
Photograph 2: View facing north of the berm features taken on September 10<sup>th</sup> 2014.

The central portion of the Phase I Property contains numerous berms which run parallel to each other in a north to south direction. These berms are reportedly stockpiled topsoil from local development sources (Section 5.0) and were used during the annual horse show. One pile of sod and some miscellaneous debris (Photograph 4) were also found adjacent to the berms.

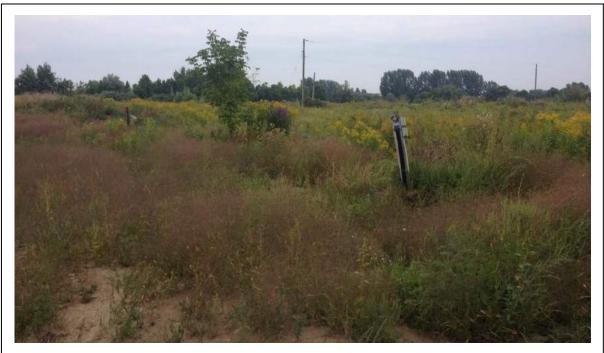
Photograph 3: View facing north  $\,$  east of the hydraulic and irrigation hook ups taken on September 10<sup>th</sup> 2014.

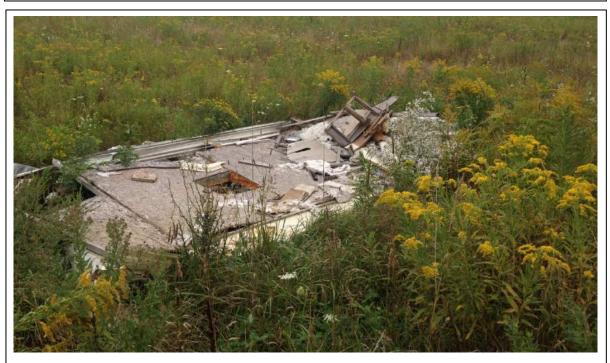
Photograph 4: View of a debris pile taken on September 10<sup>th</sup> 2014.

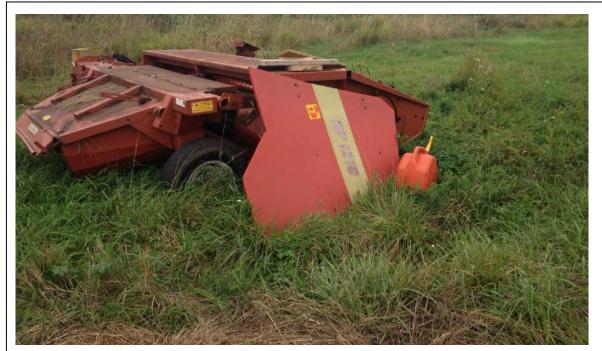
Farming equipment is stored next to the barn foundations and within the north agricultural field at the Phase I Property (Photographs 5 and 7). Two cars (one on the ground and one on a trailer) were also stored here. One empty jerry can was found adjacent to the equipment and is assumed to store gasoline for equipment operation. Some surficial soil staining was found beneath one of the tractors stored next to the barn foundation; however this stain was confined to the upper 10 cm of surficial material.

One empty jerry can of gasoline was found next to some farm equipment during the site reconnaissance visit. This gasoline fuel is used in farming equipment as needed. The MOE (2011) Guidance document for Phase I ESAs states "... storage of several 44 gallon drums of fuel oil would be considered 'bulk storage'; however, a typical jerrycan of fuel stored in a residential garage would not be considered 'bulk' storage ...". Based on our site visit there was no evidence of liquid bulk storage.

Photograph 5: View of farming equipment stored on site and associated fuel storage taken on September  $10^{\text{th}}$  2014.

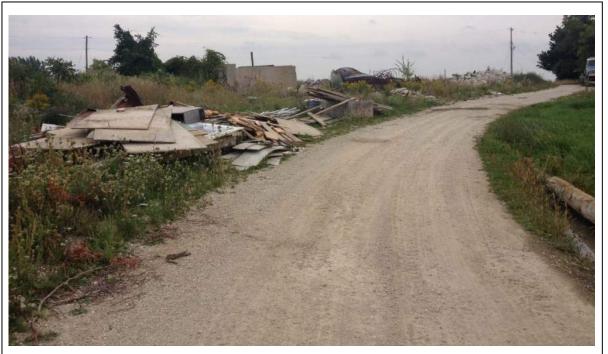
The Phase I Property also contains remnants of two barn structures at the end of a second gravel driveway off of Tenth Line. Within this localized area of the Phase I Property two cement foundations remain in addition to numerous piles of wood, cement, household garbage, scrap metal, a small quantity of 4 L old / empty paint cans, and the roof of a silo (Photographs 6, 8, and 9). It appears that the barns were semi demolished and that some

Photograph 6: View facing east of the north barn foundation and debris piles taken on September 10<sup>th</sup> 2014.

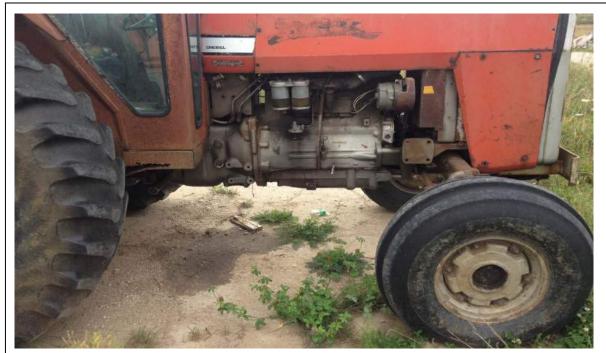
In addition, there was a surficial soil stain found beneath one of the tractors stored next to the barn foundation. This stain was confined to the upper 10 cm of surficial material and is not considered to be a significant environmental concern.

Photograph 7: View of a tractor stored on site and soil staining taken on September 10<sup>th</sup> 2014.

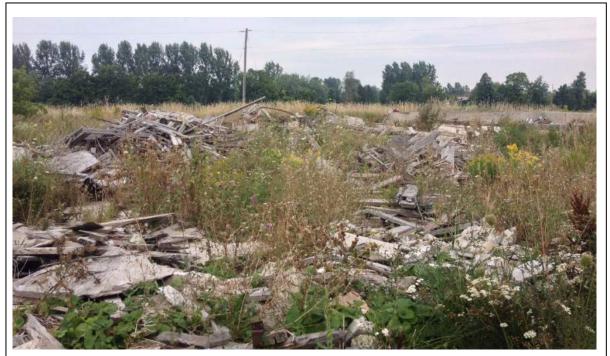
Photograph 8: View facing north of the wood and concrete piles taken on September 10<sup>th</sup> 2014.

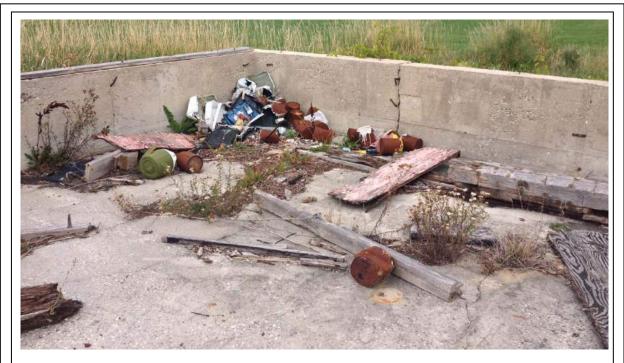
At the time of site reconnaissance visit, there were numerous rusty 1 L paint cans stored in a corner of the former barn foundation at the Phase I Property (Photograph 9). It is not known if these are from the original barn structure or are the result of illegal dumping, however some paint material did remain within the cans. There did not appear to be any paint which had leaked into the cement foundation. Due to the limited quantity of paint within the cans and the lack of any evidence of surficial contamination, the paint cans are not expected to represent a significant environmental concern. The presence of a secondary containment area (i.e., the poured cement barn foundation) would prevent the leakage of any liquid paint into the subsurface soils. Other debris such as wood, cement, household garbage, scrap metal, and the roof of a silo is also present at the Phase I Property. There was no ability to inspect under these debris piles; but the nature of the materials would suggest it is relatively inert. This debris material should be removed from the Phase I Property and properly disposed.

Photograph 9: View facing north east of material storage within the north barn foundation taken on September 10<sup>th</sup> 2014.

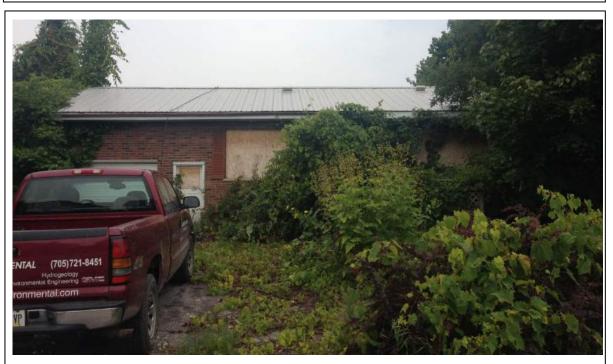
The permanent structure currently located at the Phase I Property is an abandoned residence on the south east corner (Photograph 10). The abandoned residence is a one storey structure which is rectangle in shape and approximately 19 m long and 9 m wide. The residence contains a basement, kitchen washrooms, living room, and bedrooms. The foundation is poured cement with brick walls. Baseboard heaters were noted along the interior walls. No evidence of any ASTs/USTs was found during the site visit. Although the residence is abandoned, it contained miscellaneous household garbage and construction material (wood, cement, etc.). This residence is accessed by an overgrown driveway from Tenth Line. It is currently boarded up and locked. A wooden shed measuring ~ 4 m by 6 m is present in the backyard; however it was locked during the site reconnaissance.

Photograph 10: View facing west of the abandoned residence taken on September 10<sup>th</sup> 2014.

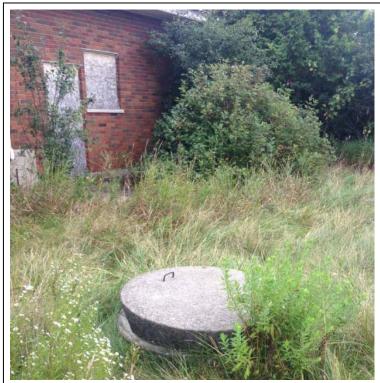
Tenth Line is not currently municipally serviced. The EcoLog Report (Section 4.0) identified two well records on the Phase I Property. The first record corresponds to an 11.5 m deep bored well constructed on October 21, 1971. This well was found during the site reconnaissance adjacent to the abandoned residence and appears to be a dug well construction (Photograph 11). The second well record corresponded to a 17 m deep drilled well constructed on May 23, 1960. This well was not identified during the site reconnaissance. The EcoLog Report listed this well as abandoned, so it is likely that this well ran dry and was decommissioned. It is assumed that each well is connected to its designated use (house, barn, etc.) through underground water lines, however their precise location have not be identified as part of this ESA.

Photograph 11: View of the dug well located next to the abandoned residence taken on September 10<sup>th</sup> 2014.

As noted in the PML (2014) report, it is recommended that the onsite well(s) be properly decommissioned prior to site development.

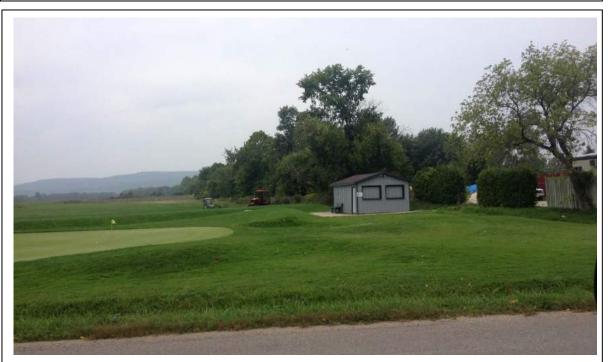
Photograph 12: View facing east of the driving range and storage shed on the north east corner of the property taken on September 10<sup>th</sup> 2014.
