August 30, 2024

Reference No. G2S21366A

**Phase One Environmental Site Assessment Update  
839, 853 and 869 Hurontario Street & 7564 Poplar Sideroad  
Collingwood, Ontario**

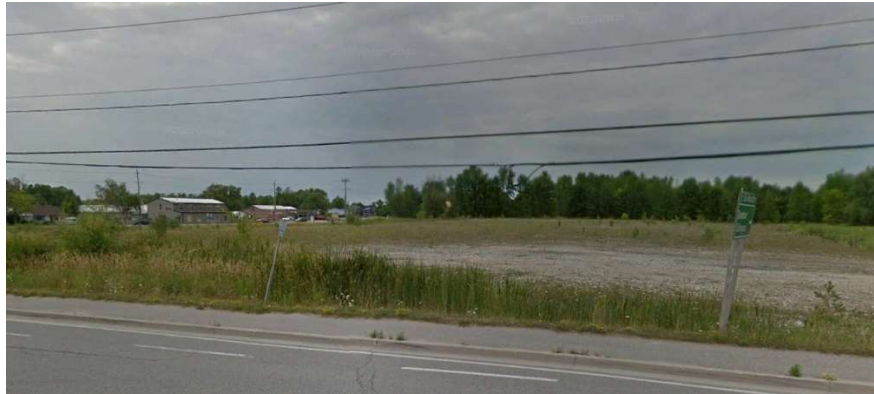
- The Site remains vacant, undeveloped land at addresses 839 and 869 Hurontario Street and 7564 Poplar Sideroad. The fill pad is still located at the central portion of the Site.
- Vegetation covers most of the Site.
- 853 Hurontario Street is a residential property with a storey house. No indication of historic or current fuel storage tanks were observed on the interior or exterior of the residential building.

**Photo #1:** Site, looking north from Poplar Sideroad

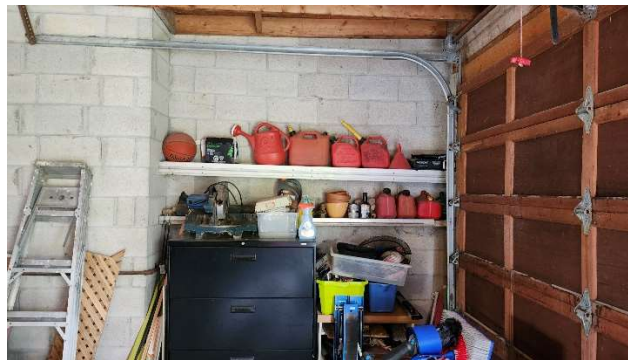
**Photo #5:** View of interior of garage and typical storage.

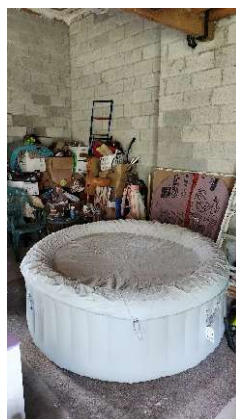
**Photo #6:** View of interior of garage and typical storage.
