Reference No. G2S21366A-Rev2

**Phase One Environmental Site Assessment Update
839, 853 and 869 Hurontario Street & 7564 Poplar Sideroad
Collingwood, Ontario**

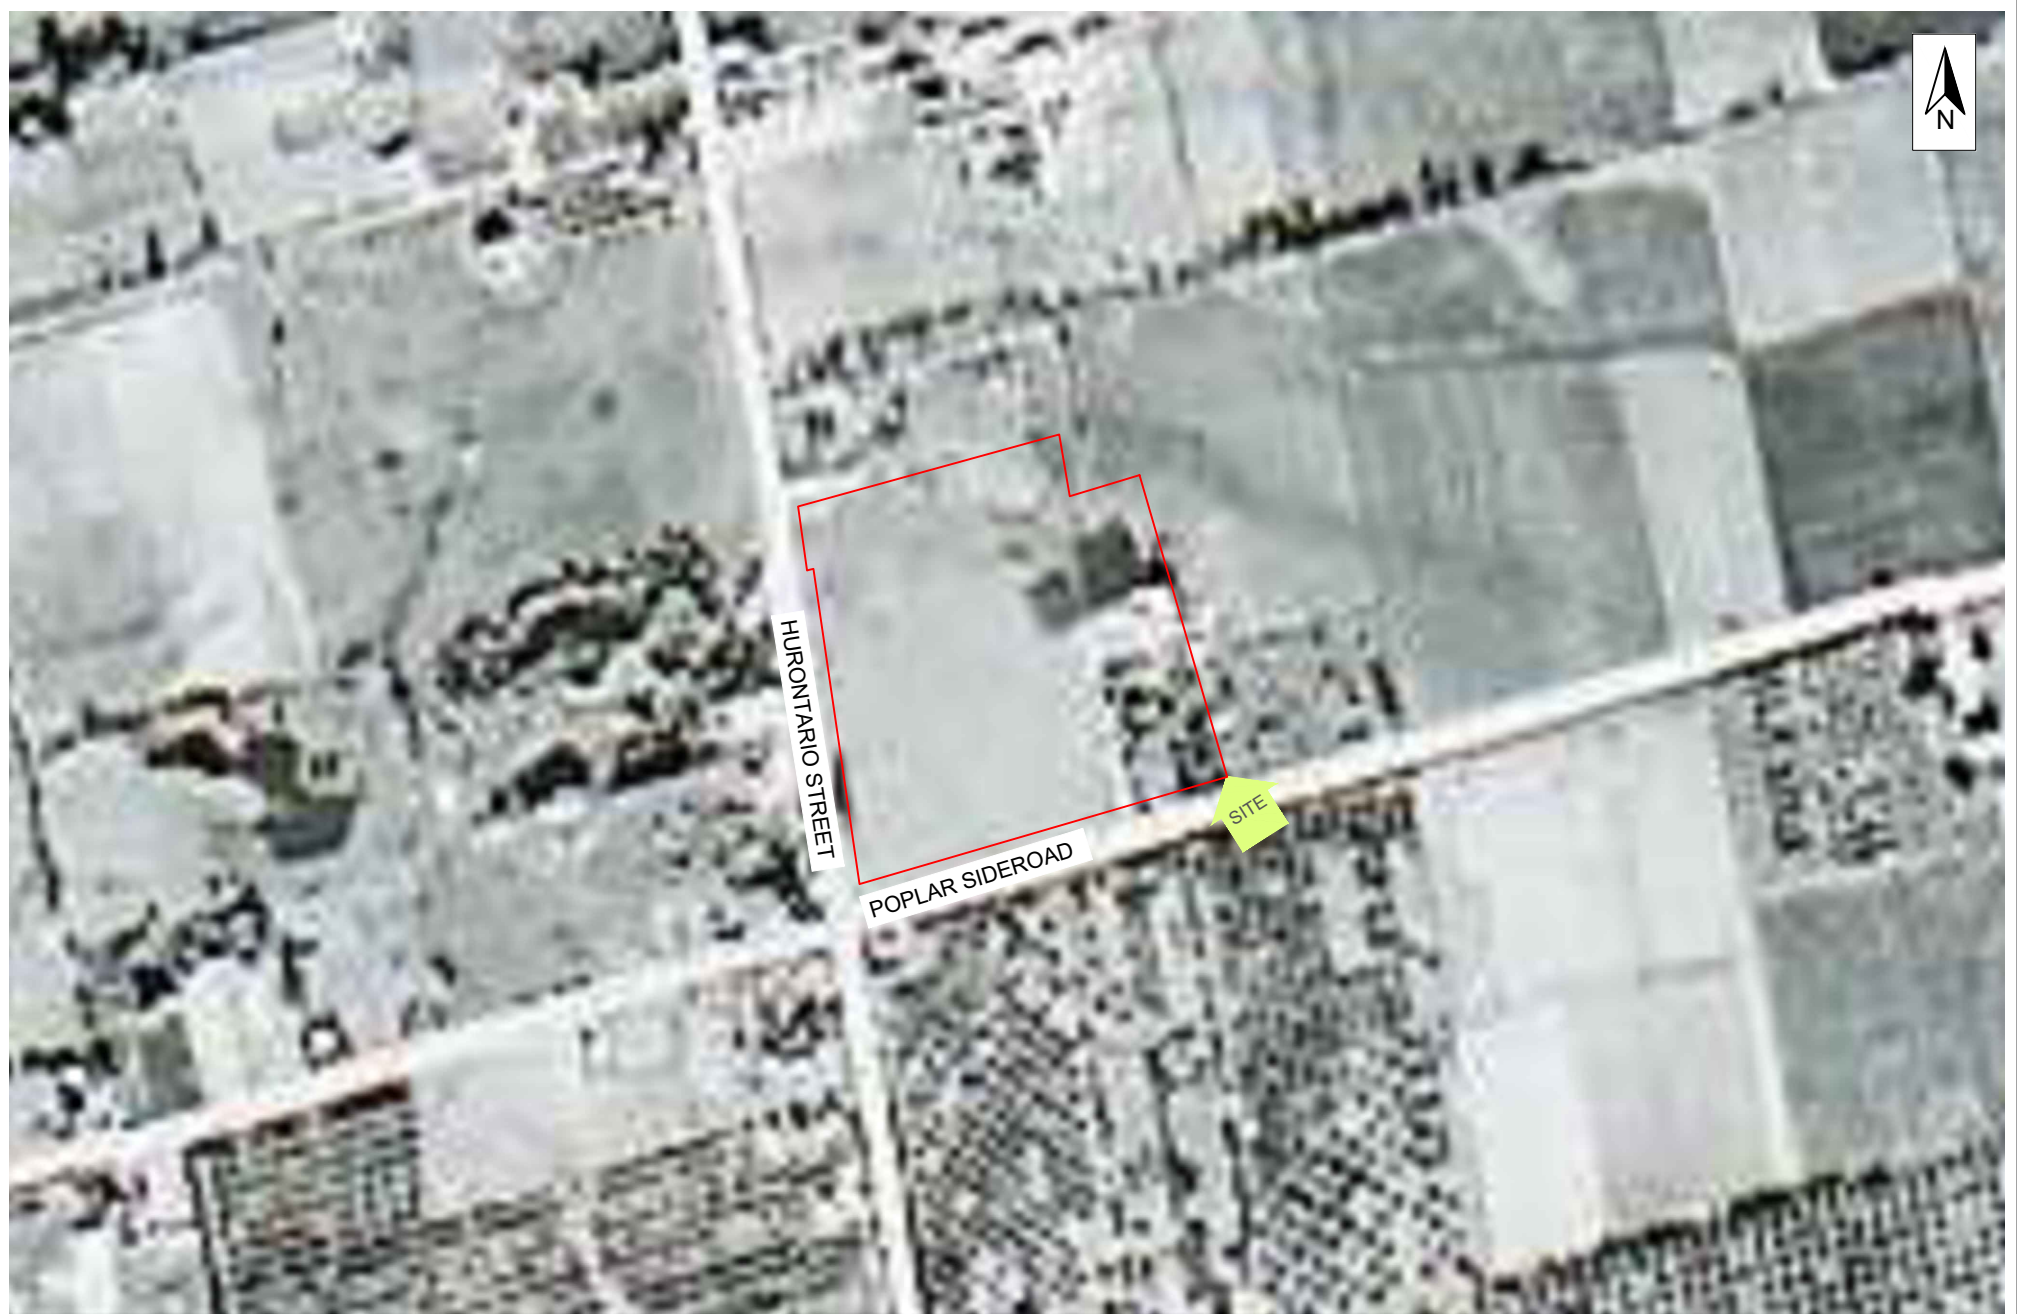
4

Year	Site Description	Study Area Description
1954	Due to the scale of the image, details are difficult to depict; however, it appears as though a residential building is developed at 7564 Poplar Sideroad in the southeast portion of the Site. The remainder of the Site appears to be undeveloped and/or used for agricultural purposes.	The Study Area is primarily undeveloped or used for agricultural/rural residential purposes. Orchards are located south and southwest of the Site on the south side of Poplar Sideroad.
1978	The residential building at Poplar Sideroad remains on-Site. Construction of a residential dwelling at 853 Hurontario Street in the northwest portion of the Site appears to be commencing, and a driveway extends along the north side of the property and through 839 Hurontario Street. A small pond is located in the northwest part of the Site.	Residential buildings are located east and north adjacent to the Site, and on the west side of Hurontario Street. Several commercial buildings have also been constructed west of the Site on Hurontario Street.

1954 AERIAL PHOTOGRAPH
839, 853 AND 869 HURONTARIO STREET &
7564 POPLAR SIDEROAD

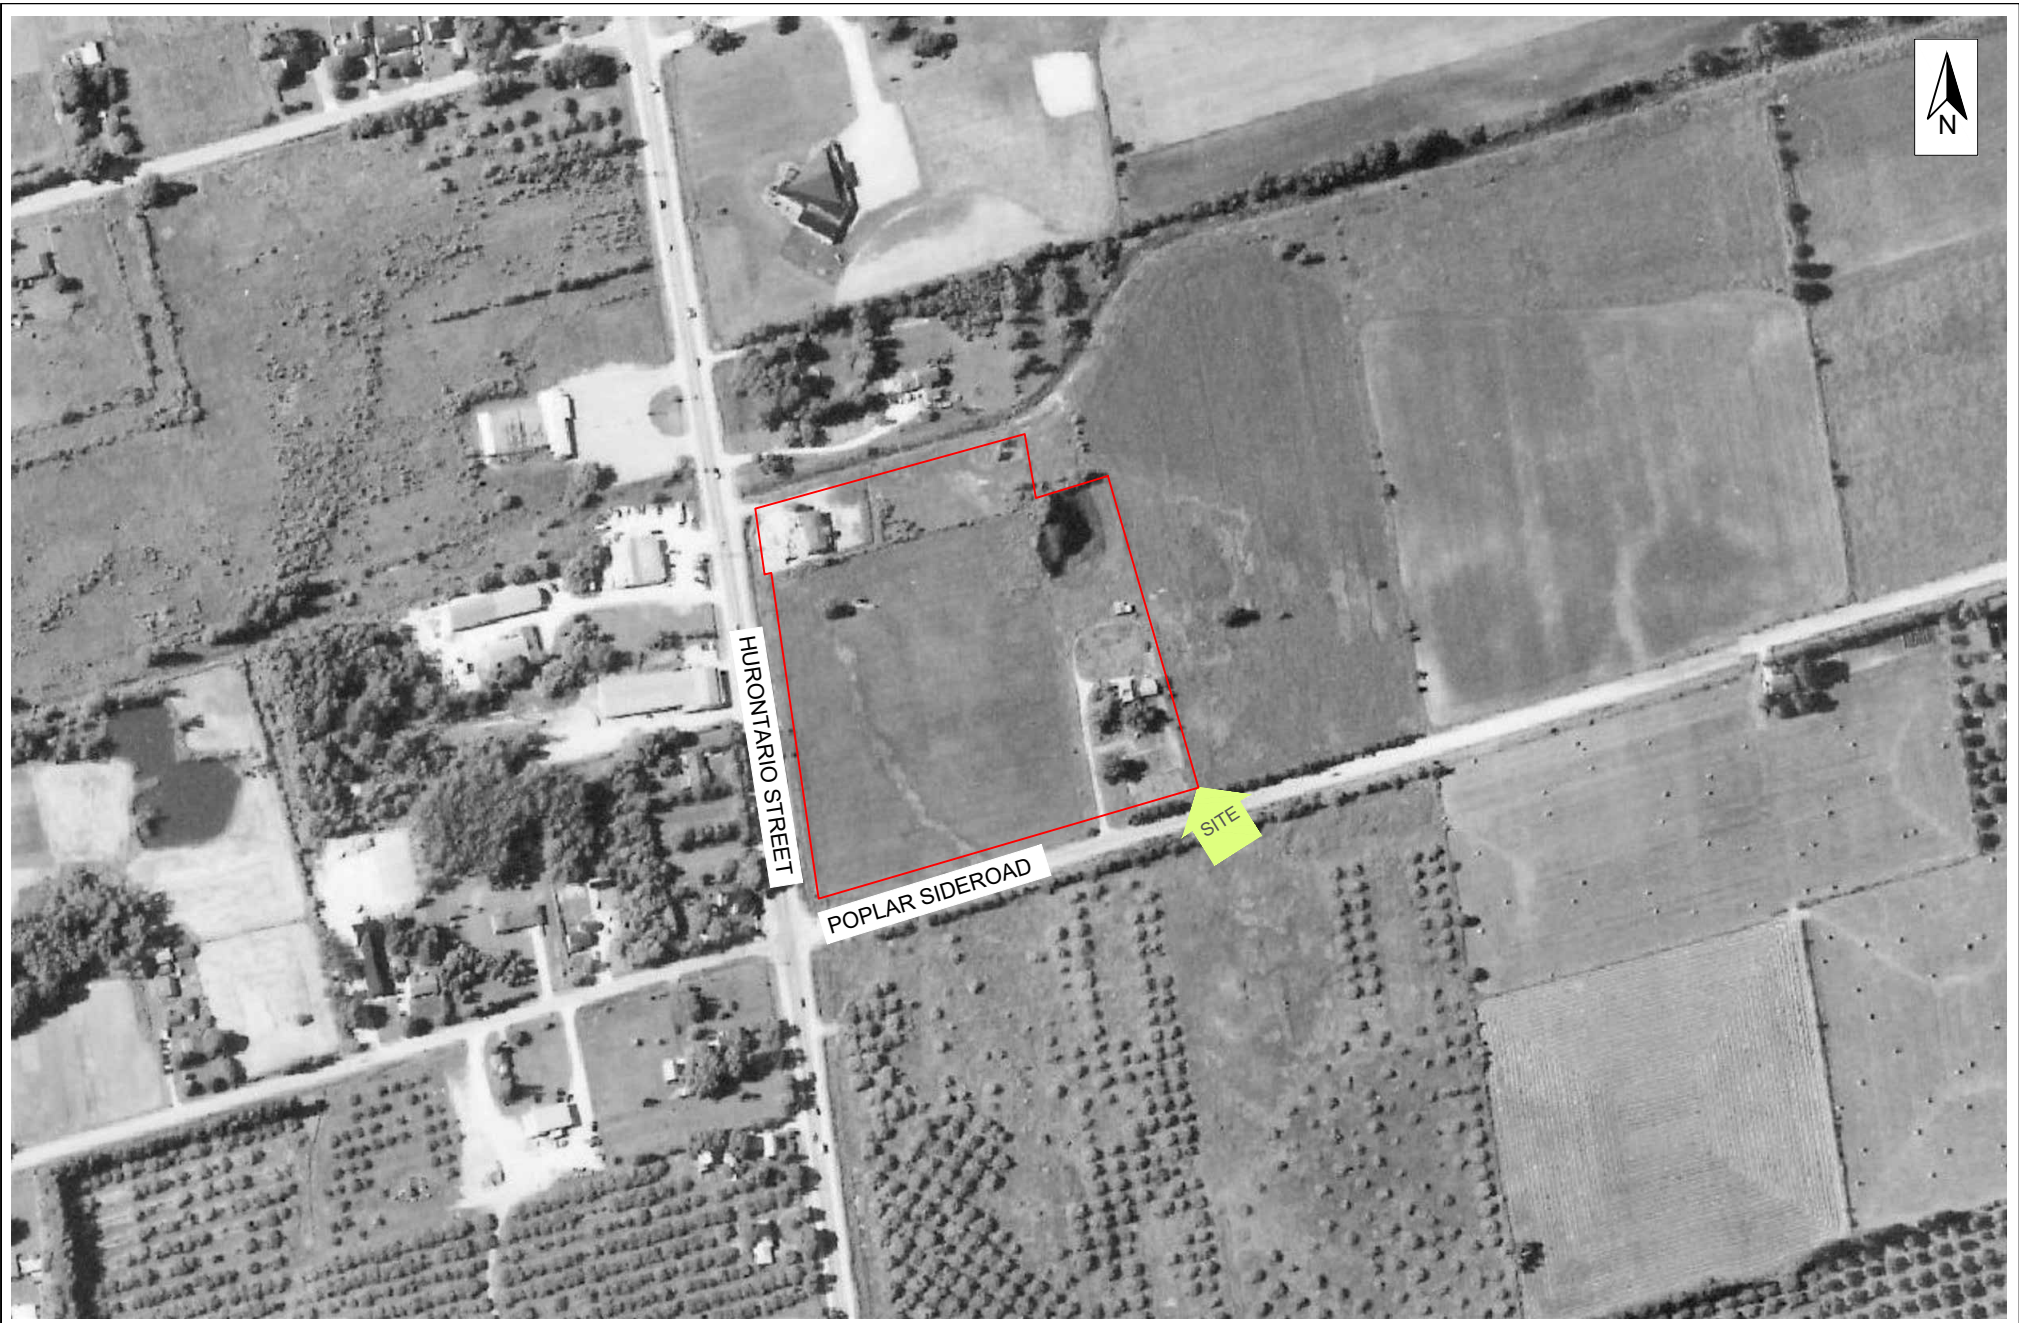
6

1989	The residence has been constructed on the northwest corner of the Site at 853 Hurontario Street. 839 and 869 Hurontario Street remain undeveloped. A pond is located within the northeast portion of the Site.	
1997	869 Hurontario Street appears to have been cultivated, and several hay bails are located across the property in 1997. The remainder of the Site is developed similar to 1989 with residential buildings at 853 Hurontario Street and 7654 Poplar Sideroad. 839 Hurontario remains undeveloped. In 2002 there appears to be a drainage swale/wet area in the southwest part of the Site.	Additional commercial or industrial buildings have been constructed on the west side of Hurontario Street.
2002		
2008	A fill pad is present in the central area of the Site, across the majority of the property located at 869 Hurontario Street. The pond on the west side of the Site has been converted to a stormwater management pond. The residential building at 7564 Poplar Sideroad has been demolished, 839 Hurontario Street remains undeveloped, and 853 Hurontario Street is still developed with a residential building. The Site is developed similar to present.	The east adjacent property has been cleared and appears to be in the early stages of development.

1989 AERIAL PHOTOGRAPH
839, 853 AND 869 HURONTARIO STREET &
7564 POPLAR SIDEROAD

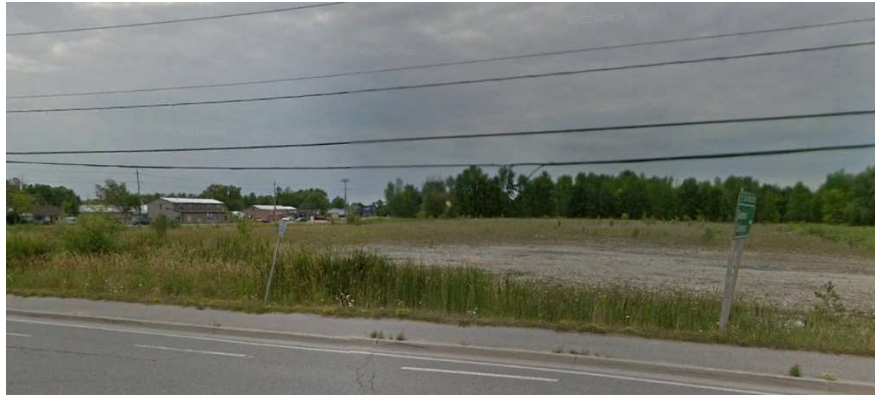
- The Site remains vacant, undeveloped land at addresses 839 and 869 Hurontario Street and 7564 Poplar Sideroad. The fill pad is still located at the central portion of the Site.
- Vegetation covers most of the Site.
- 853 Hurontario Street is a residential property with a single storey house. No indication of historic or current fuel storage tanks were observed on the interior or exterior of the residential building.

Photo #1: Site, looking north from Poplar Sideroad

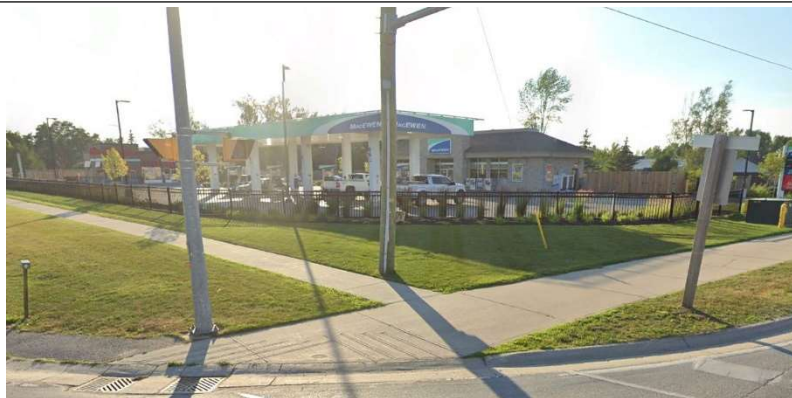
- 7618 Poplar Sideroad (~30 m west): Technical Standards and Safety Authority (TSSA) records for a gasoline service station and three liquid fuel tanks on the property.

The occupant located at 7618 Poplar Sideroad was deemed to represent a potential PCA for the Site, which is included in Section 7.0 of this report. The environmental source information is included in Appendix C.

Photo #3: Gas station at 7618 Poplar Sideroad (~30 m west of Site).

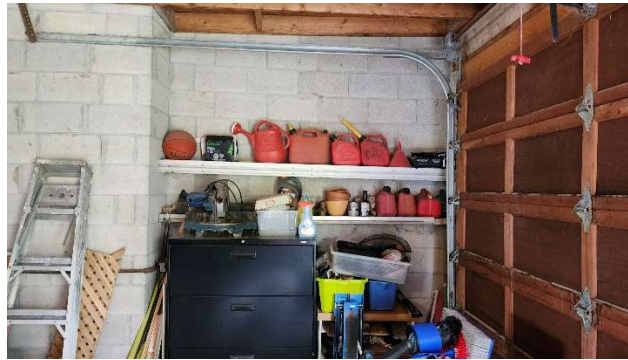
Photo #5: View of interior of garage and typical storage.

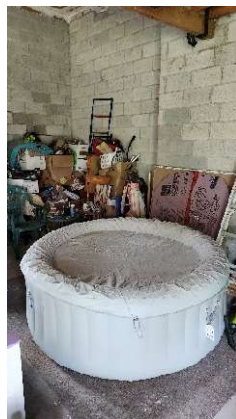
Photo #6: View of interior of garage and typical storage.
