# Phase I Environmental Site Assessment 780 Tenth Line, Collingwood, Ontario

Prepared for  
Rayville Developments (Legacy) Inc.

AEC Project No. 25-172 | June 6<sup>th</sup>, 2025

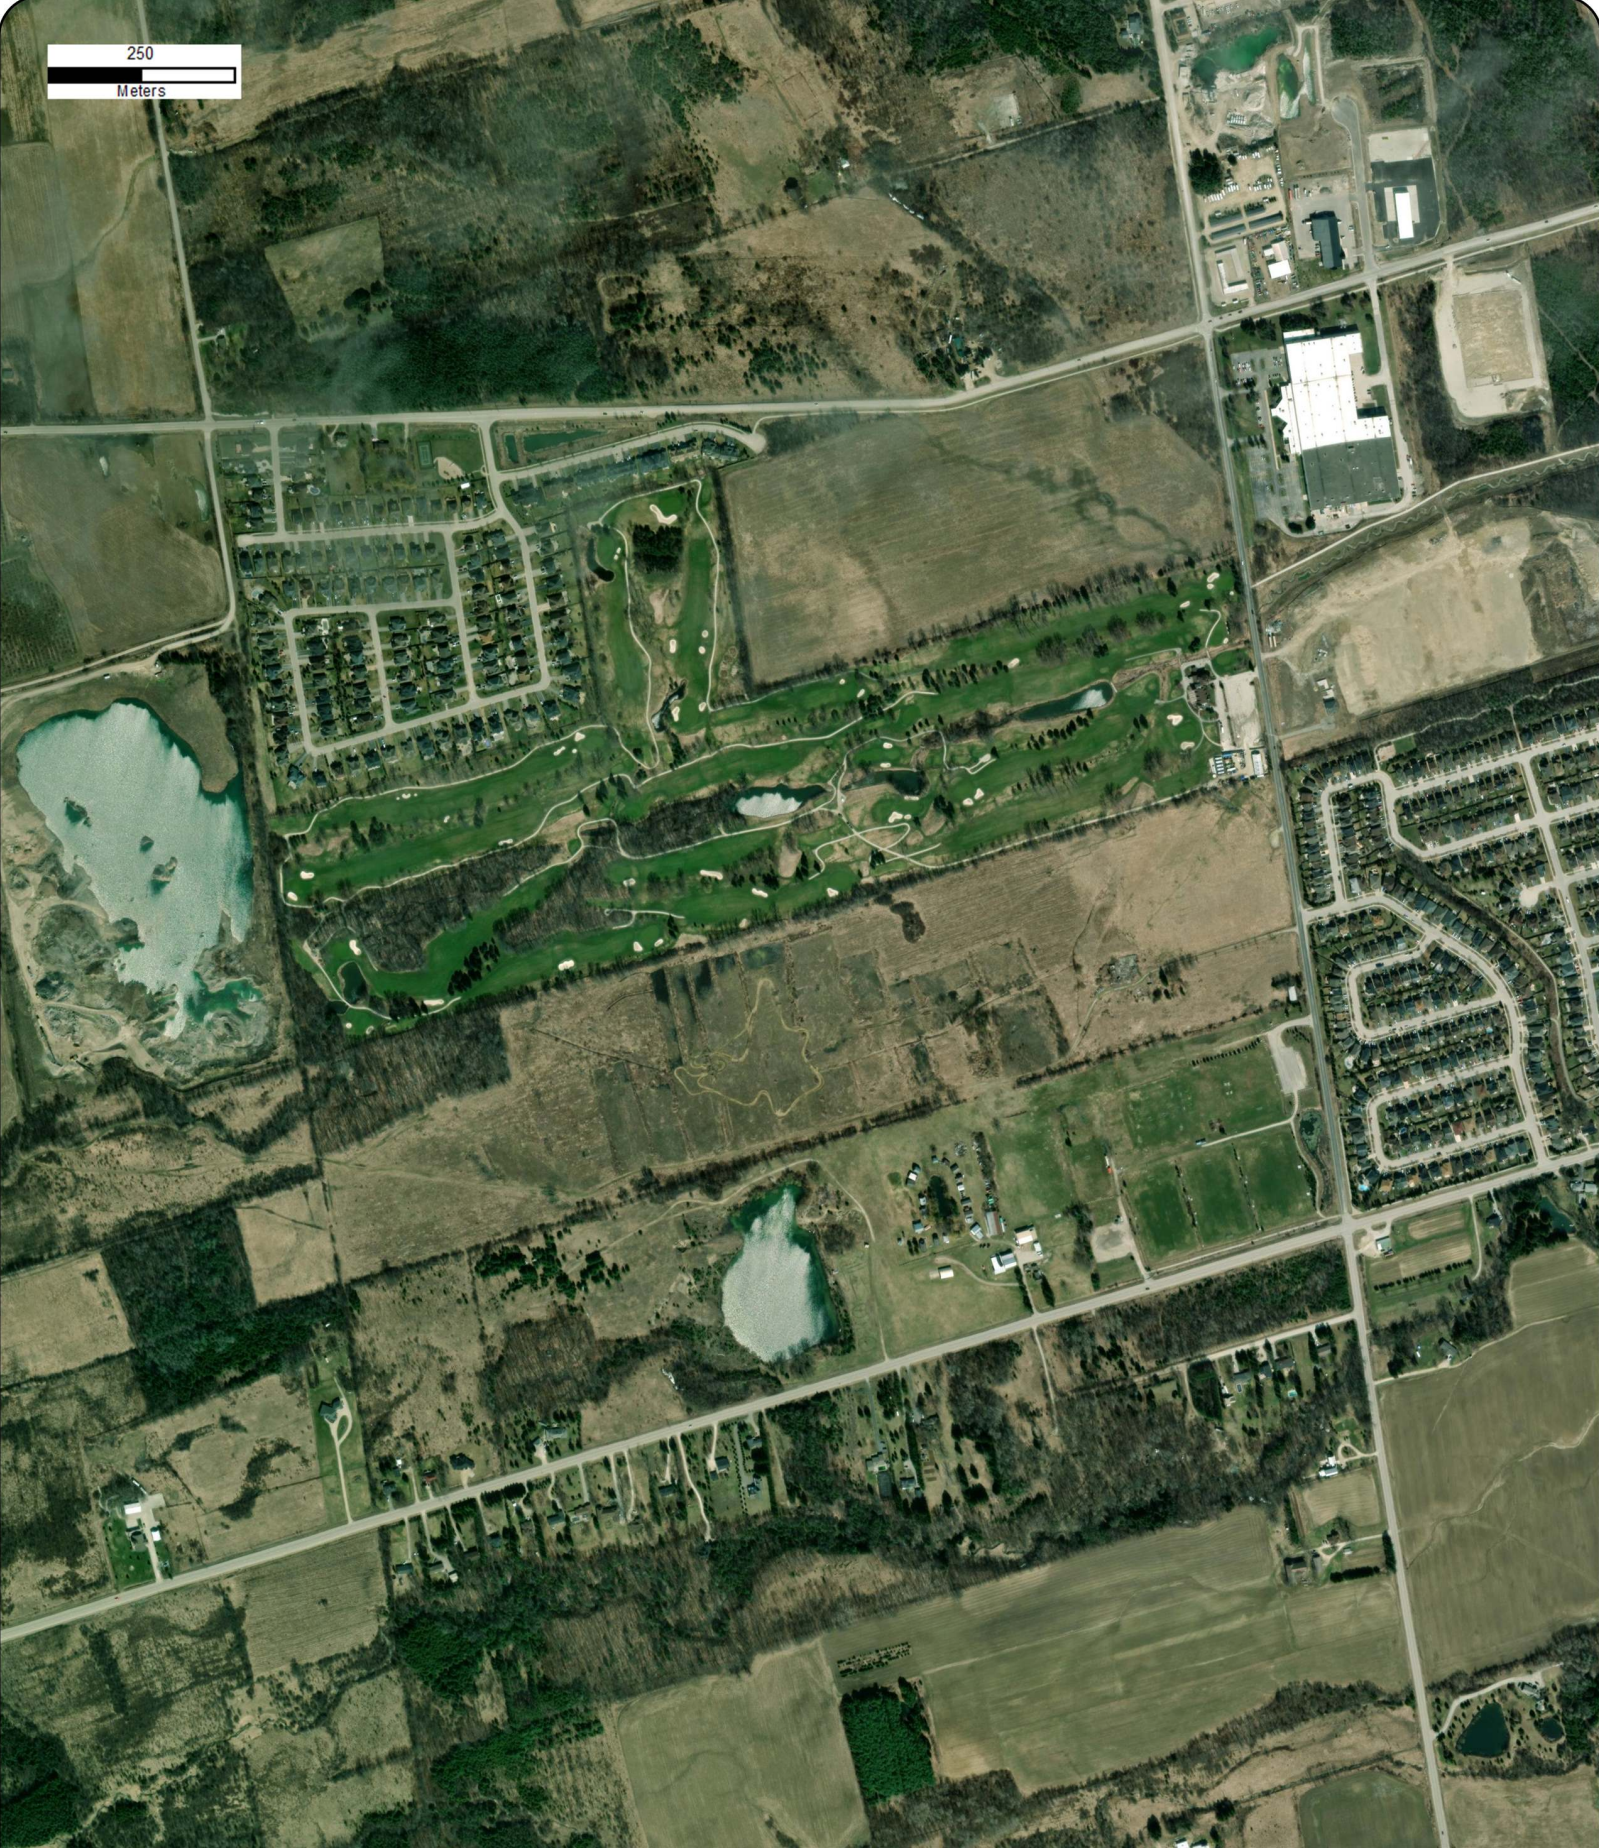
Year: 2020  
Source: MAXAR  
Scale: 10,000  
Comment:

| Year | Observations |
|---|---|
| 2018, 2023 | Review of the 2018 and 2023 aerial photographs indicate that conditions at the Site and surrounding lands were similar to those observed in the 2016 aerial image. As of 2023, the north eastern portion of the Site was no longer in use as a driving range. The concrete foundations in the former farmstead area had also been removed as of 2023. |

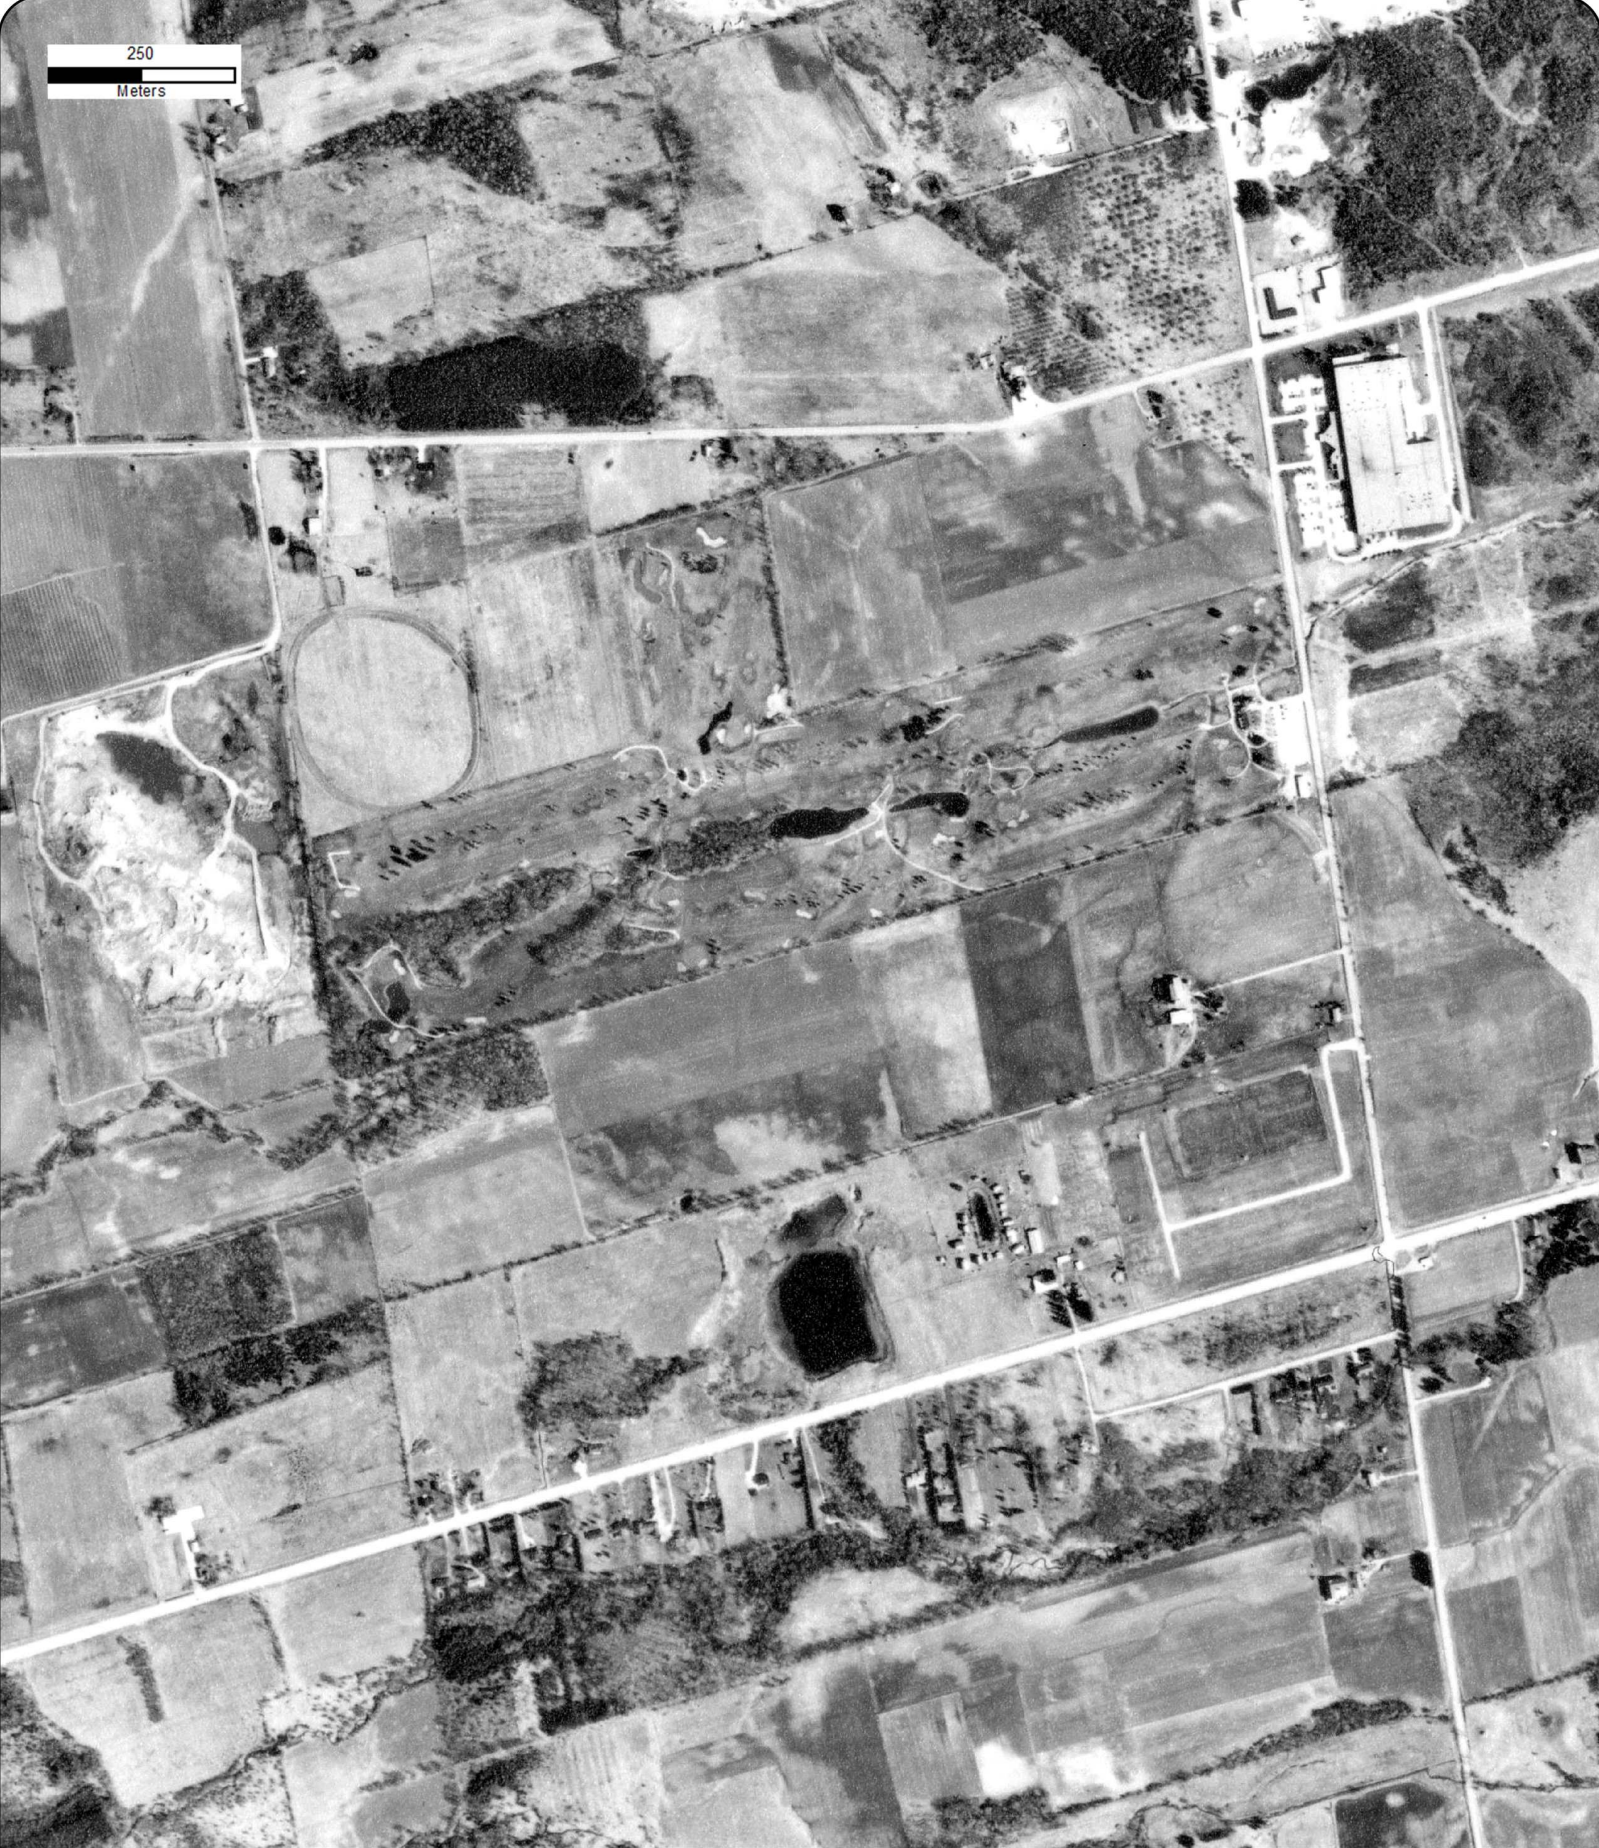
Year: 1995  
Source: NAPL  
Scale: 10,000  
Comment:

| Year | Observations |
|---|---|
| 1995 | Review of the 1995 aerial photograph indicates that conditions at the Site and surrounding lands were generally similar to those observed in the 1987 aerial image. |

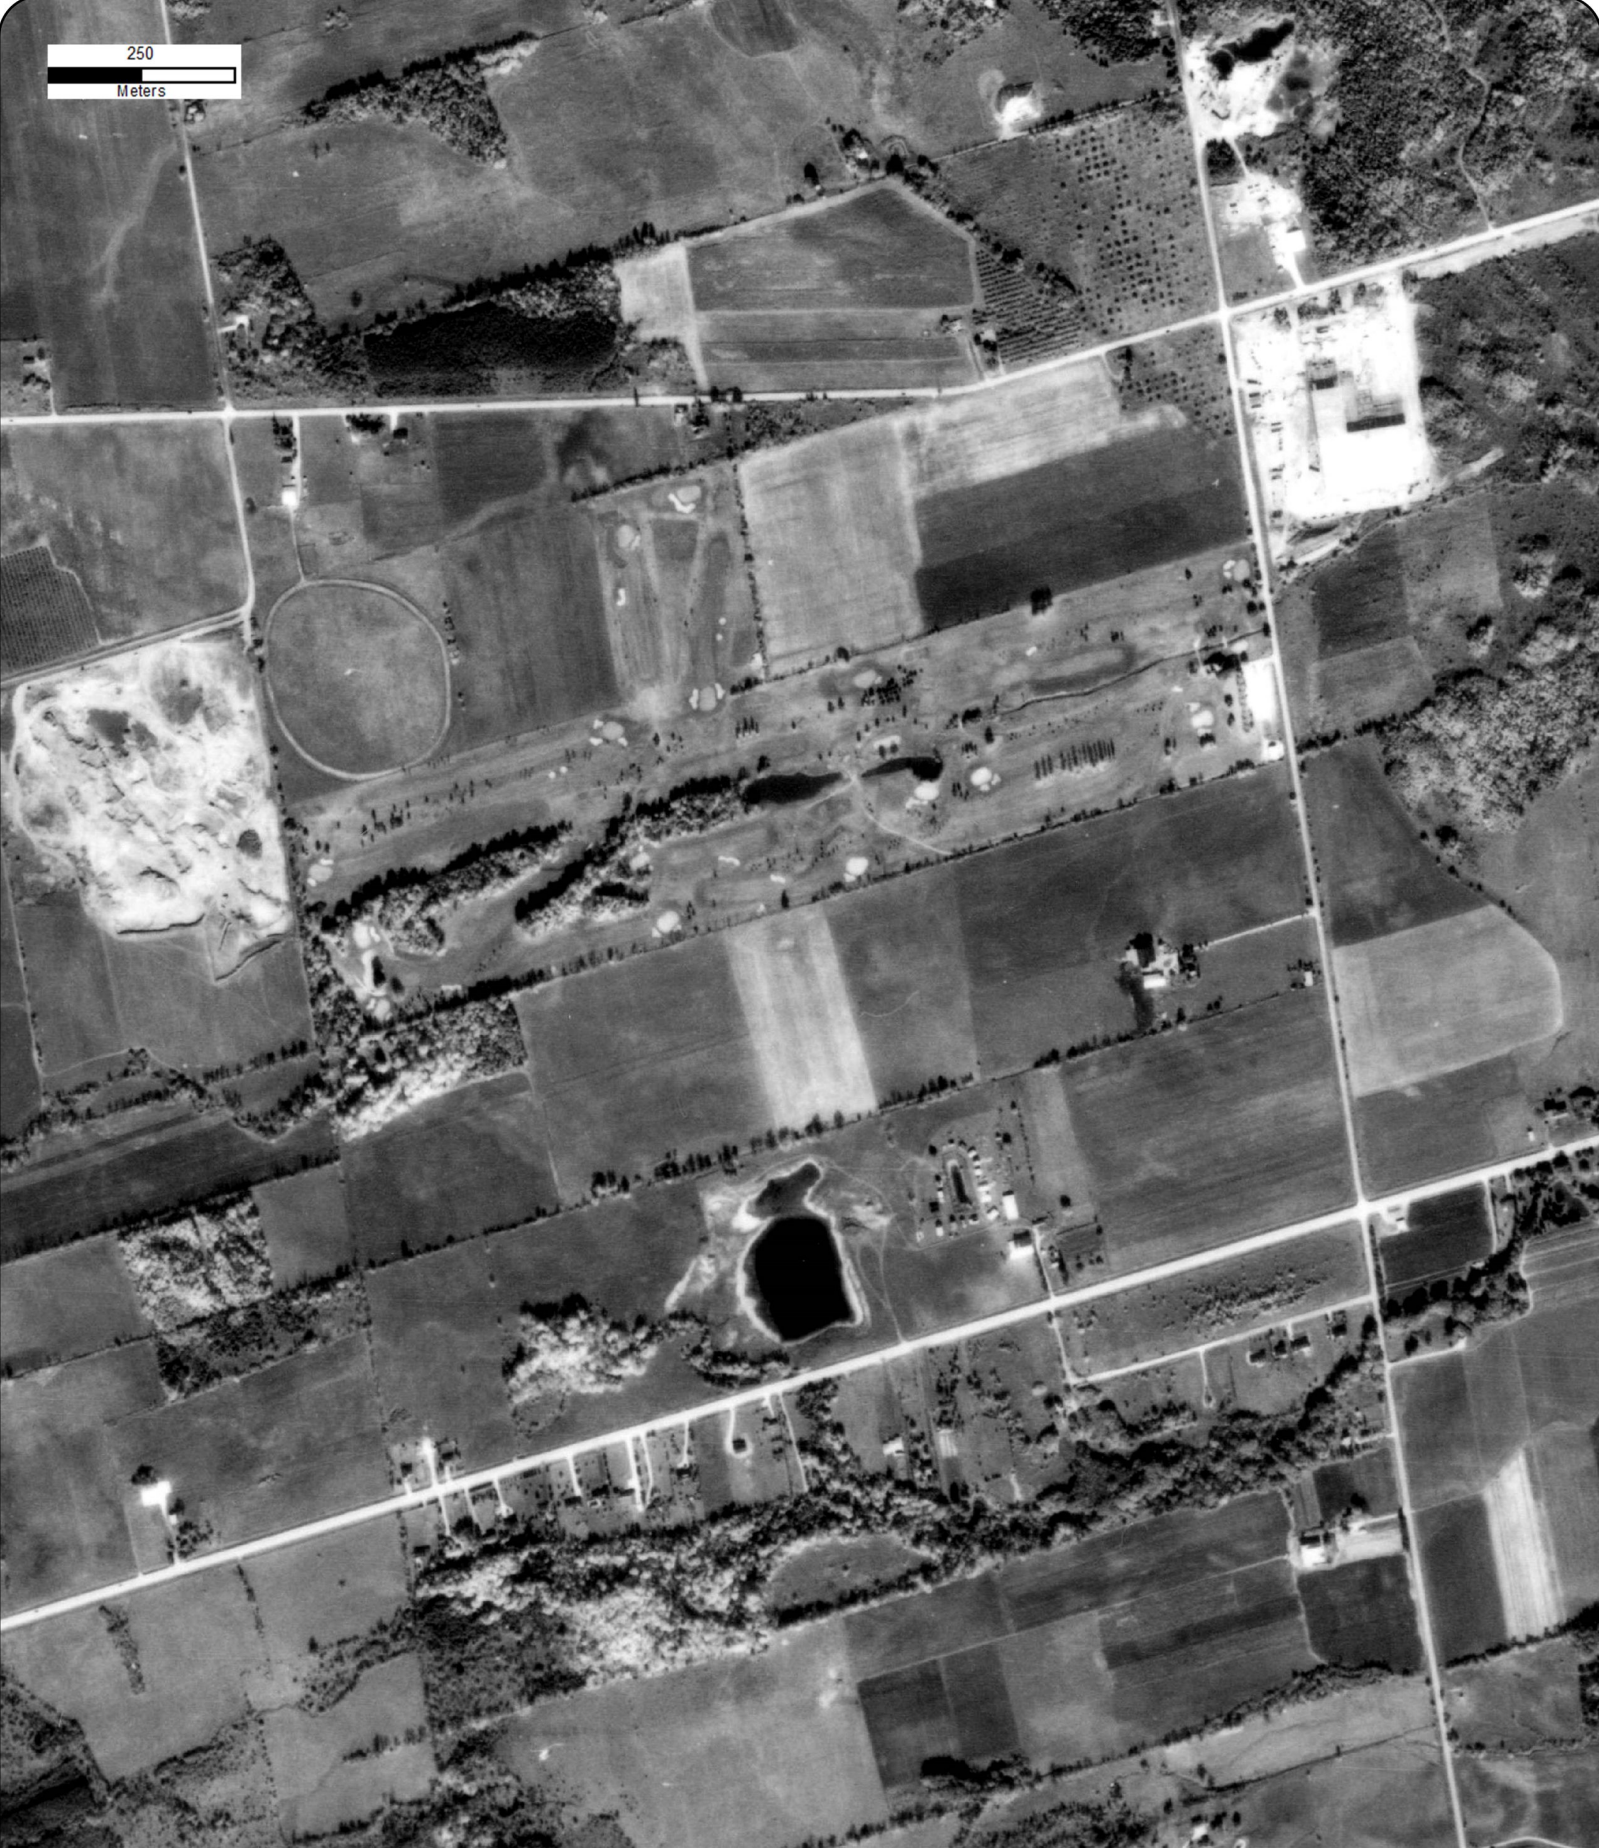
Year: 1987  
Source: NAPL  
Scale: 10,000  
Comment:

| Year | Observations |
|---|---|
| 1987 | Review of the 1987 aerial photograph indicates that conditions at the Site and surrounding lands were generally similar to those observed in the 1976 aerial image. The golf course located north of the Site had been expanded, as had the aggregate pit located north west of the Site. To the south of the Site, multiple small buildings lined a pond area associated with the former aggregate extraction in this area. These small buildings are consistent with the location of a historical enactment village currently operated south of the Site. |

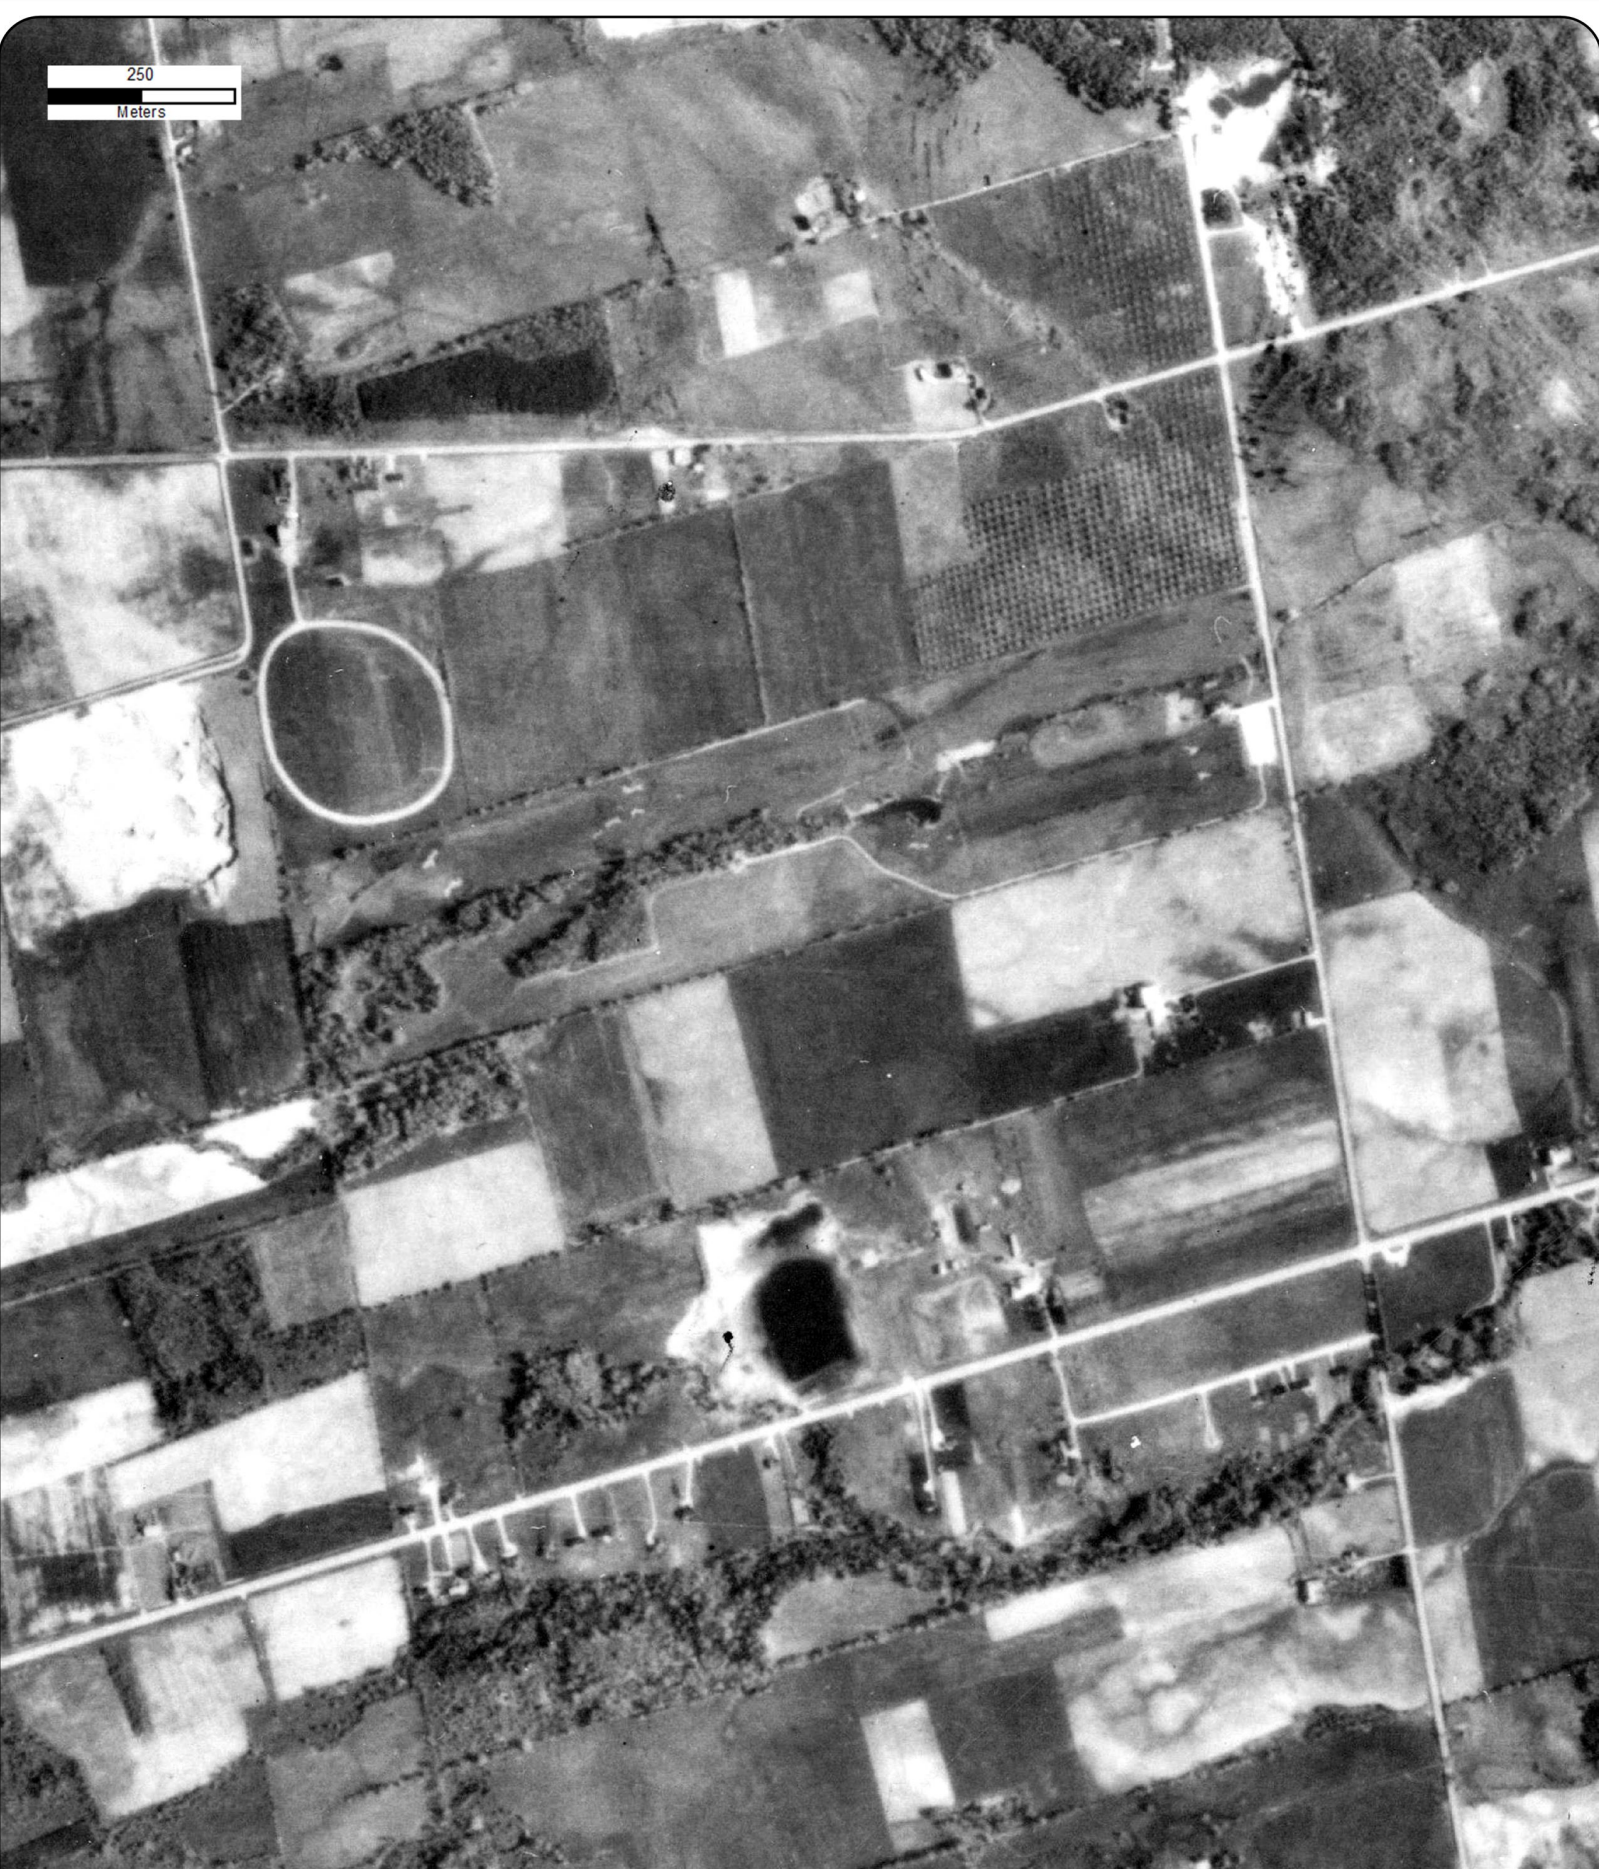
Year: 1976  
Source: NAPL  
Scale: 10,000  
Comment:

| Year | Observations |
|---|---|
| 1976 | Review of the 1976 aerial photograph indicates that conditions at the Site and surrounding lands were generally similar to those observed in the 1969 aerial image. Aggregate extraction south of the Site had ceased, with the former pit area regraded into a pond. |

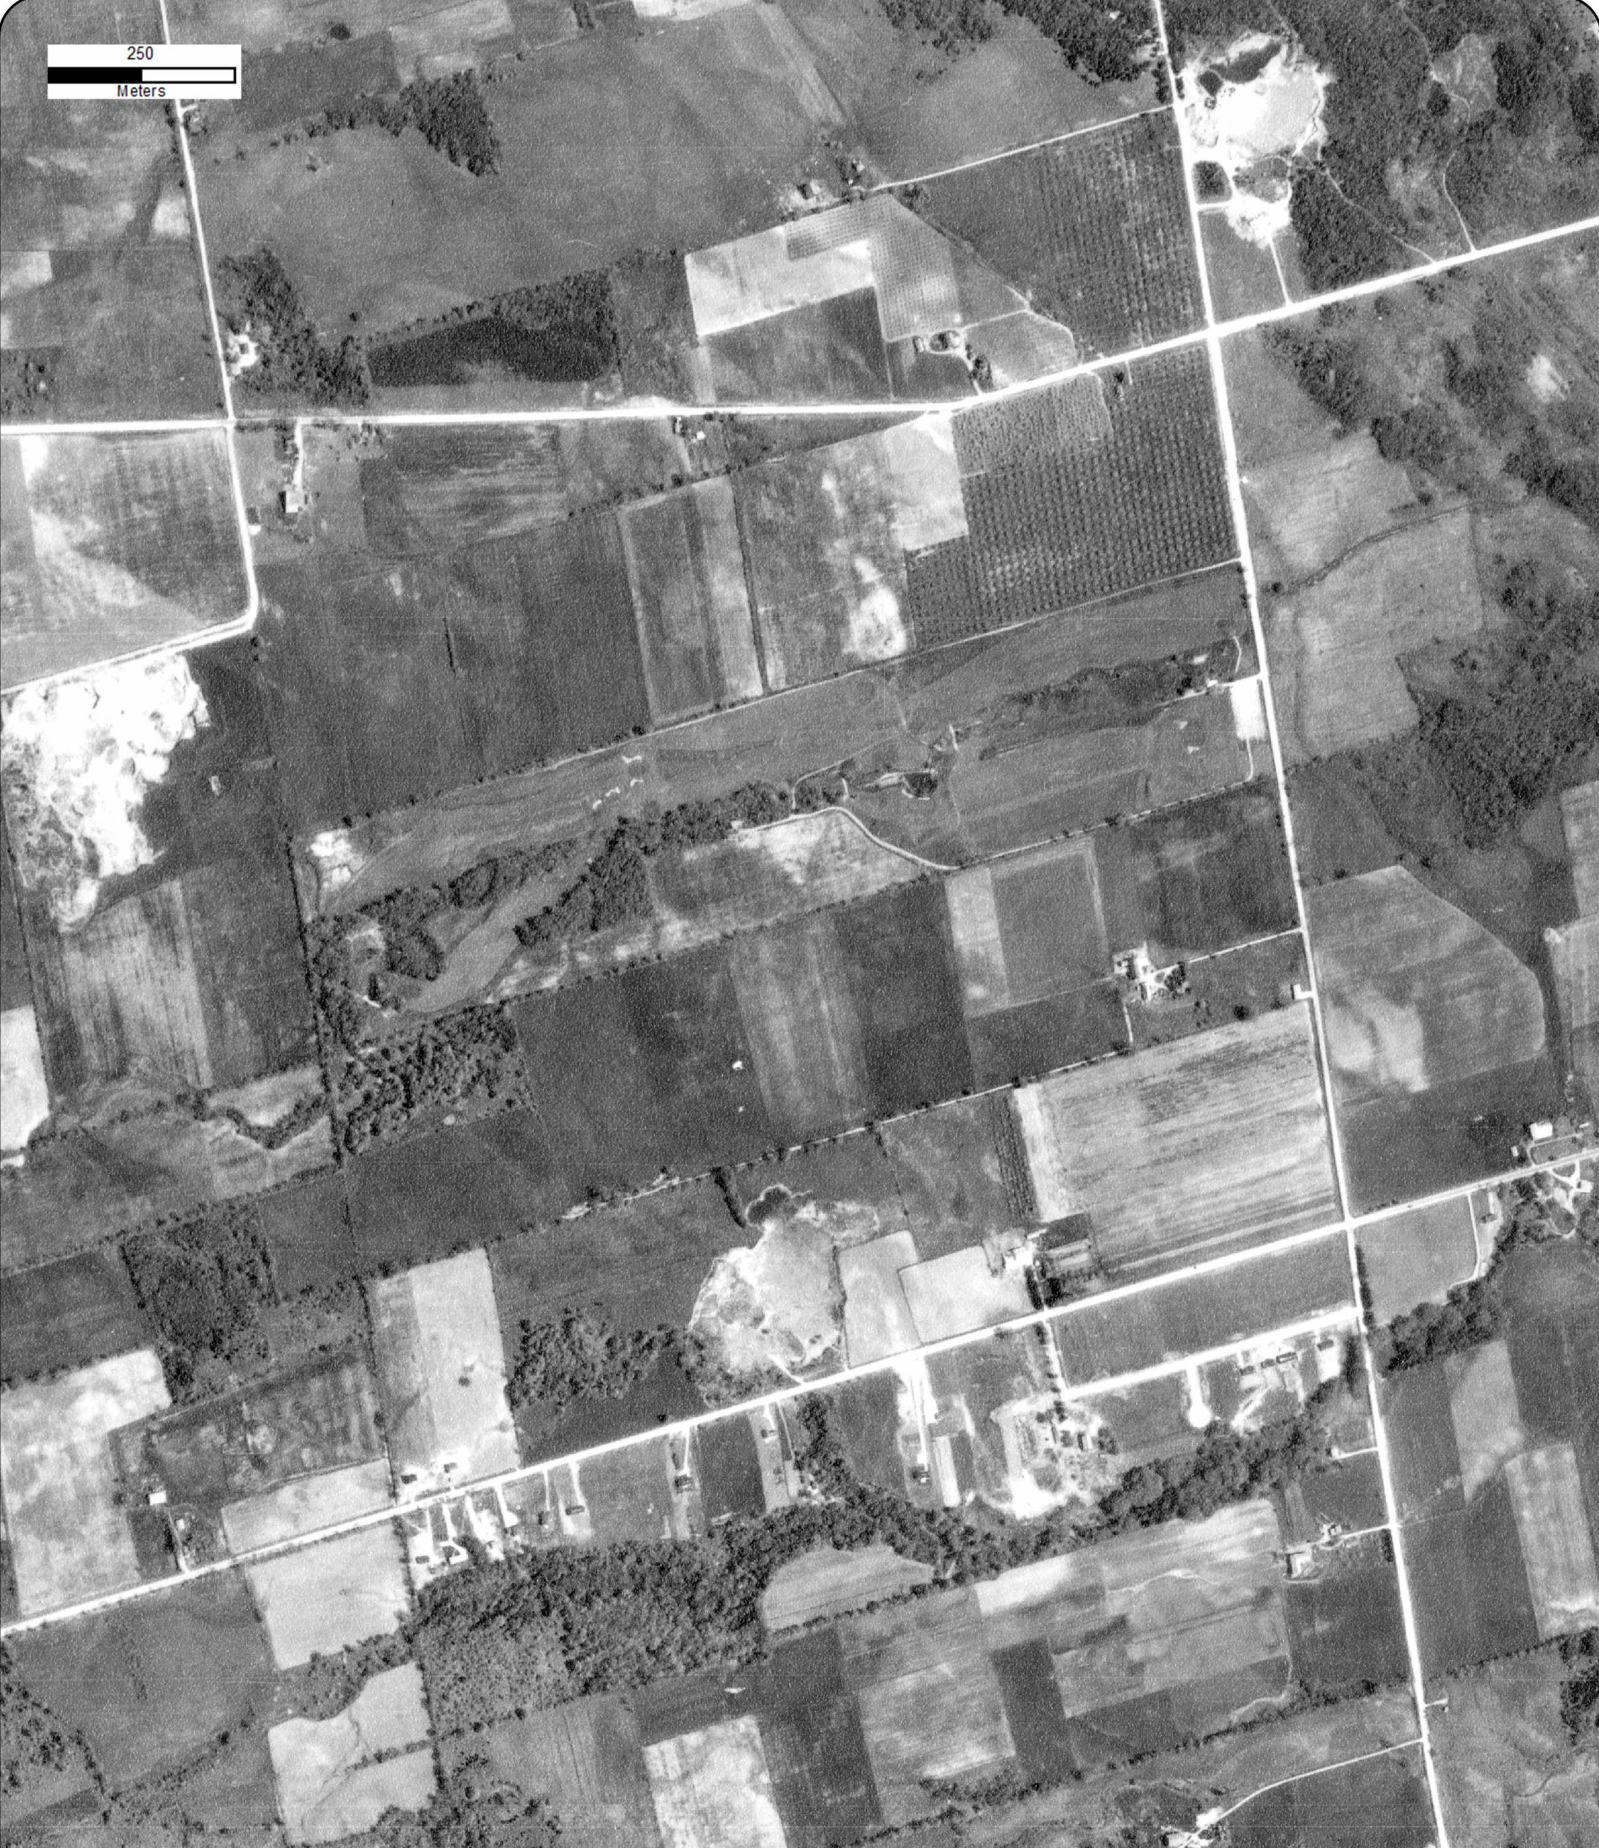
Year: 1969  
Source: NAPL  
Scale: 10,000  
Comment:

| Year | Observations |
|---|---|
| 1969 | <p>Review of the 1969 aerial imagery indicates that conditions at the Site were similar to those observed in the 1954 aerial image. Further details could be observed regarding the on-Site farmstead, including the presence of a residential dwelling and two agricultural barns. A second residential dwelling was visible in the south east corner of the Site building. The remaining areas of the Site consisted of open agricultural fields, with the exception of a small wooded area in the north west corner of the Site.</p> <p>Formerly agricultural lands north of the Site had been redeveloped as a golf course (currently, Blue Mountain Golf &amp; Country Club). Lands to the south of the central portion of the Site appeared to be undergoing aggregate extraction, as were lands located to the northwest of the Site. Remaining lands in the vicinity of the Site continued to be occupied primarily as agricultural fields.</p> |

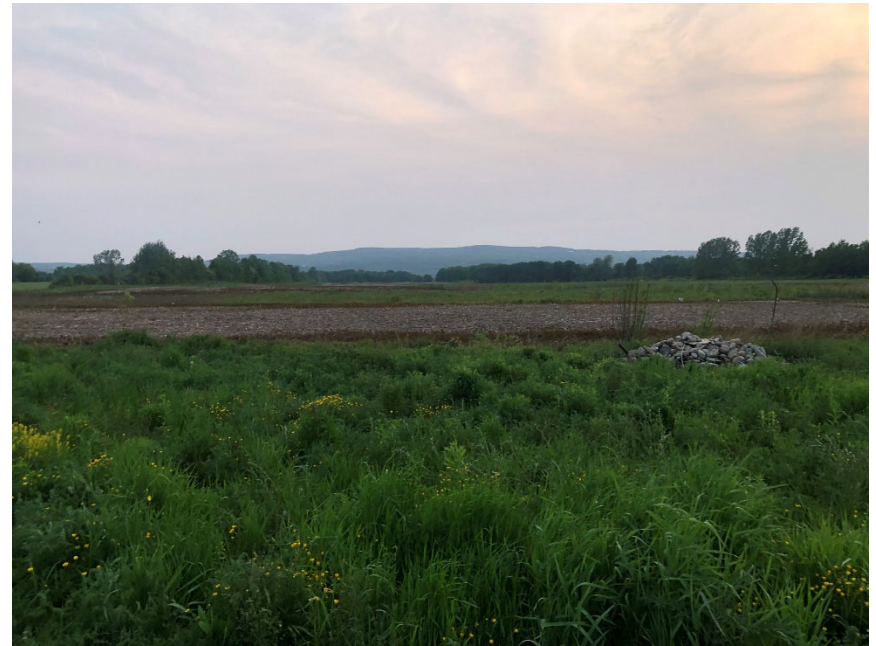
**Photograph 2:** View of the central portion of the Site, former farmstead location

- The Site was occupied for agricultural purposes from Crown grant in 1836 until the report date (additional uses noted below). Two barns and two residential dwellings were reportedly constructed at the Site in the 1950's. The Site residences were reportedly vacant as of 1993, and one of the residential dwellings and both barns were demolished as of 2010. A vacant residence remained at the Site as of 2014, as did the foundations of the other former Site buildings.

- Site inspections completed in 2014 identified the presence of debris piles in the vicinity of the former farmstead area, interpreted to be associated with the demolition of former on-Site buildings. Unspecified debris piles (appear to be wood pallets or crates based on aerial imagery) were also noted interior to some of the agricultural fields. It was recommended that this debris be removed and disposed of off-Site. A limited area of staining was also observed in the vicinity of farm equipment storage. The staining was found to be surficial in nature, and was not identified as a significant environmental concern.

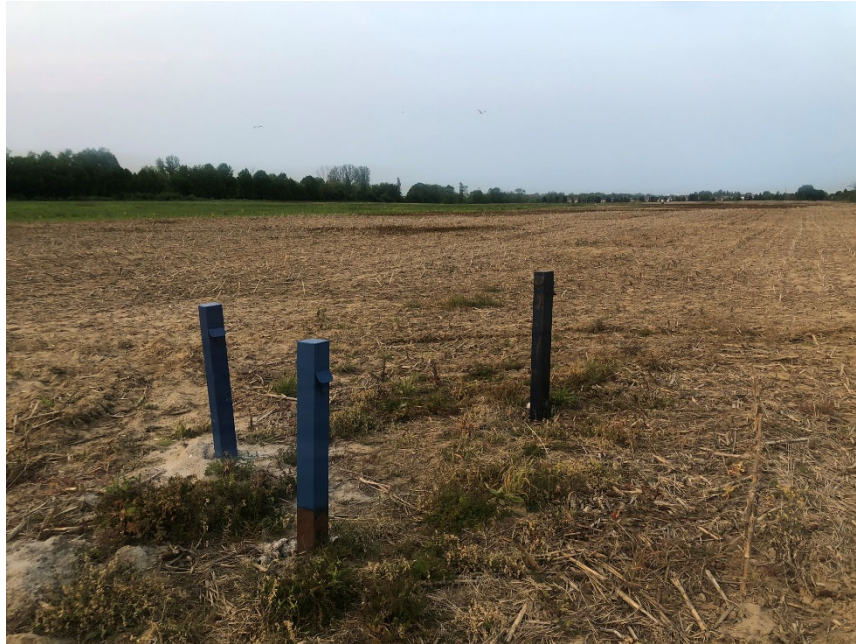
**Photograph 3:** View of southern portion of Site, monitoring wells in foreground.
