CLIENT: JARLETTE HEALTH SERVICES COLLINGWOOD CARE CENTRE

PROJECT: JARLETTE COLLINGWOOD CARE CENTRE, 250 CAMPBELL ST. COLLINGWOOD, ON

DRAWING: BOREHOLE ACCESS ROUTES

DRAWN BY: E.F, J.M.S.K. CHECKED BY: J.H. DRAWING No.: BH-1

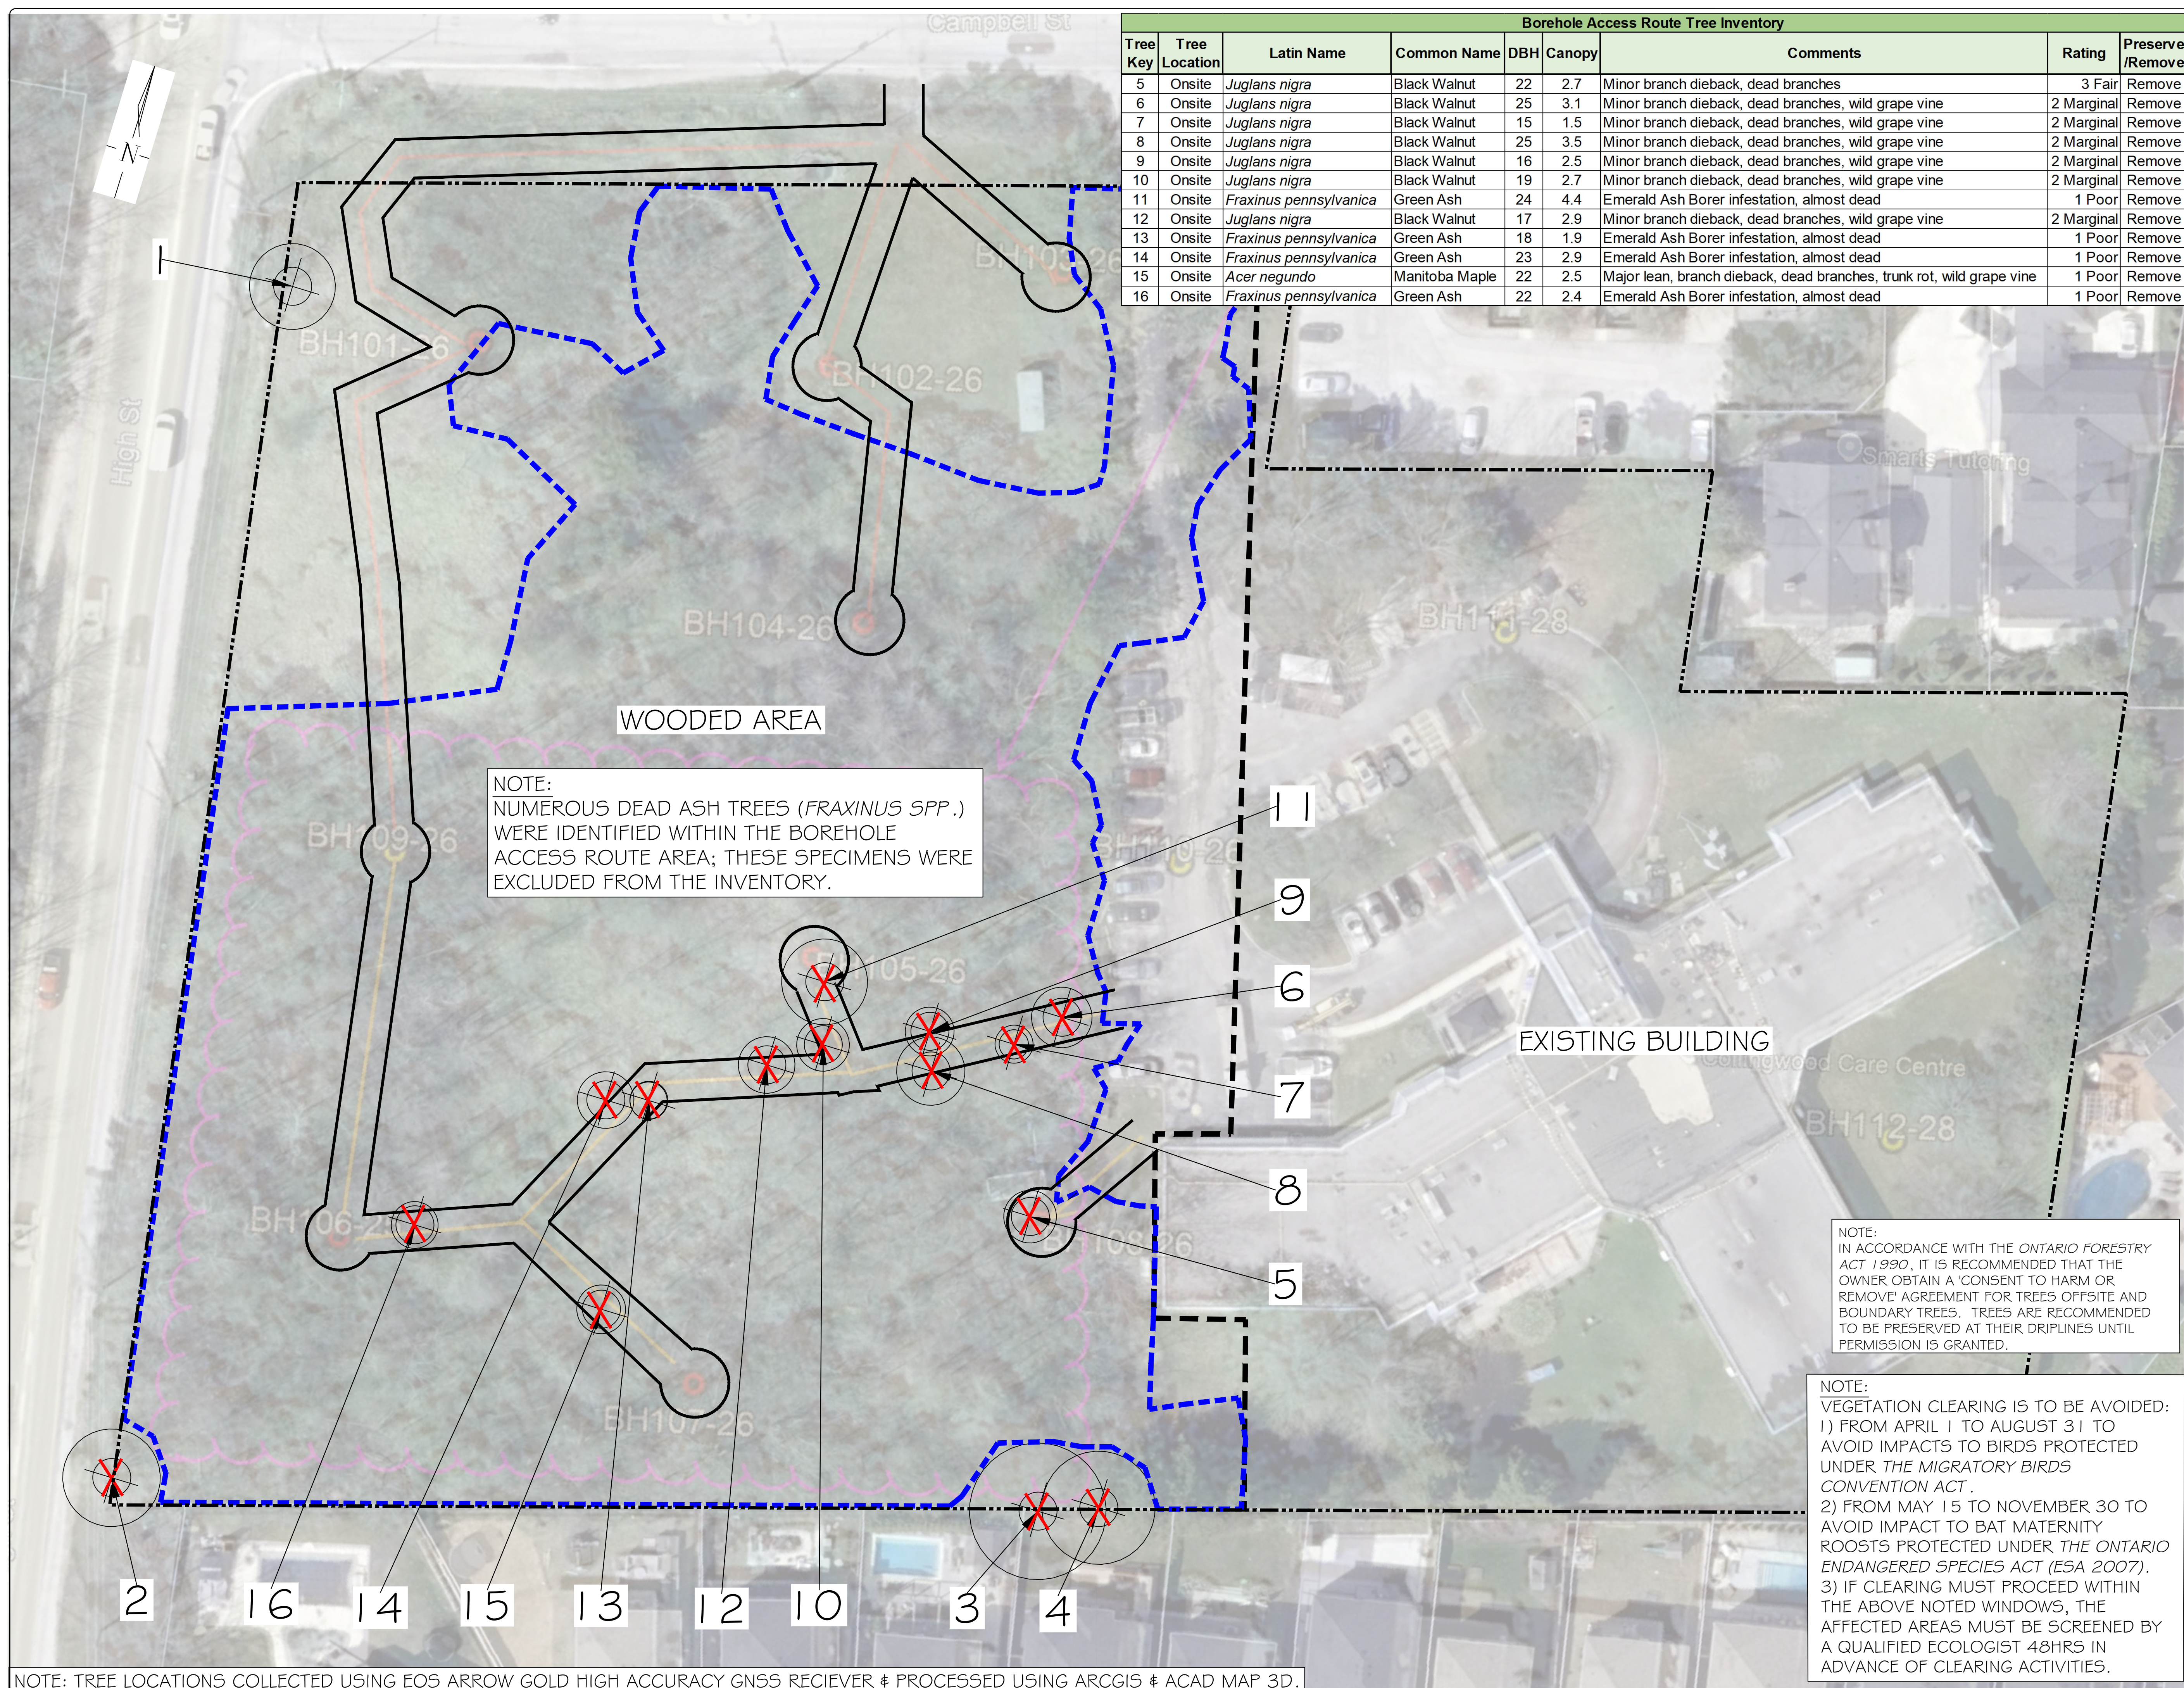
Borehole Access Route Tree Inventory									
Tree Key	Tree Location	Latin Name	Common Name	DBH	Canopy	Comments	Rating	Preserve/Remove	
5	Onsite	<i>Juglans nigra</i>	Black Walnut	22	2.7	Minor branch dieback, dead branches	3 Fair	Remove	
6	Onsite	<i>Juglans nigra</i>	Black Walnut	25	3.1	Minor branch dieback, dead branches, wild grape vine	2 Marginal	Remove	
7	Onsite	<i>Juglans nigra</i>	Black Walnut	15	1.5	Minor branch dieback, dead branches, wild grape vine	2 Marginal	Remove	
8	Onsite	<i>Juglans nigra</i>	Black Walnut	25	3.5	Minor branch dieback, dead branches, wild grape vine	2 Marginal	Remove	
9	Onsite	<i>Juglans nigra</i>	Black Walnut	16	2.5	Minor branch dieback, dead branches, wild grape vine	2 Marginal	Remove	
10	Onsite	<i>Juglans nigra</i>	Black Walnut	19	2.7	Minor branch dieback, dead branches, wild grape vine	2 Marginal	Remove	
11	Onsite	<i>Fraxinus pennsylvanica</i>	Green Ash	24	4.4	Emerald Ash Borer infestation, almost dead	1 Poor	Remove

12	Onsite	<i>Juglans nigra</i>	Black Walnut	17	2.9	Minor branch dieback, dead branches, wild grape vine	2 Marginal	Remove	
13	Onsite	<i>Fraxinus pennsylvanica</i>	Green Ash	18	1.9	Emerald Ash Borer infestation, almost dead	1 Poor	Remove	
14	Onsite	<i>Fraxinus pennsylvanica</i>	Green Ash	23	2.9	Emerald Ash Borer infestation, almost dead	1 Poor	Remove	
15	Onsite	<i>Acer negundo</i>	Manitoba Maple	22	2.5	Major lean, branch dieback, dead branches, trunk rot, wild grape vine	1 Poor	Remove	
16	Onsite	<i>Fraxinus pennsylvanica</i>	Green Ash	22	2.4	Emerald Ash Borer infestation, almost dead	1 Poor	Remove

NOTE:  
NUMEROUS DEAD ASH TREES (*FRAXINUS SPP.*) WERE IDENTIFIED WITHIN THE BOREHOLE ACCESS ROUTE AREA; THESE SPECIMENS WERE EXCLUDED FROM THE INVENTORY.

NOTE:  
IN ACCORDANCE WITH THE ONTARIO FORESTRY ACT 1990, IT IS RECOMMENDED THAT THE OWNER OBTAIN A 'CONSENT TO HARM OR REMOVE' AGREEMENT FOR TREES OFFSITE AND BOUNDARY TREES. TREES ARE RECOMMENDED TO BE PRESERVED AT THEIR DRIP LINES UNTIL PERMISSION IS GRANTED.

NOTE:  
VEGETATION CLEARING IS TO BE AVOIDED:  
1) FROM APRIL 1 TO AUGUST 31 TO AVOID IMPACTS TO BIRDS PROTECTED UNDER THE MIGRATORY BIRDS CONVENTION ACT.  
2) FROM MAY 15 TO NOVEMBER 30 TO AVOID IMPACT TO BAT MATERNITY ROOSTS PROTECTED UNDER THE ONTARIO ENDANGERED SPECIES ACT (ESA 2007).  
3) IF CLEARING MUST PROCEED WITHIN THE ABOVE NOTED WINDOWS, THE AFFECTED AREAS MUST BE SCREENED BY A QUALIFIED ECOLOGIST 48HRS IN ADVANCE OF CLEARING ACTIVITIES.
