# MEMO

| <b>Subject:</b> | Addendum to Heritage Impact Assessment for 35 Elgin Street, Collingwood |

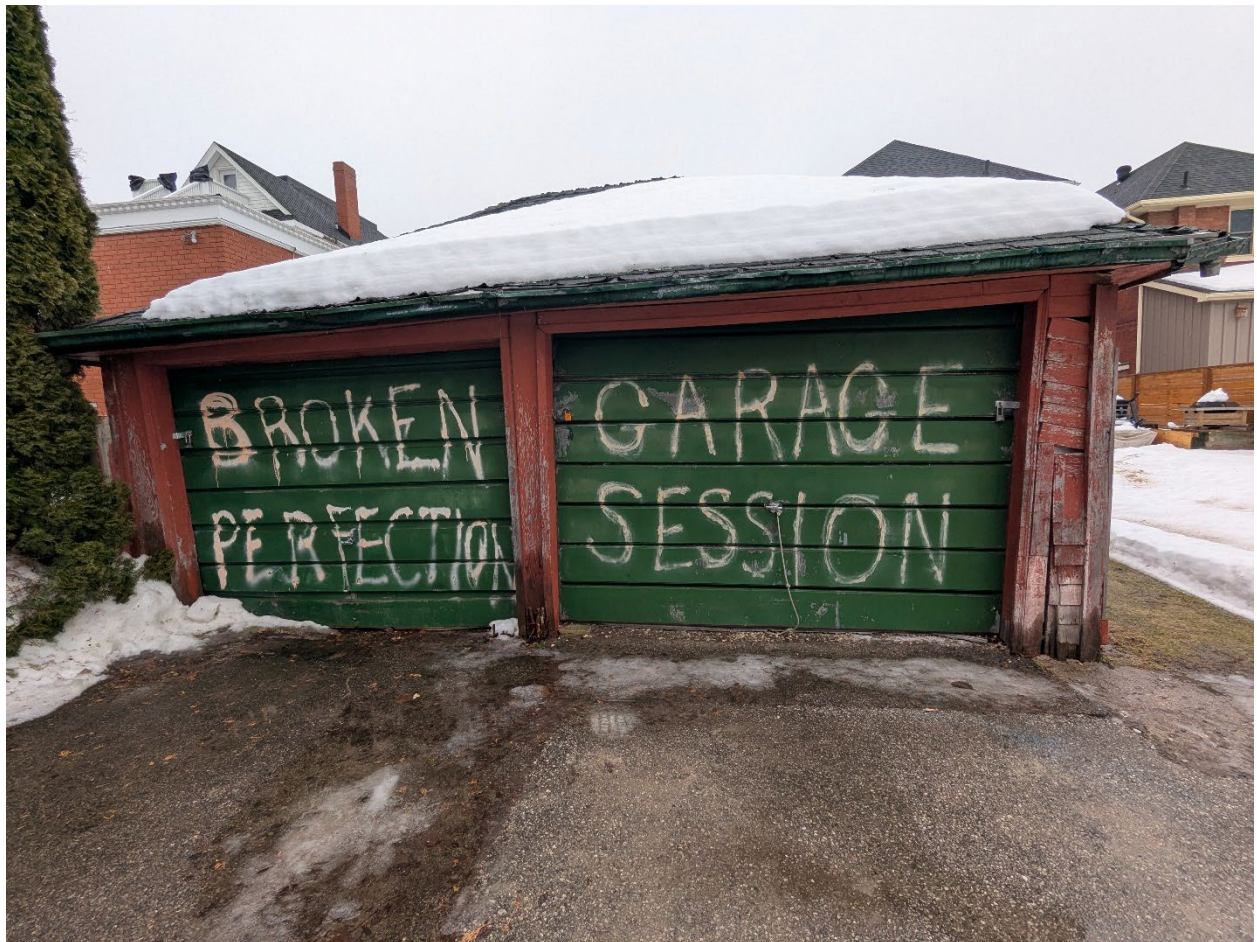
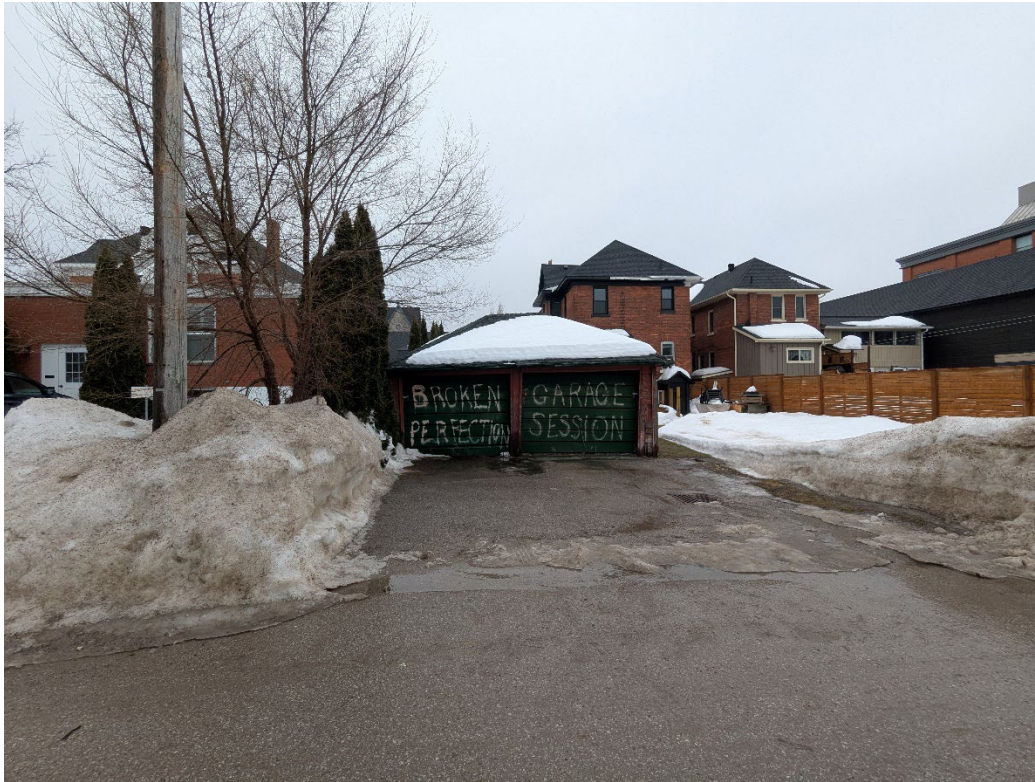
### **Primary (East) Elevation:**

The existing garage has a square plan with a hip roof and two metal garage doors at its east (principal) elevation. The structure is partially clad in painted vertical wood siding and partially in painted wood shingles. The north elevation includes one inoperative 10-pane wood window, and the west elevation includes two original shed doors with two 6-pane wood windows; the original shed doors have been

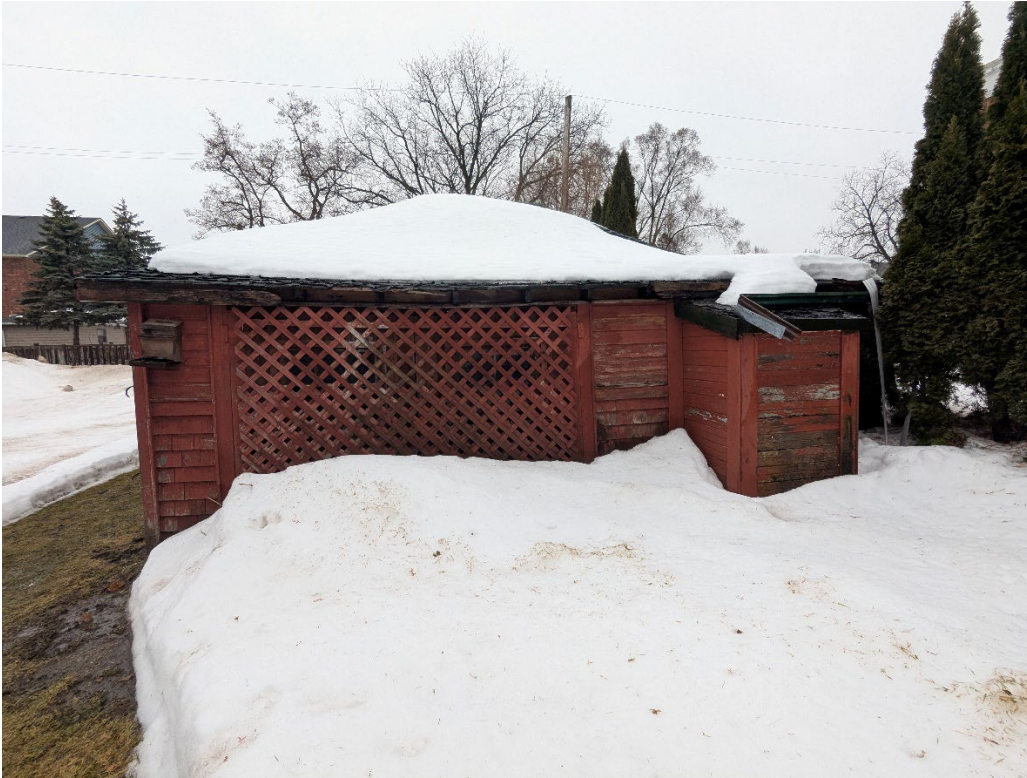
**West Elevation:**

permanently closed and sealed with wood lattice cladding on the exterior. The garage also includes a small rear (west) addition. An interior examination indicates that the garage is constructed of milled lumber in modern dimensions and metal fasteners with butt joinery, indicating a likely construction date in the mid-20<sup>th</sup> century or later. See **Attachment 2** for interior and exterior photographs of the existing garage.

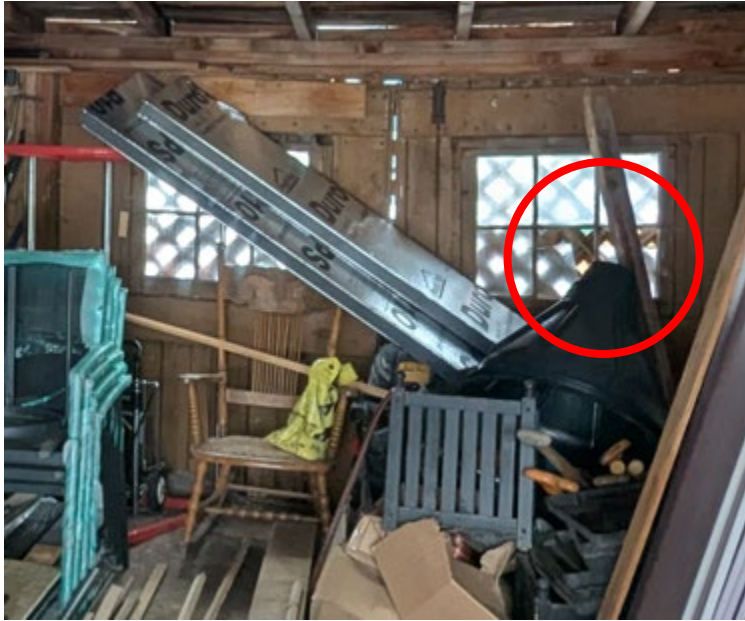
Broken window panes noted with a red circle above.

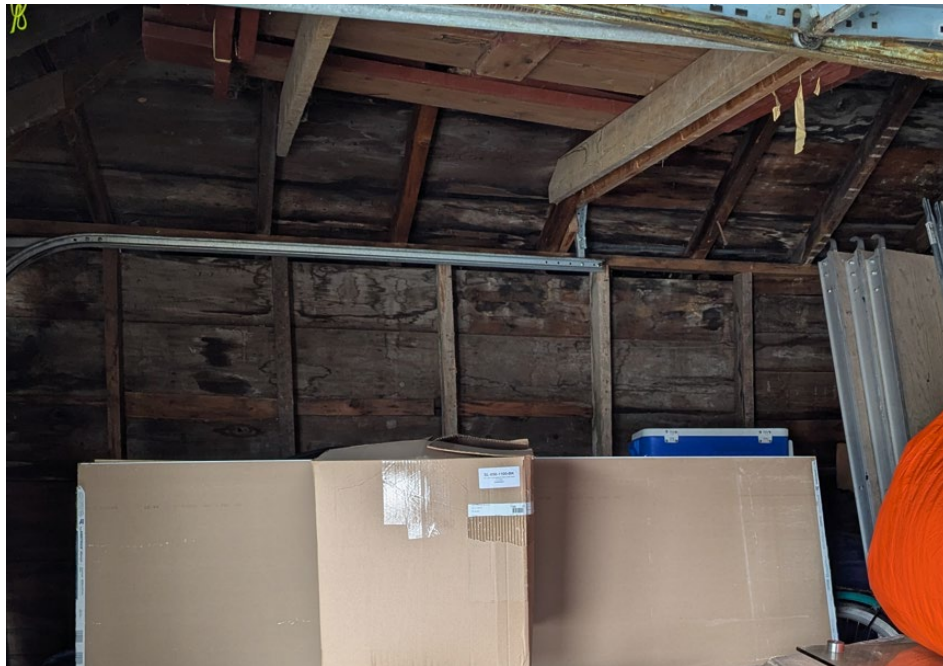
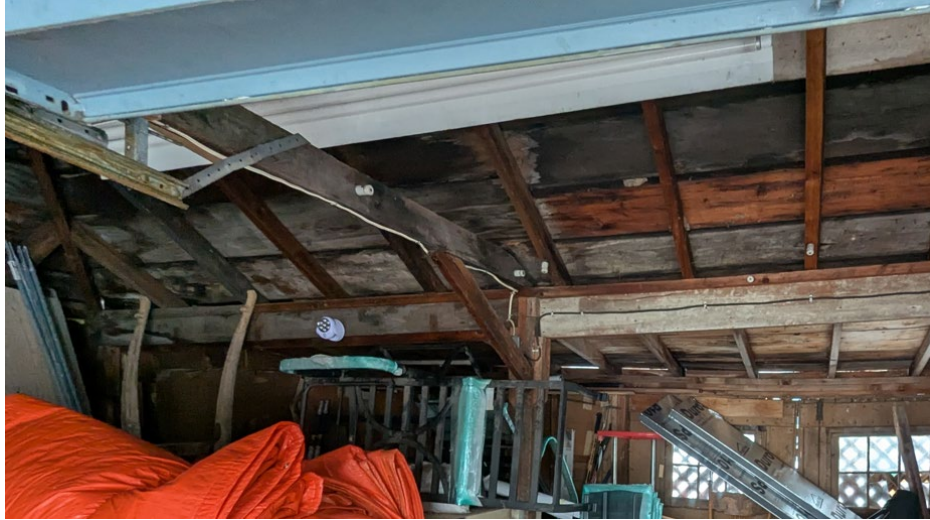
Multiple signs of water damage noted on the interior of the roof above.

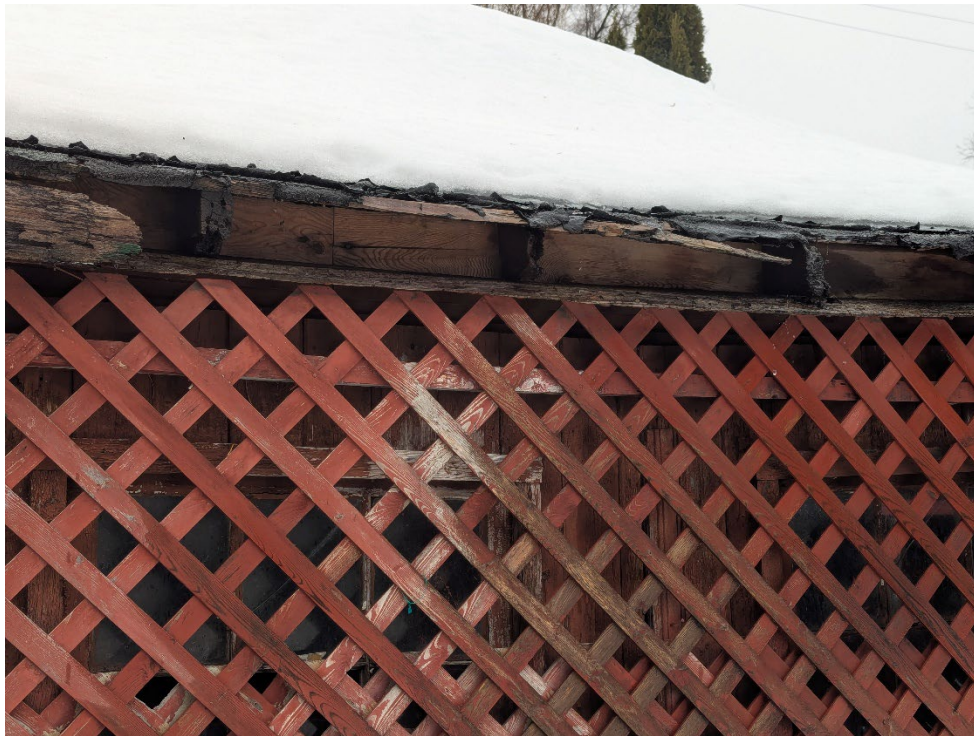
Damaged wood and deteriorated shingles noted at the roofline (west elevation) above.

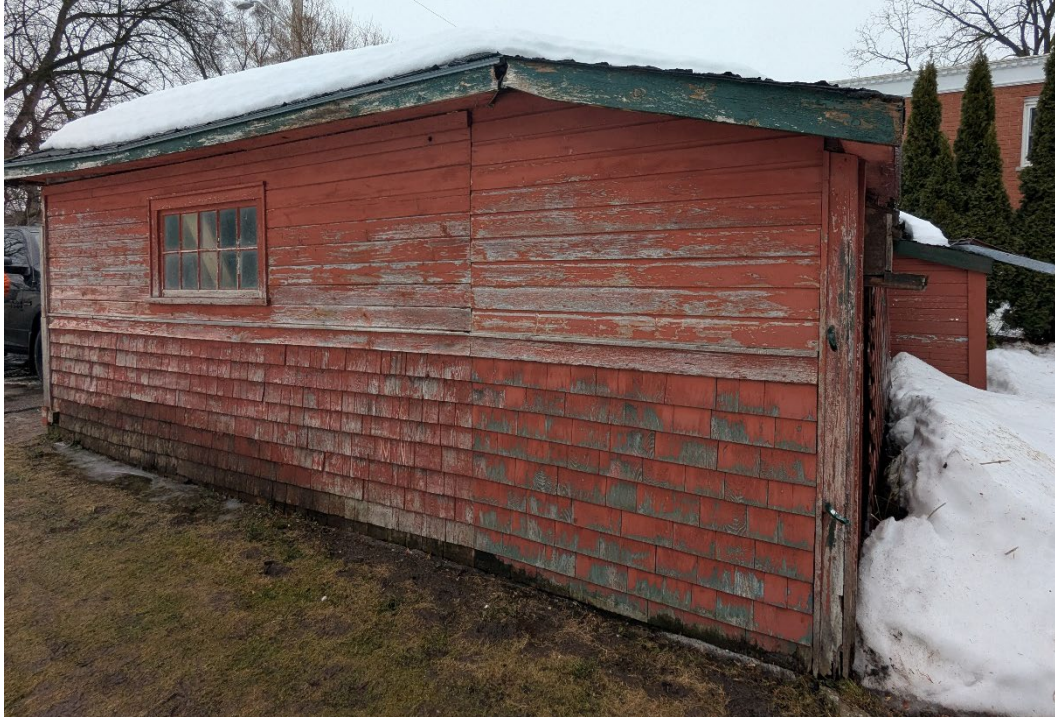
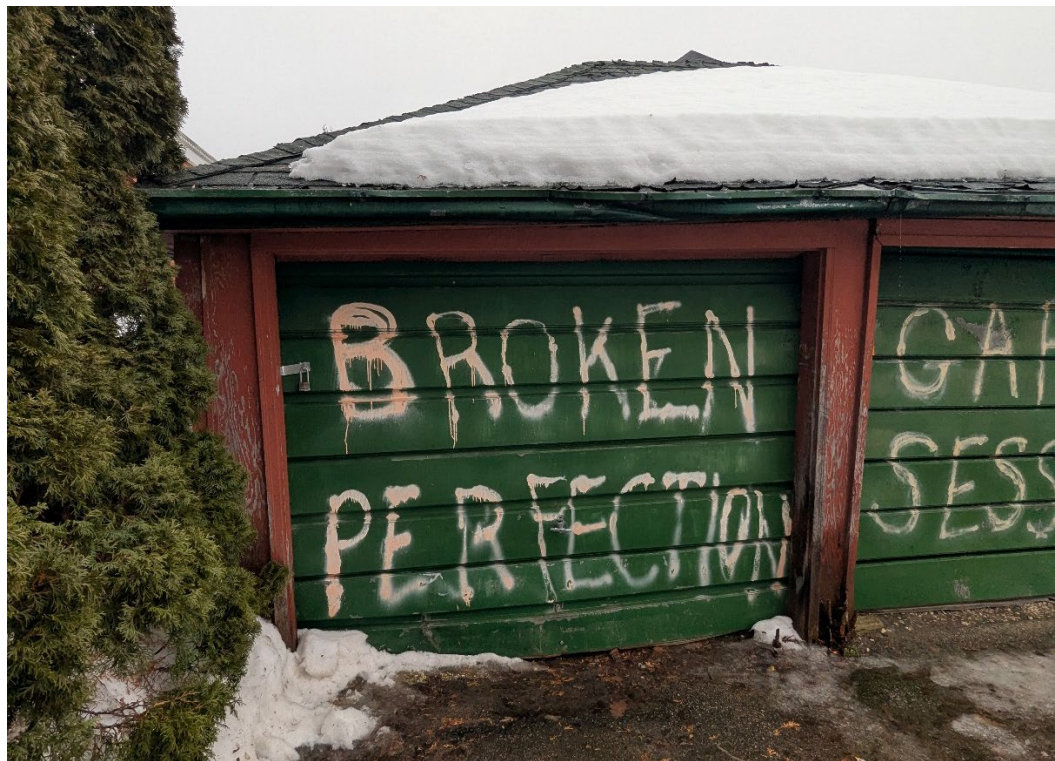
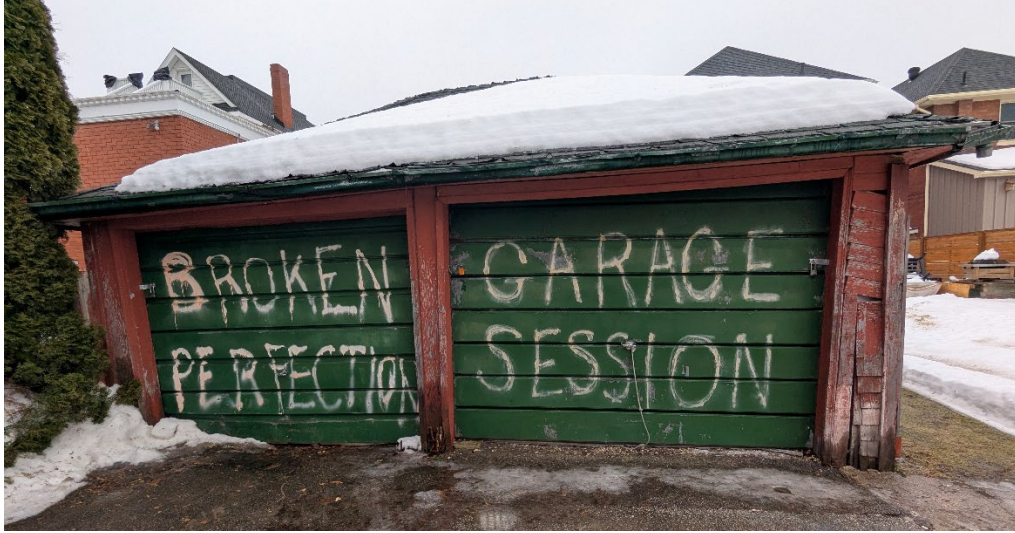
Rotted and water damaged wood noted along the base of the structure and roofline at the north and east elevations above, along with badly deteriorated shingles at the roof peak.

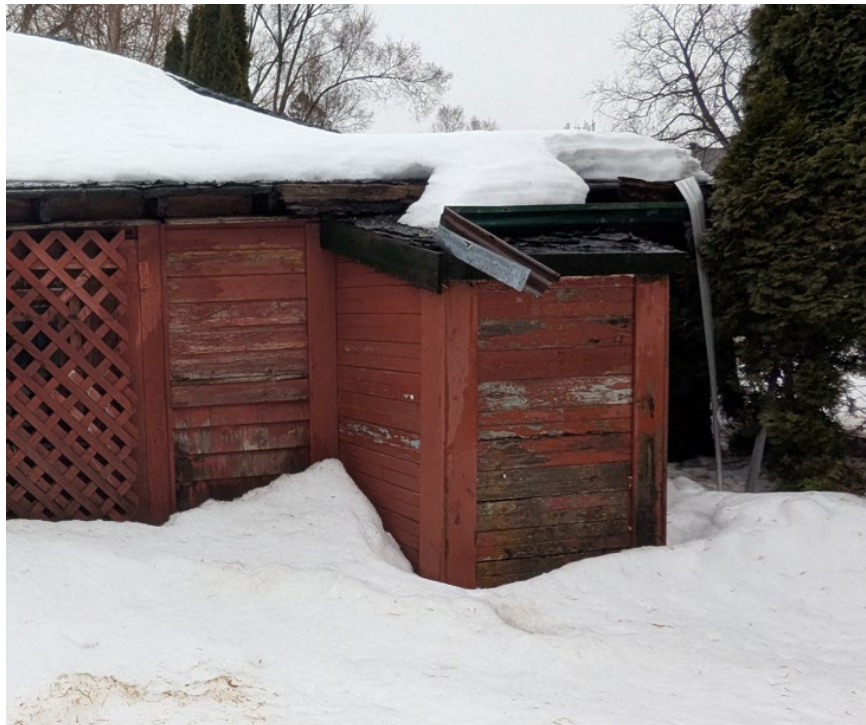
Damaged roof at the small garage rear addition above.

The existing garage currently exhibits physical condition issues, including missing and deteriorated roof shingles, rotted and water damaged wood, broken window panes, and missing and deteriorated paint (see **Attachment 2**). The Owner proposes to salvage usable timbers from the portion of the structure proposed for removal for reuse rather than depositing in a landfill. Portions of the structure are proposed to be removed by manual demolition to facilitate the salvage of as many reusable components as possible, which is considered a positive outcome from a sustainability perspective.

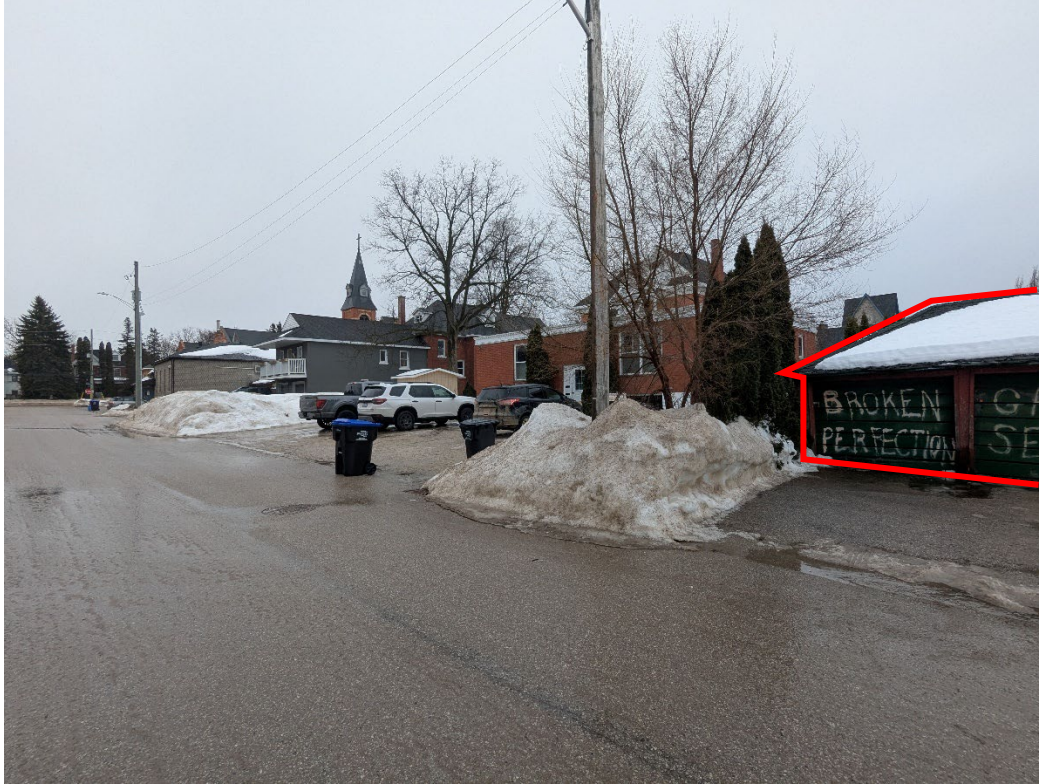
**Photo 2:** Looking southwest along Tremont Lane. The existing garage on the subject property is outlined in red.

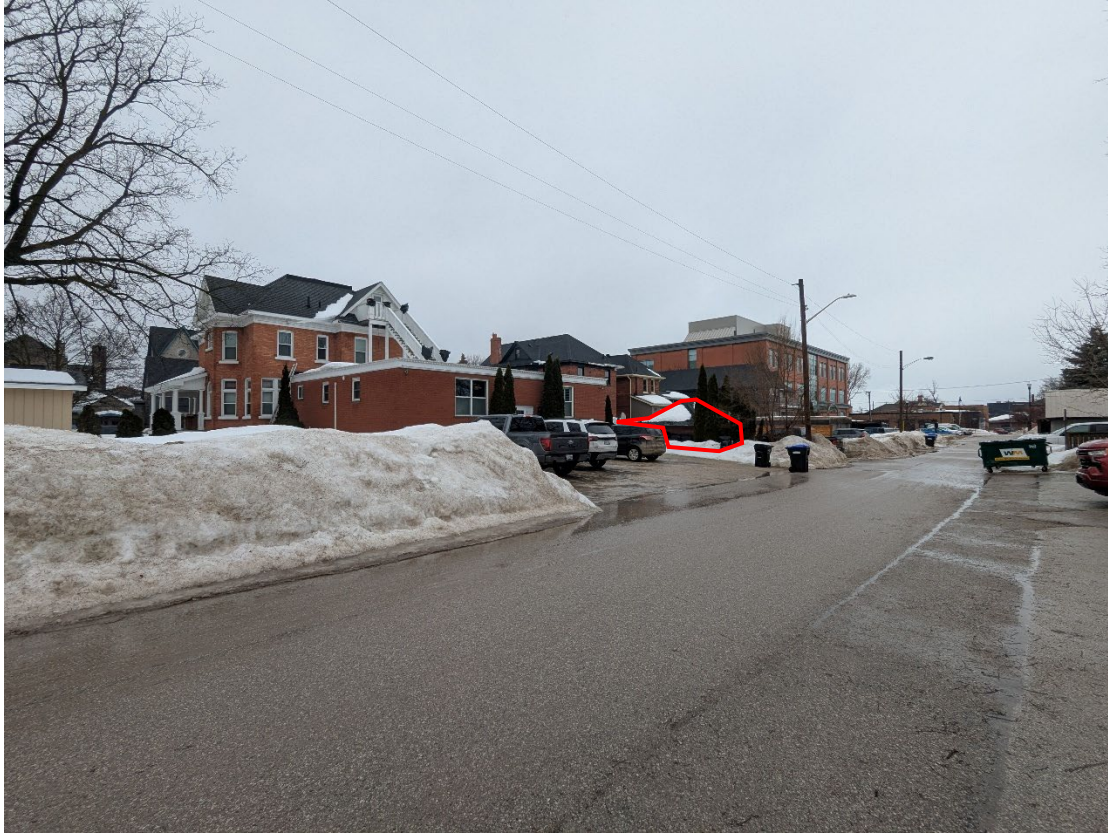
**Photo 9:** View looking northwest down Tremont Lane with the location of the existing garage on the subject property noted in red.

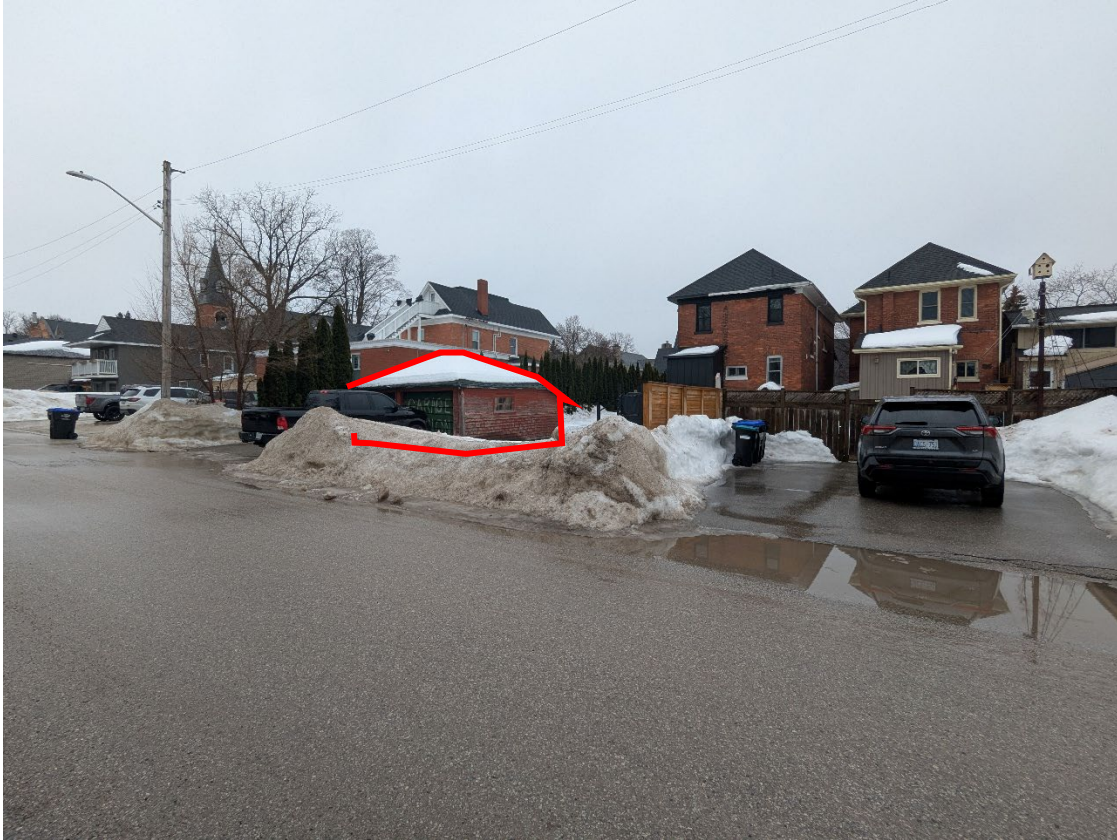
character and contribute to the identified CHVI of the CDHCD. The property at 43 Elgin Street includes a rear one-storey red brick addition which appears to have been constructed in the mid-20<sup>th</sup> century or later and is currently used for commercial purposes. The property also includes a large gravel parking pad at the rear lot line directly adjacent to Tremont Lane (see **Photo 9** in **Attachment 3**). The property at 31 Elgin Street includes a paved parking pad at the rear lot line adjacent to Tremont Lane (see **Photo 10** in **Attachment 3**).

**Photo 10:** View west across Tremont Lane towards the subject property. The location of the existing garage is noted in red.
