PHASE ONE ENVIRONMENTAL SITE ASSESSMENT TRAILS OF COLLINGWOD - HIGH STREET AND TELFER ROAD COLLINGWOOD, ONTARIO

File No 1-17-0918-41
May 1, 2018

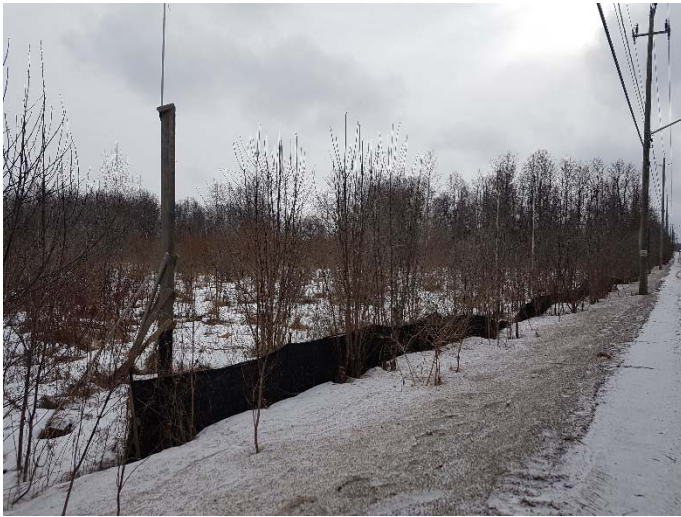
Photograph 1

Location: High Street and Telfer Rd,
Collingwood
Viewing: South
Description: Viewing south from northwest
corner of the Property.

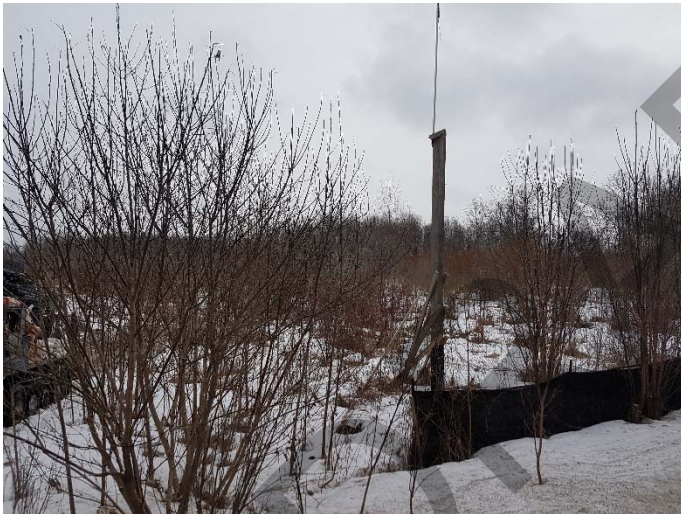
Photograph 2

Location: High Street and Telfer Rd,
Collingwood
Viewing: East
Description: Viewing east from west
Property line.

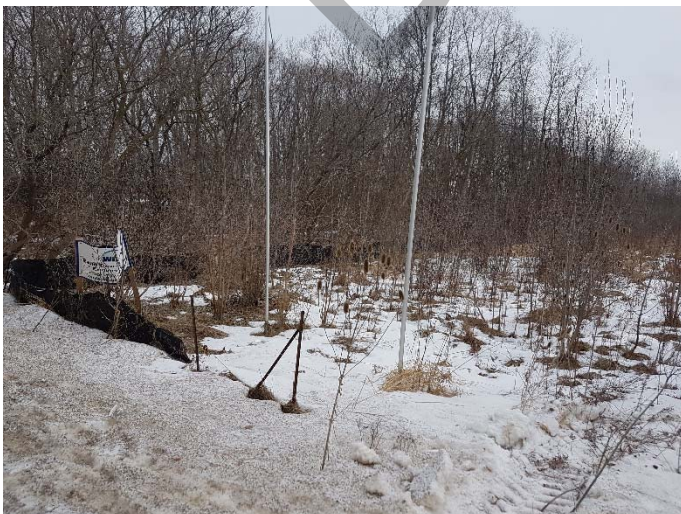
Photograph 3

Location: High Street and Telfer Rd,
Collingwood
Viewing: North
Description: Viewing north from west
Property line.

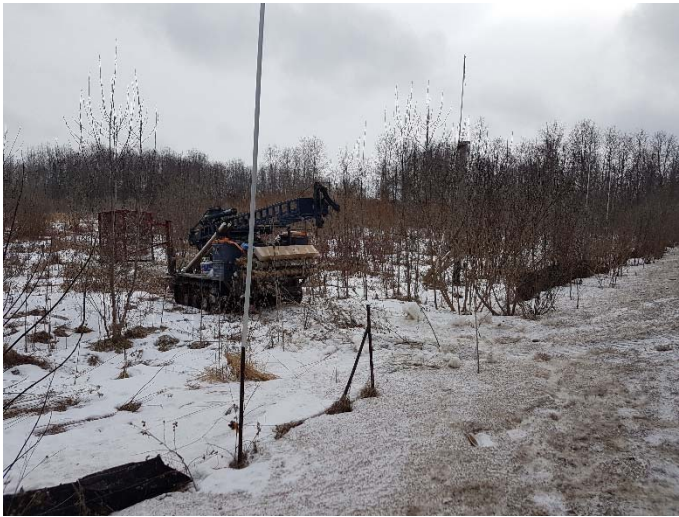
Photograph 4

Location: High Street and Telfer Rd,
Collingwood
Viewing: Southeast
Description: Viewing access to the
Property from High Street

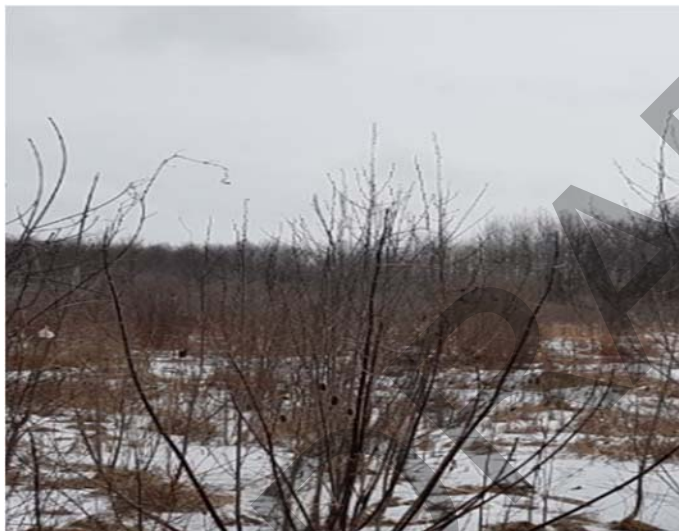
Photograph 5

Location: High Street and Telfer Rd,
Collingwood
Viewing: East
Description: Viewing east from central
portion of the Property

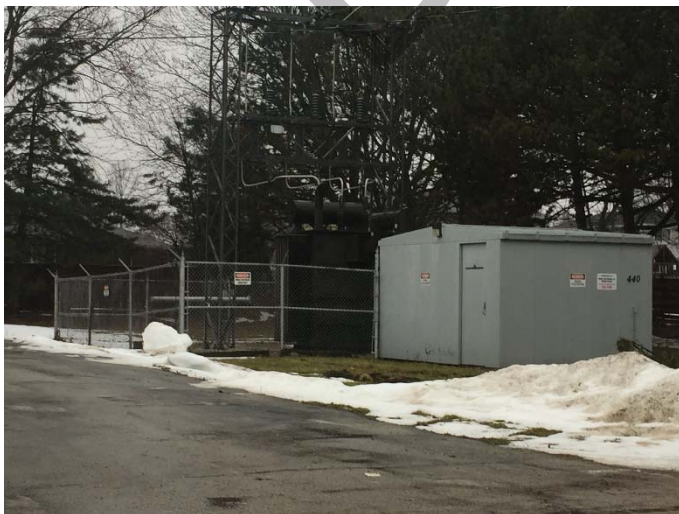
Photograph 6

Location: 440 Walnut St, Collingwood
Viewing: Northwest
Description: Hydro Sub Station #4
approximately 160 m
northeast of the Property.

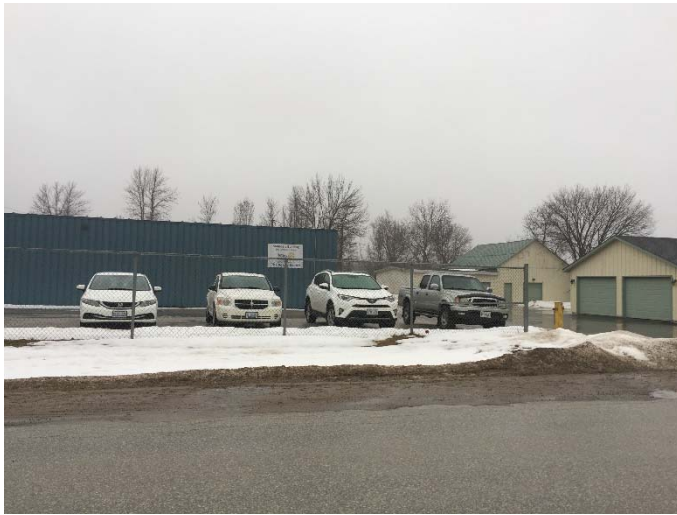
Photograph 7

Location: 199 Campbell St, Collingwood
Viewing: North
Description: Community Resource Centre.

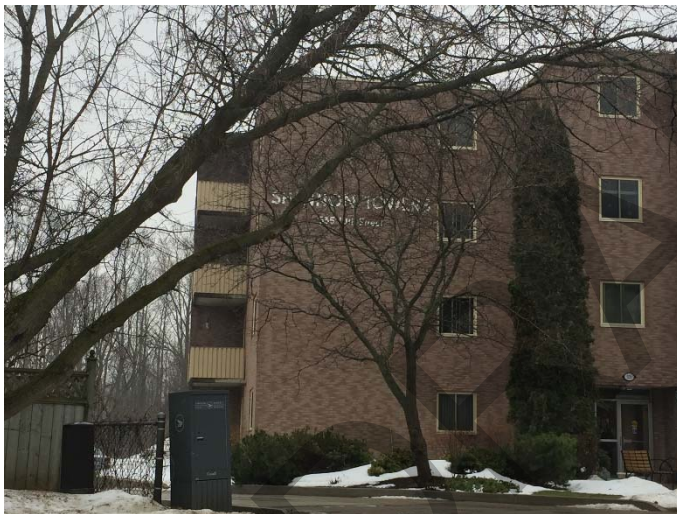
Photograph 8

Location: 535 Tenth St, Collingwood
Viewing: South
Description: Shannon Towers, residential building adjacent to the north of the Property
