**Re: Waterstone Development - EIS Addendum**

att: Table 1 - Summary of NHIC Element Occurrences (EO) in Vicinity of the Waterstone Property, Table 2 - OBBA Data - Squares 17NK52 and 17NK53, Table 3 - Plant Species List for the Waterstone Property, Figure 1 - Environmental Features

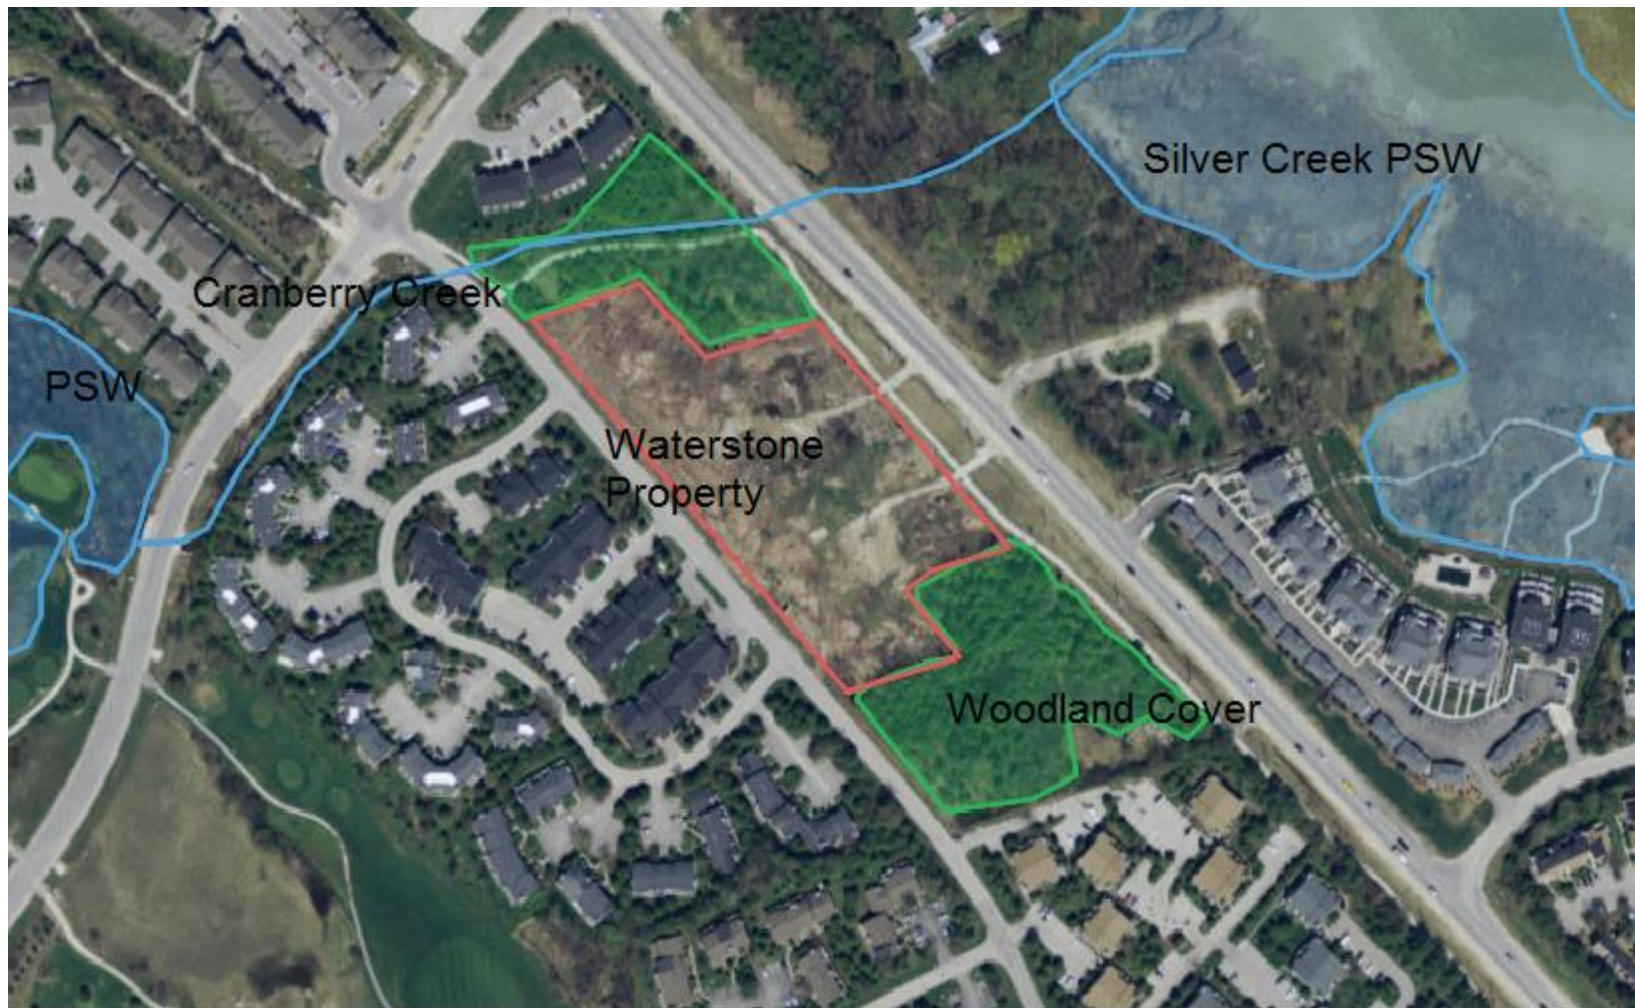
Figure 1 - Environmental Features

There are several wetland areas along the Highway 26 corridor near the Waterstone Property, and much of the wetland area is part of the Silver Creek Provincially Significant Wetland (PSW) complex. Figure 1 (attached) depicts the PSW areas in close proximity to the Property. Under Provincial and Municipal policies, development is prohibited where it may adversely affect PSWs, and any development within 120 m of a PSW must be shown not to have any potential for such effects. At the most proximate points, the Waterstone Property is more than 120 m from the nearest PSW feature. Further, there is no significant hydrological connectivity between the Property and the PSWs, and there is also no meaningful ecological connectivity owing to the largely altered landscape between the Property and the PSWs. The lack of connectivity effectively precludes the potential for adverse effects on those wetlands.
