October 27, 2014

File No. 31-14-1078  
**Barrie Office**

**RE: PHASE ONE ENVIRONMENTAL SITE ASSESSMENT  
869 HURONTARIO STREET  
COLLINGWOOD, ONTARIO**

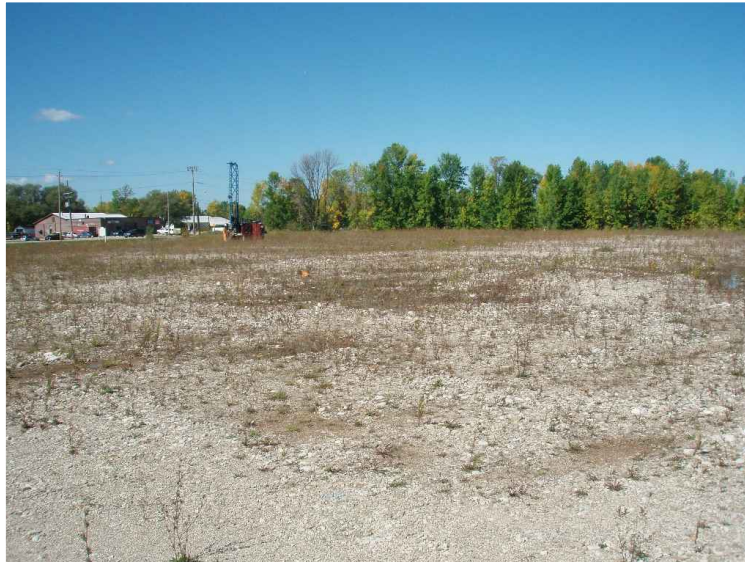
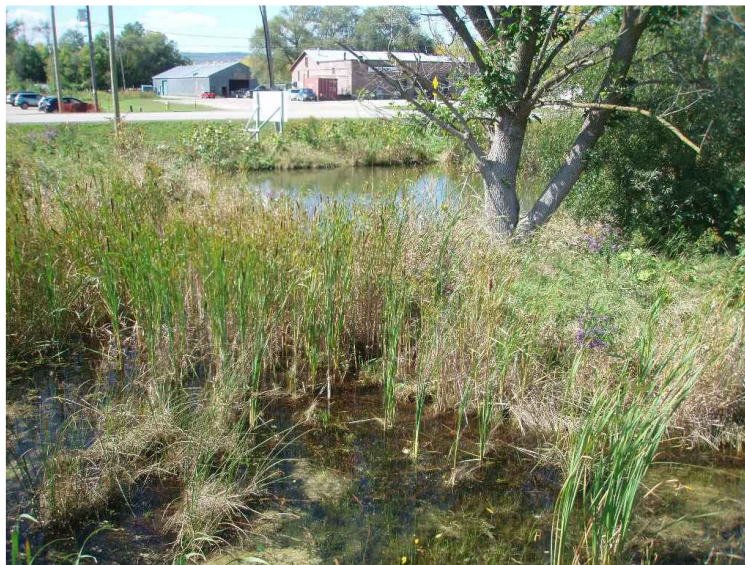
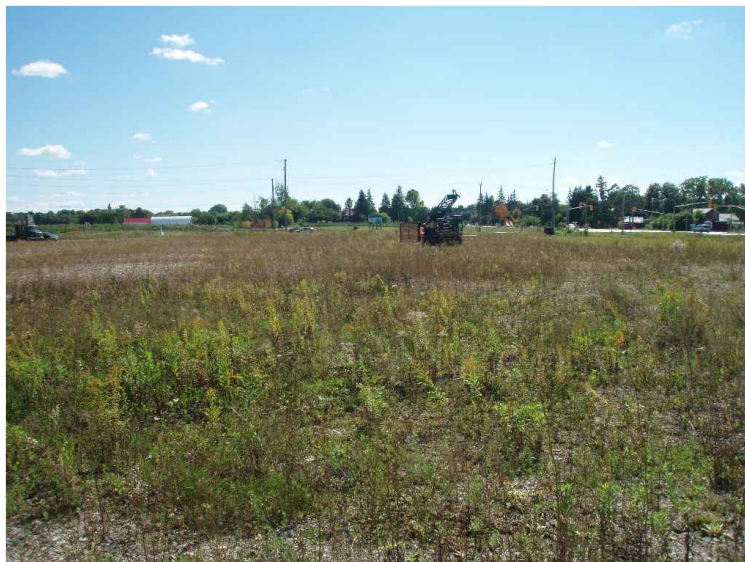
## SITE PHOTOGRAPHS

The site reconnaissance inspection included a walking tour of the property conducted on September 23, 2014. The tour consisted of an inspection of the property. Written and photographic records regarding the condition of the property were compiled.
