# Terraprobe

**PHASE ONE ENVIRONMENTAL SITE ASSESSMENT  
530 THIRD STREET  
COLLINGWOOD, ONTARIO**

**File No. 33-13-9126  
November 21, 2013  
© Terraprobe Inc.**

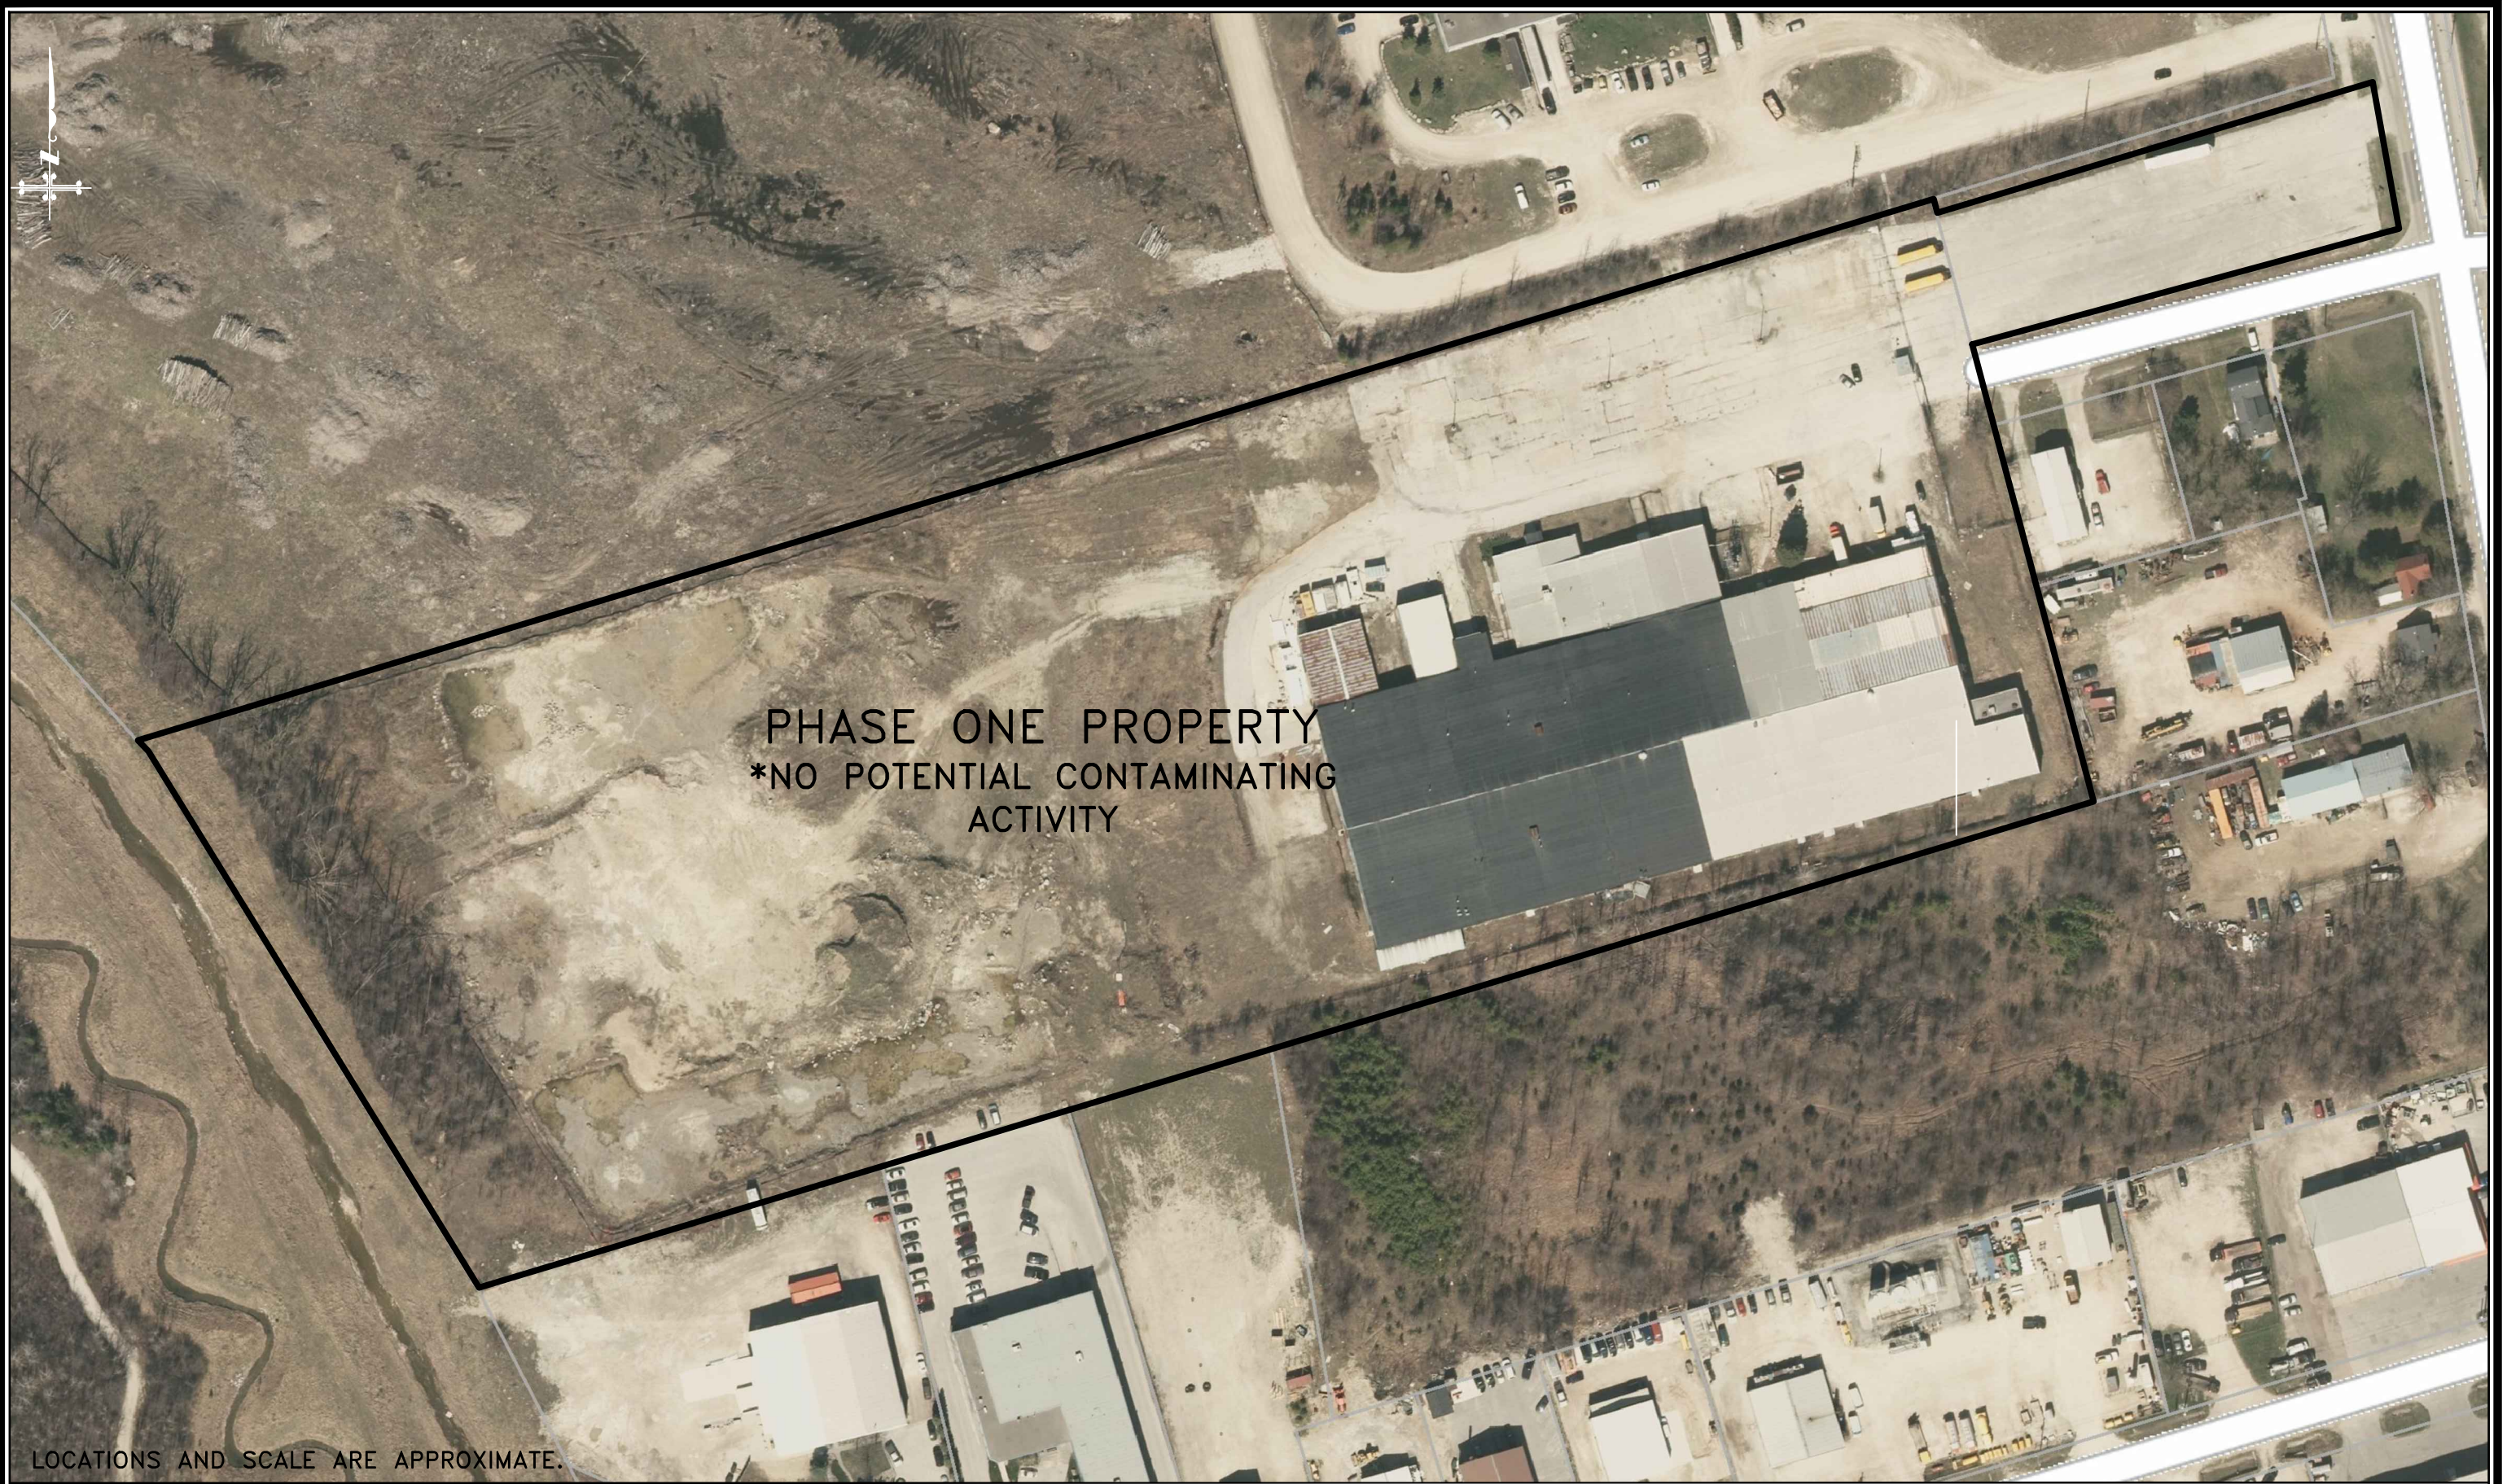
SITE PLAN: EXISTING CONDITIONS

PHASE ONE PROPERTY  
\*NO POTENTIAL CONTAMINATING  
ACTIVITY

LOCATIONS AND SCALE ARE APPROXIMATE.

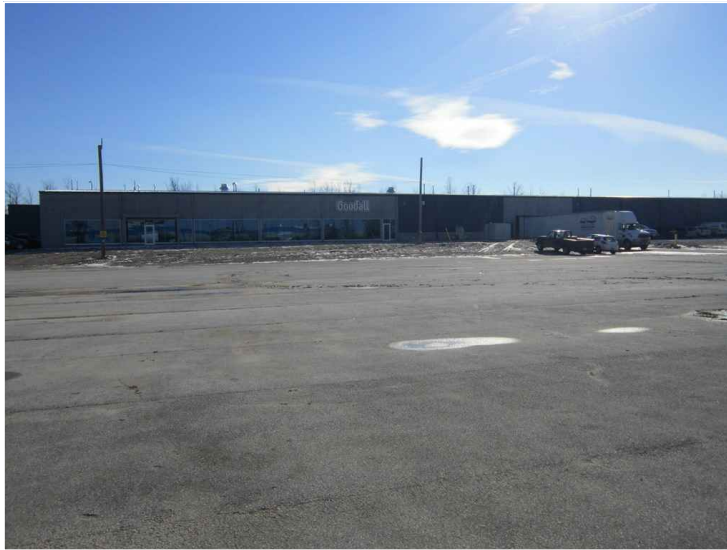
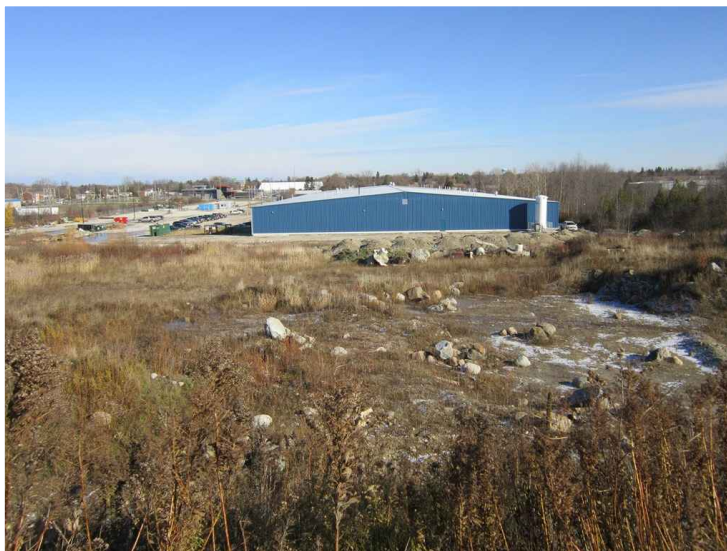
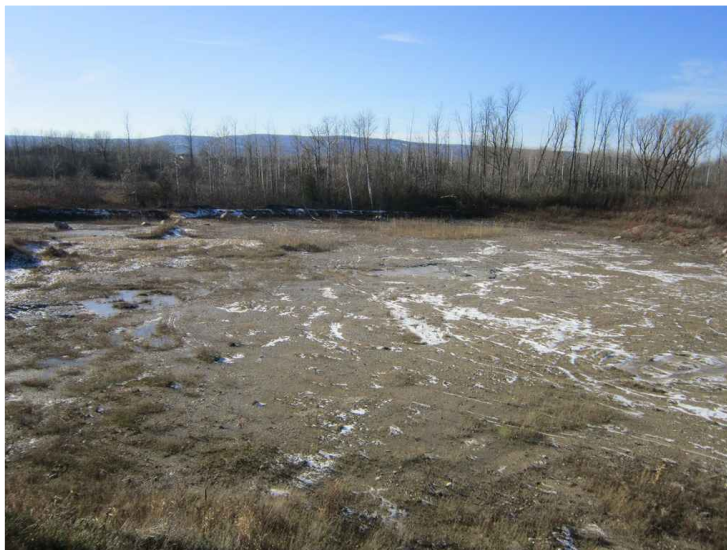
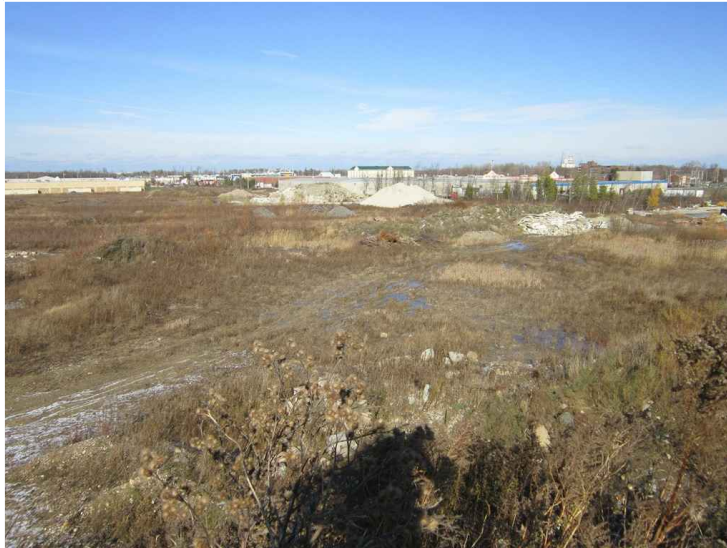
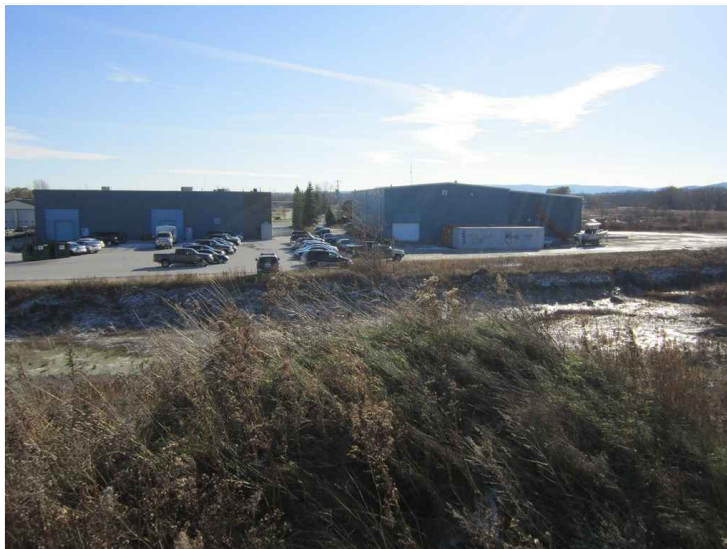
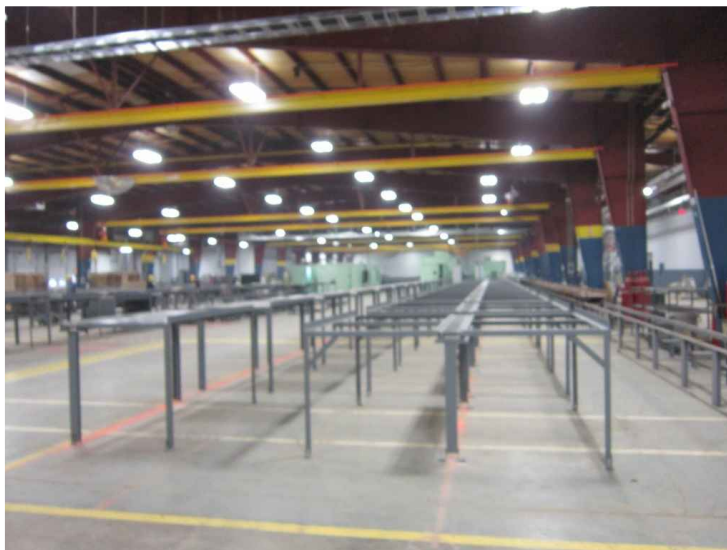
# SITE PHOTOGRAPHS

The site reconnaissance inspection included a walking tour of the Phase One property, as well as compiling written and photographic records. The layout of the Phase One property at the time of the site inspection is presented in the Site Plan - Existing Conditions (Figure 2). Photographs of the site and accompanying descriptions are presented in Appendix C.

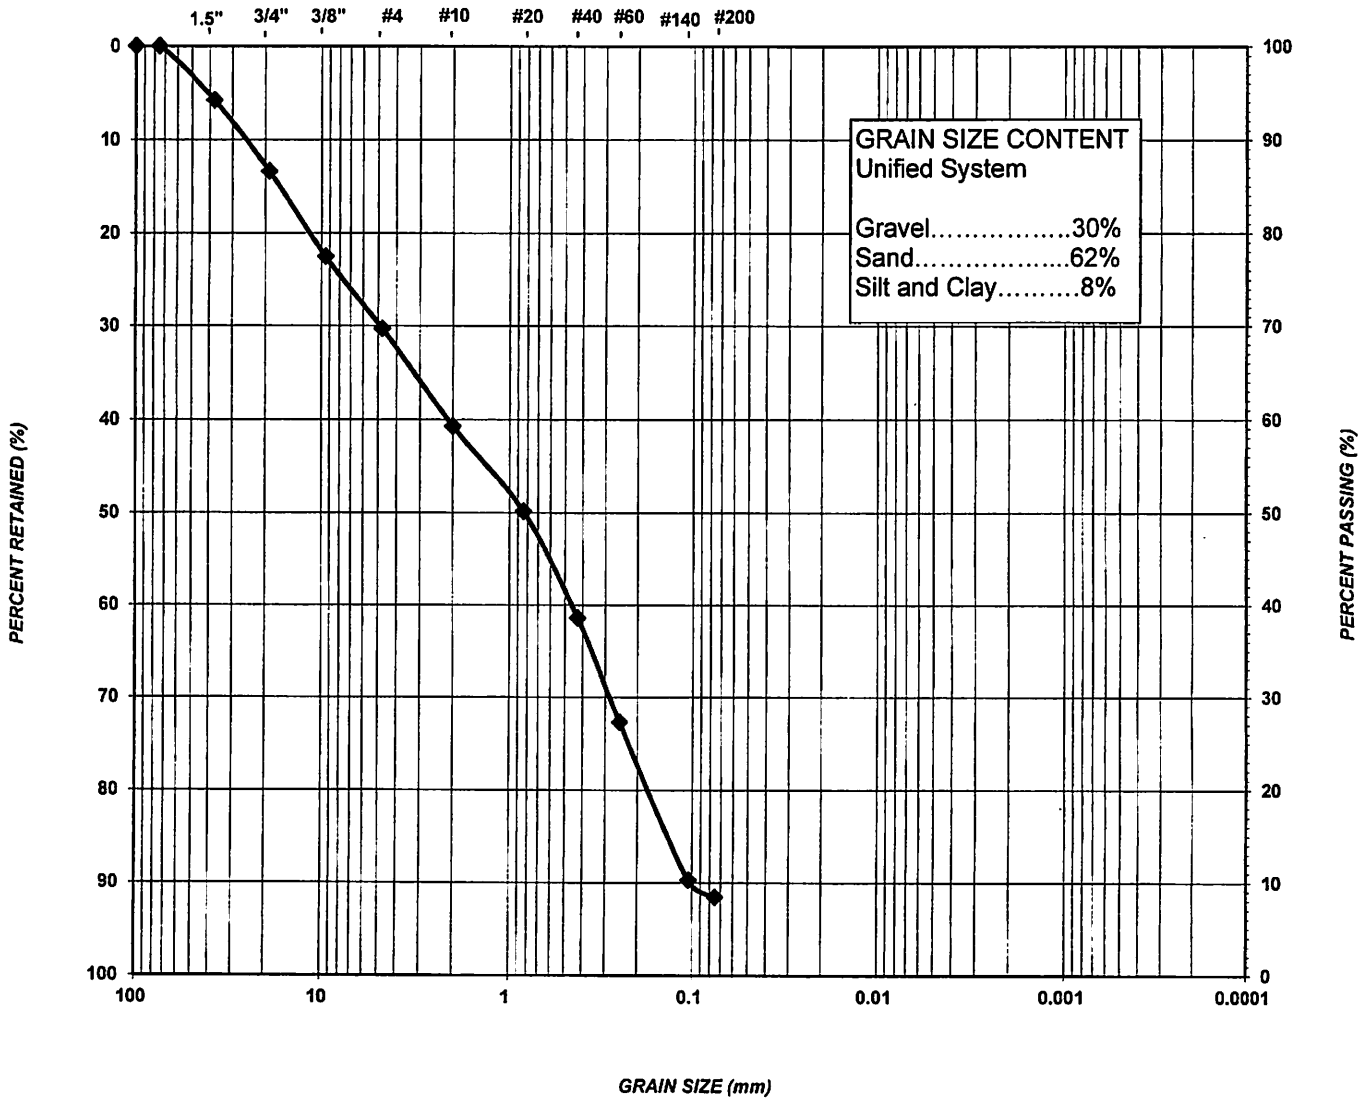
### GRAIN SIZE DISTRIBUTION

MIT SYSTEM	GRAVEL		COARSE	MEDIUM	FINE	SILT	CLAY
			SAND				
UNIFIED SYSTEM	COARSE	FINE	COARSE	MEDIUM	FINE	SILT AND CLAY	
	GRAVEL		SAND

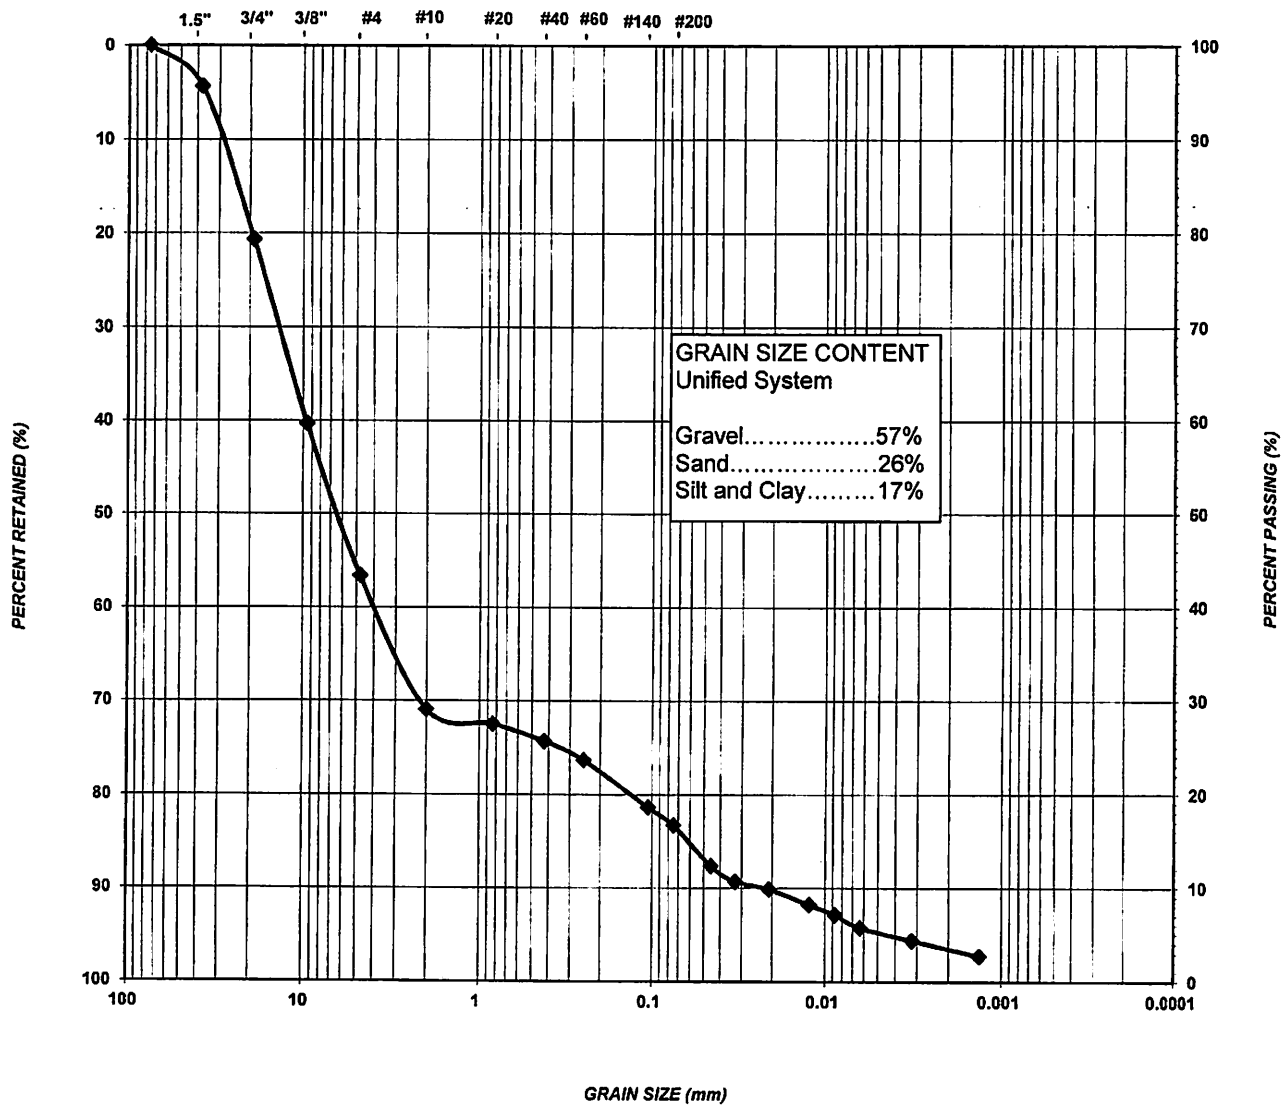
#### GRAIN SIZE DISTRIBUTION

MIT SYSTEM	GRAVEL			COARSE	MEDIUM	FINE	SILT	CLAY
	SAND							
UNIFIED SYSTEM	COARSE	FINE	COARSE	MEDIUM	FINE	SILT AND CLAY		
	GRAVEL		SAND

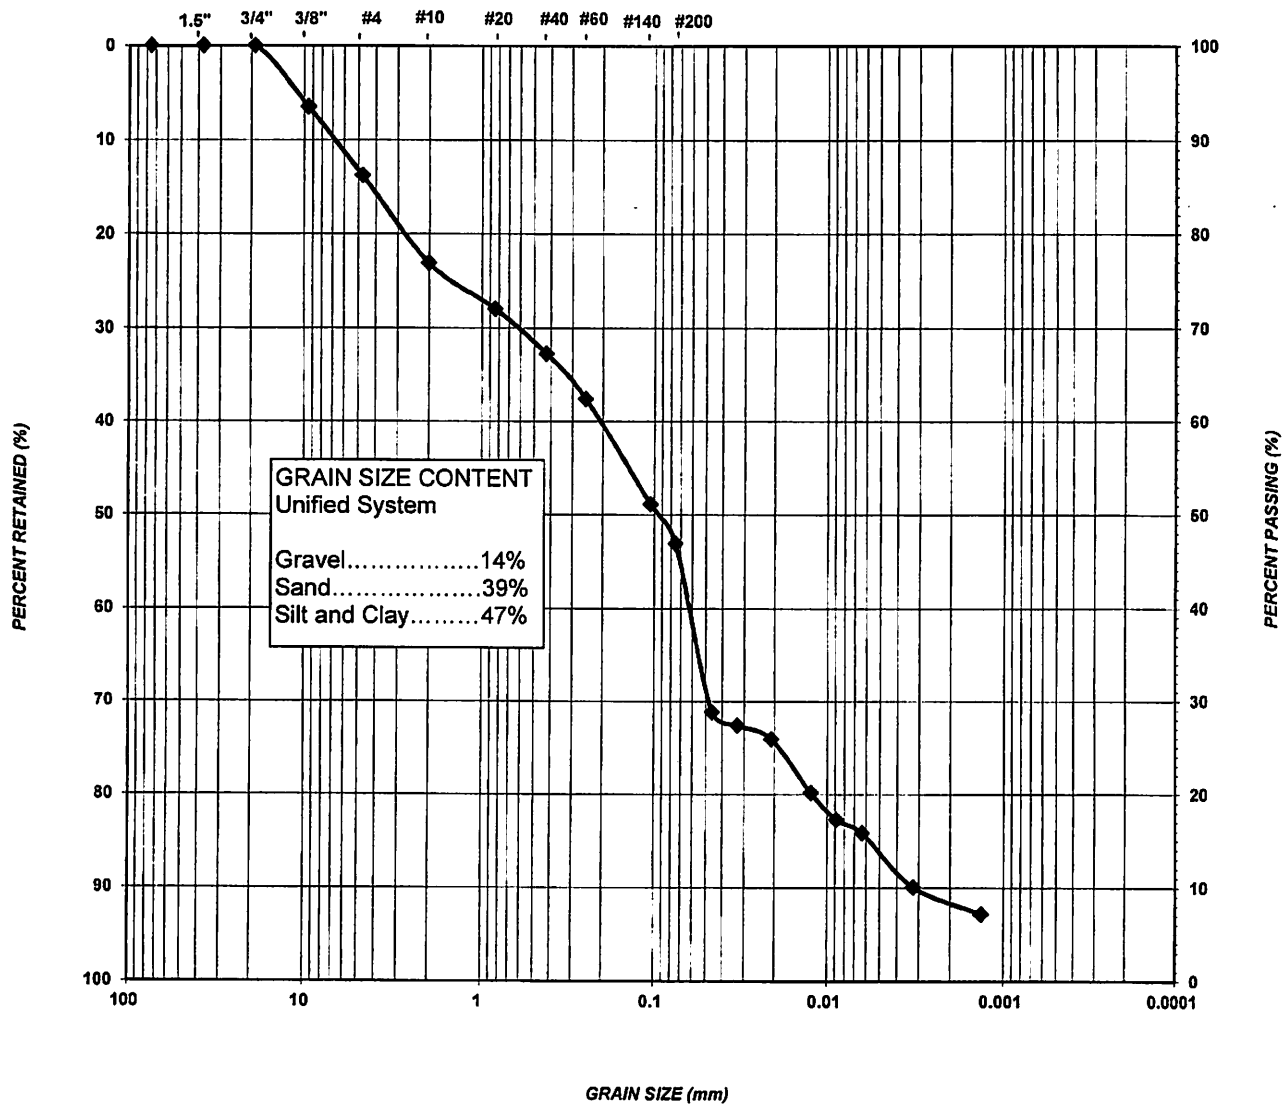
#### GRAIN SIZE DISTRIBUTION

MIT SYSTEM	GRAVEL		SAND			SILT	CLAY
	COARSE	FINE	COARSE	MEDIUM	FINE		
UNIFIED SYSTEM	GRAVEL		SAND			SILT AND CLAY	
	COARSE	FINE	COARSE	MEDIUM	FINE

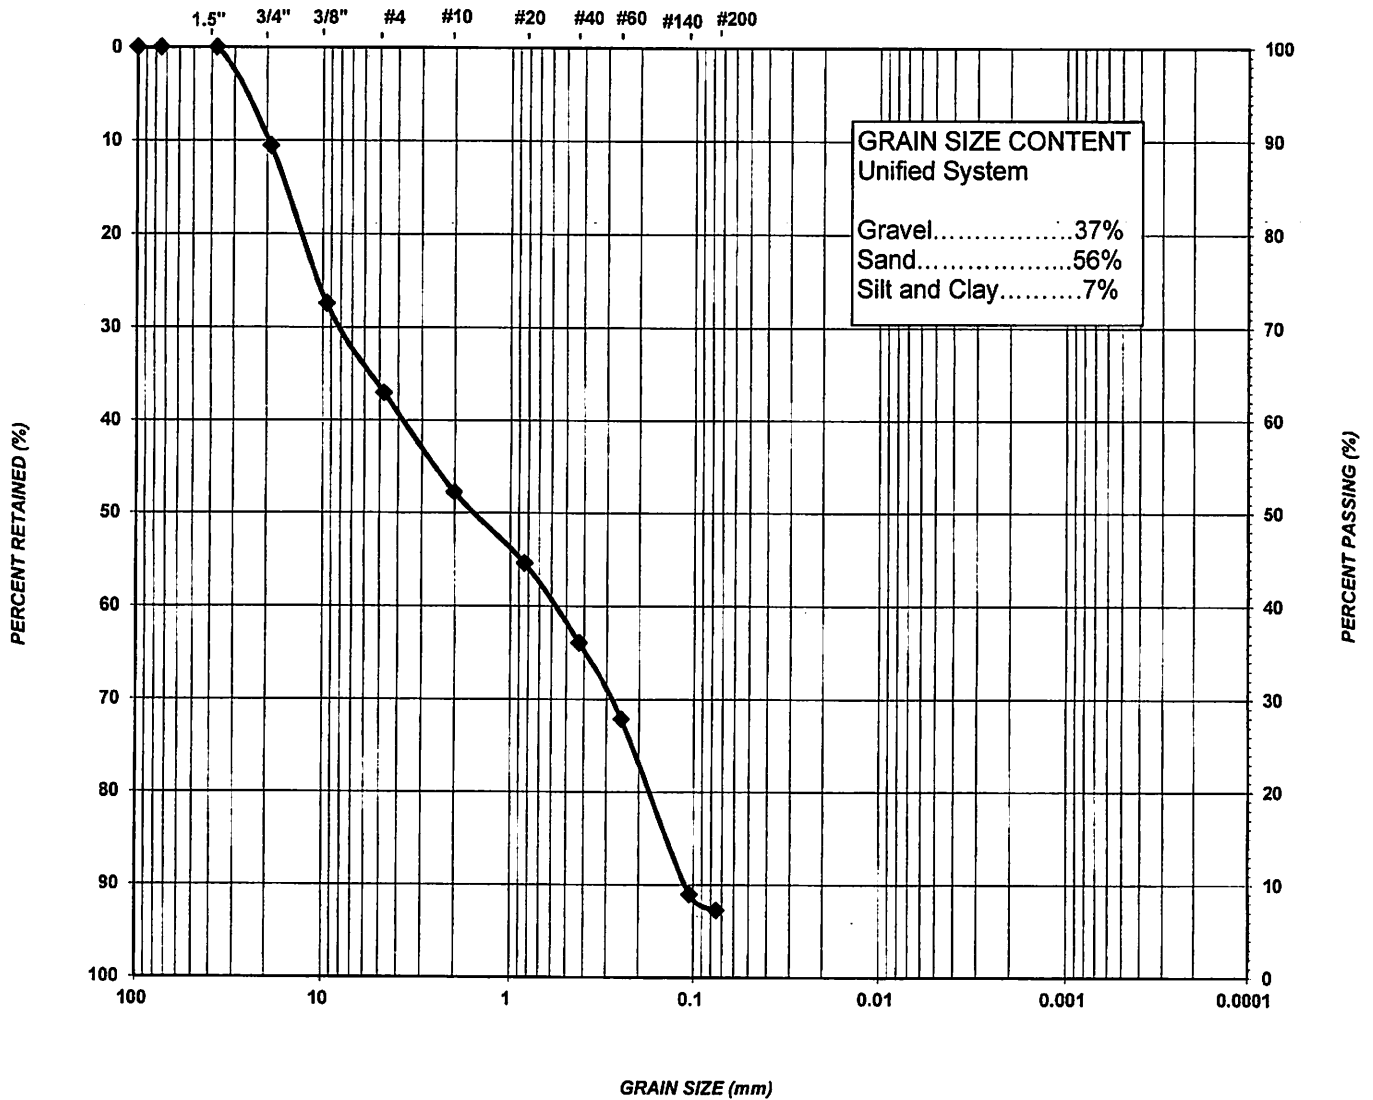
### GRAIN SIZE DISTRIBUTION

MIT SYSTEM	GRAVEL			COARSE	MEDIUM	FINE	SILT	CLAY
	SAND							
UNIFIED SYSTEM	COARSE	FINE	COARSE	MEDIUM	FINE	SILT AND CLAY		
	GRAVEL		SAND

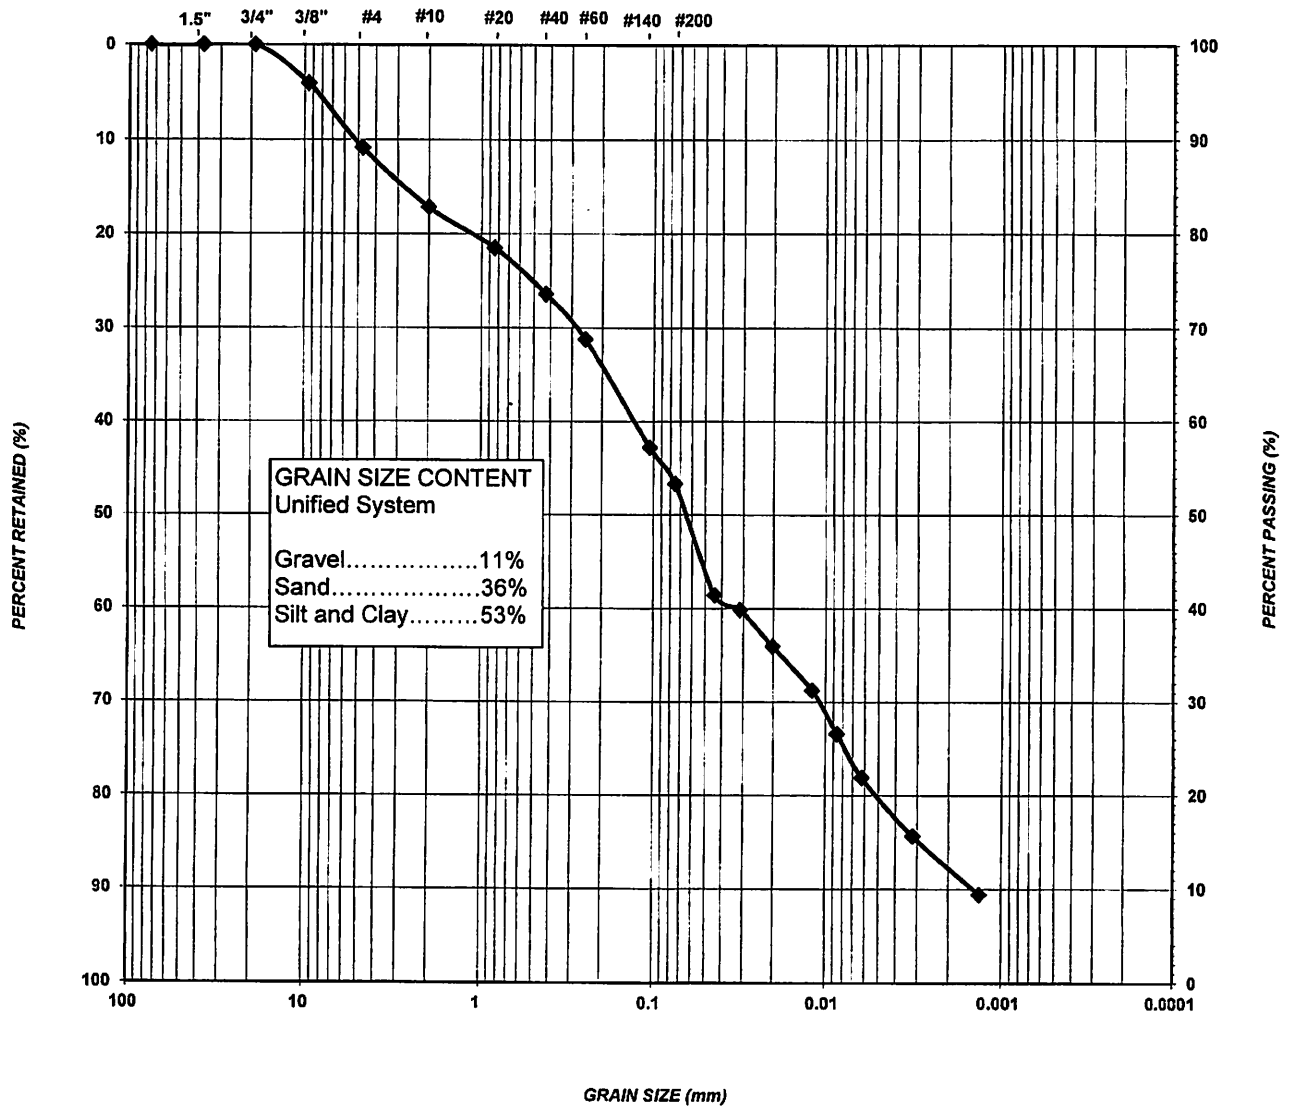
#### GRAIN SIZE DISTRIBUTION

MIT SYSTEM	GRAVEL			COARSE	MEDIUM	FINE	SILT	CLAY
	SAND							
UNIFIED SYSTEM	COARSE	FINE	COARSE	MEDIUM	FINE	SILT AND CLAY		
	GRAVEL		SAND

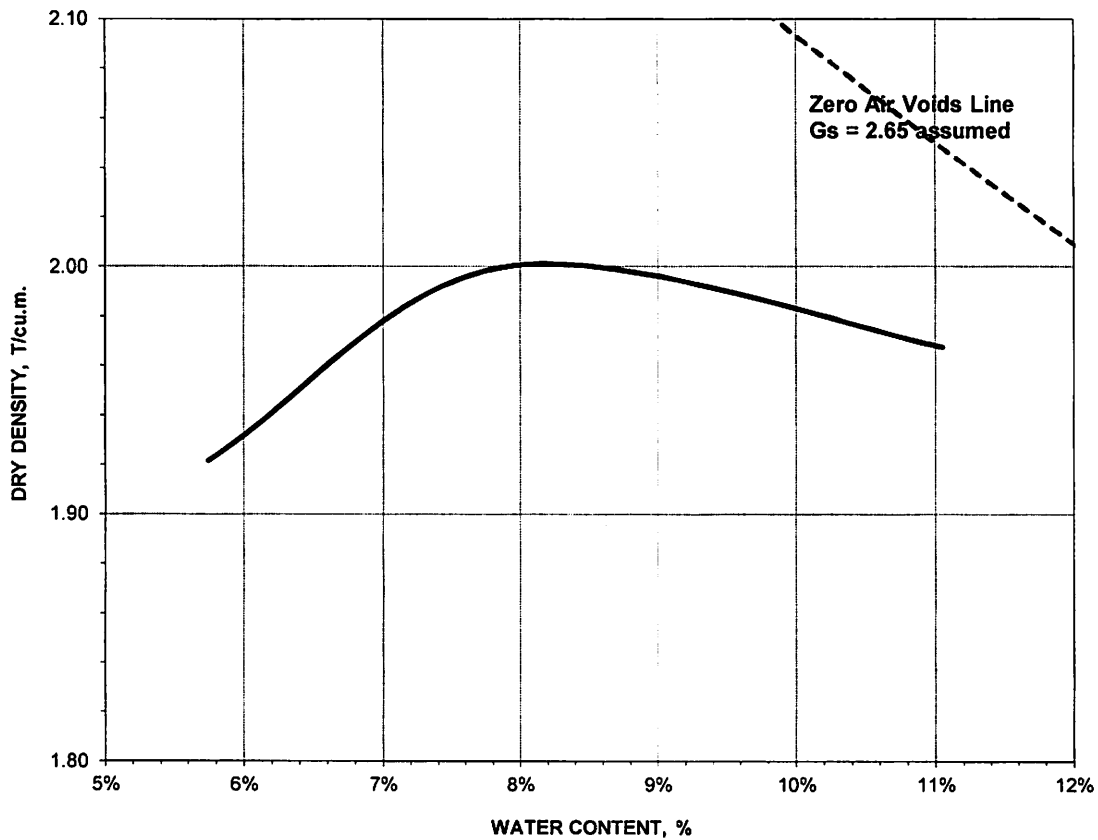
### STANDARD PROCTOR COMPACTION

Base proctor value corrected for gravel content greater than 26.5mm = 2.030 t/m<sup>3</sup>

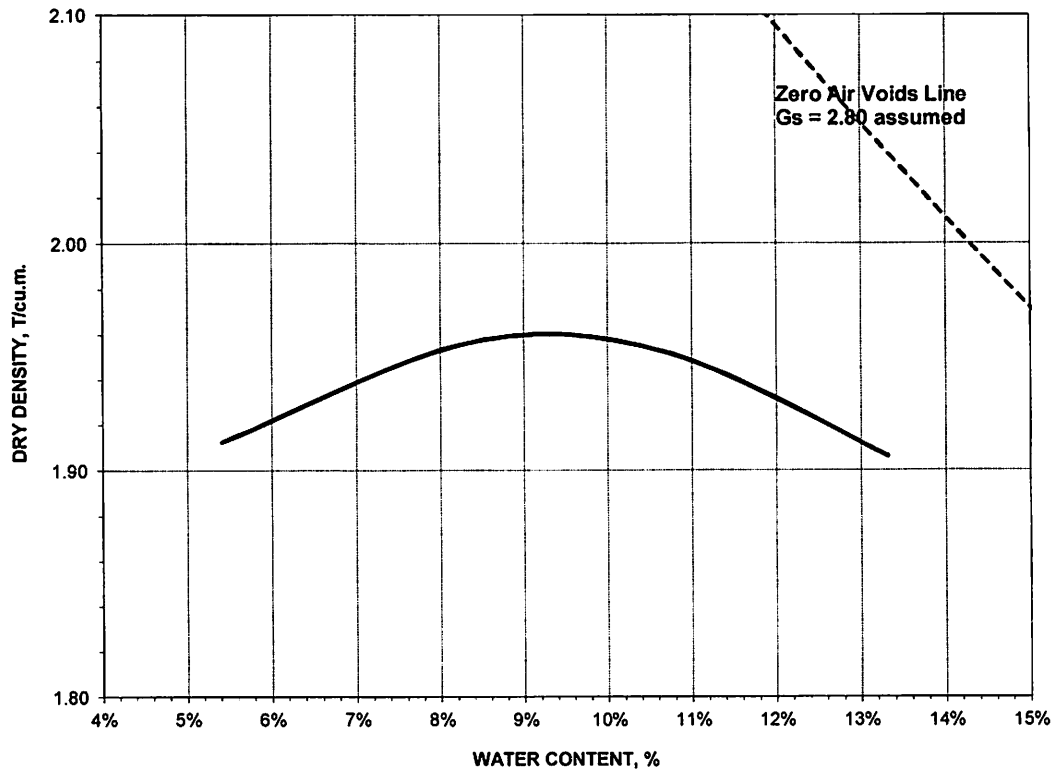
### STANDARD PROCTOR COMPACTION

Base proctor value corrected for gravel content greater than 26.5mm = 2.010 t/m<sup>3</sup>
