October 2, 2014

*Updated January 7, 2021*

**RE: LINKSVIEW DEVELOPMENT / BLUE MOUNTAIN GOLF & COUNTRY CLUB**

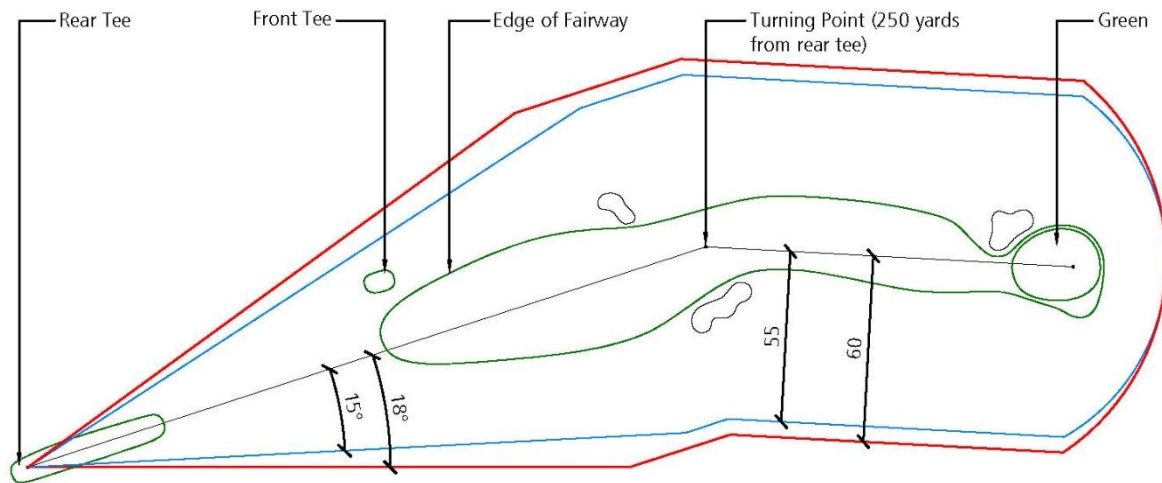
The zone of safety is the area surrounding a golf hole in which 92% of all golf shots can be expected to come to rest. That means that 8% of errant shots can still fall outside the zone of safety, the majority of which will come to rest slowly. It can be expected that 60% of all errant shots will be on the right side of the hole, since the majority of golfers are right handed and their errant shots are more likely to travel to the right, also referred to as a slice. The majority of these errant shots which fall beyond the zone of safety are moving slowly, having already bounced within the zone of safety or having been deflected by trees or shrubs. It must be remembered, however, that there is no absolute guarantee of safety with respect to golf balls leaving the property. It can be expected that, from time to time, golf balls may be intentionally struck to leave the property.

Actual dimensions of this envelope can vary depending on the following factors:
