Collingwood Terminals Foundation Pile Assessment

1 Heritage Drive
Collingwood, Ontario

Project: TE-35355-20
August 2020

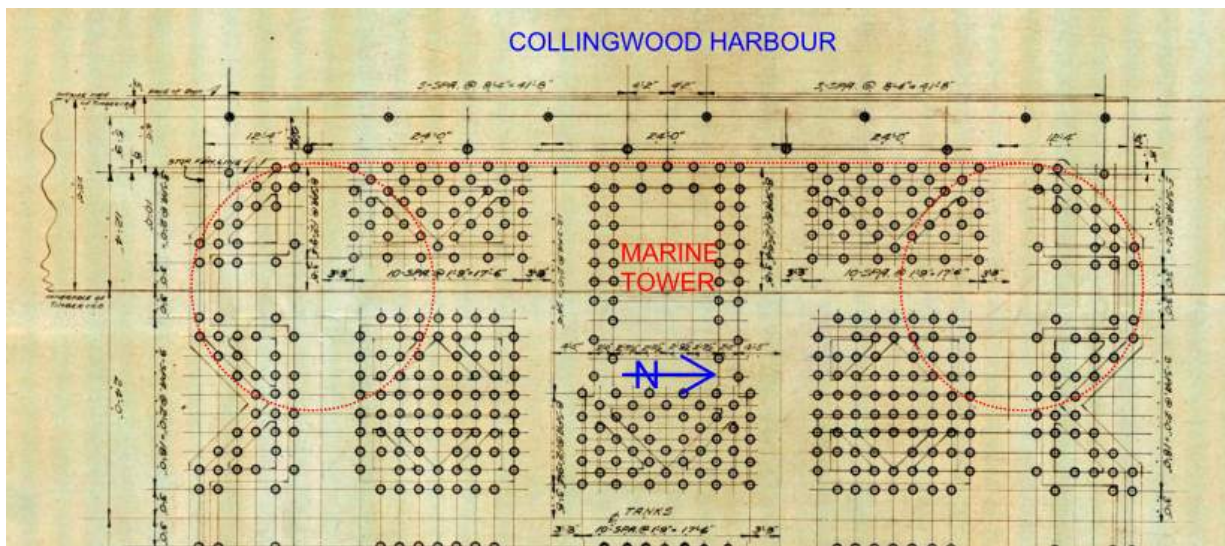
As per the June 1928 Piling Plan (excerpt below), prepared by C.D. Howe Consulting Engineers, the pile layout at the western end of the terminal (silos and marine tower) is characterized by tightly spaced piles below the primary structures and a more loosely spacing below the west wharf. All of the piles at the western end of the terminal are enclosed within a heavy timber crib system which is approximately 20' wide (8' below the wharf and 12' below the terminal) and extends the full length of the terminal (and beyond).

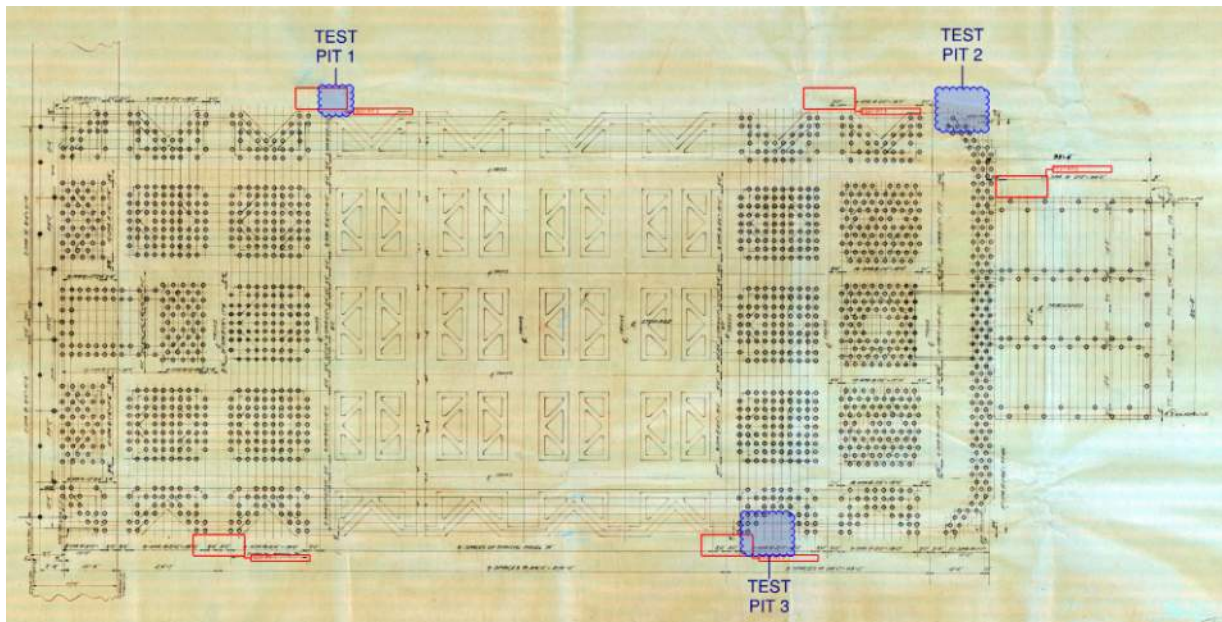
The perimeter excavation investigation indicated that the piles were installed consistent with the C.D. Howe Consulting Engineers’ 1928 Piling Plan (copy below). Further the excavation confirmed a generally uniform base slab with a thickness of 14-18” and a projection from the perimeter wall of approximately 16”. The slab is constructed directly on the top of the wood piles.
