# **D-4 Guideline Study 295 Mountain Road February 2020**

Collingwood, Ontario

Todco Investments Inc. and Ted North  
(295 Mountain Road) Ltd.

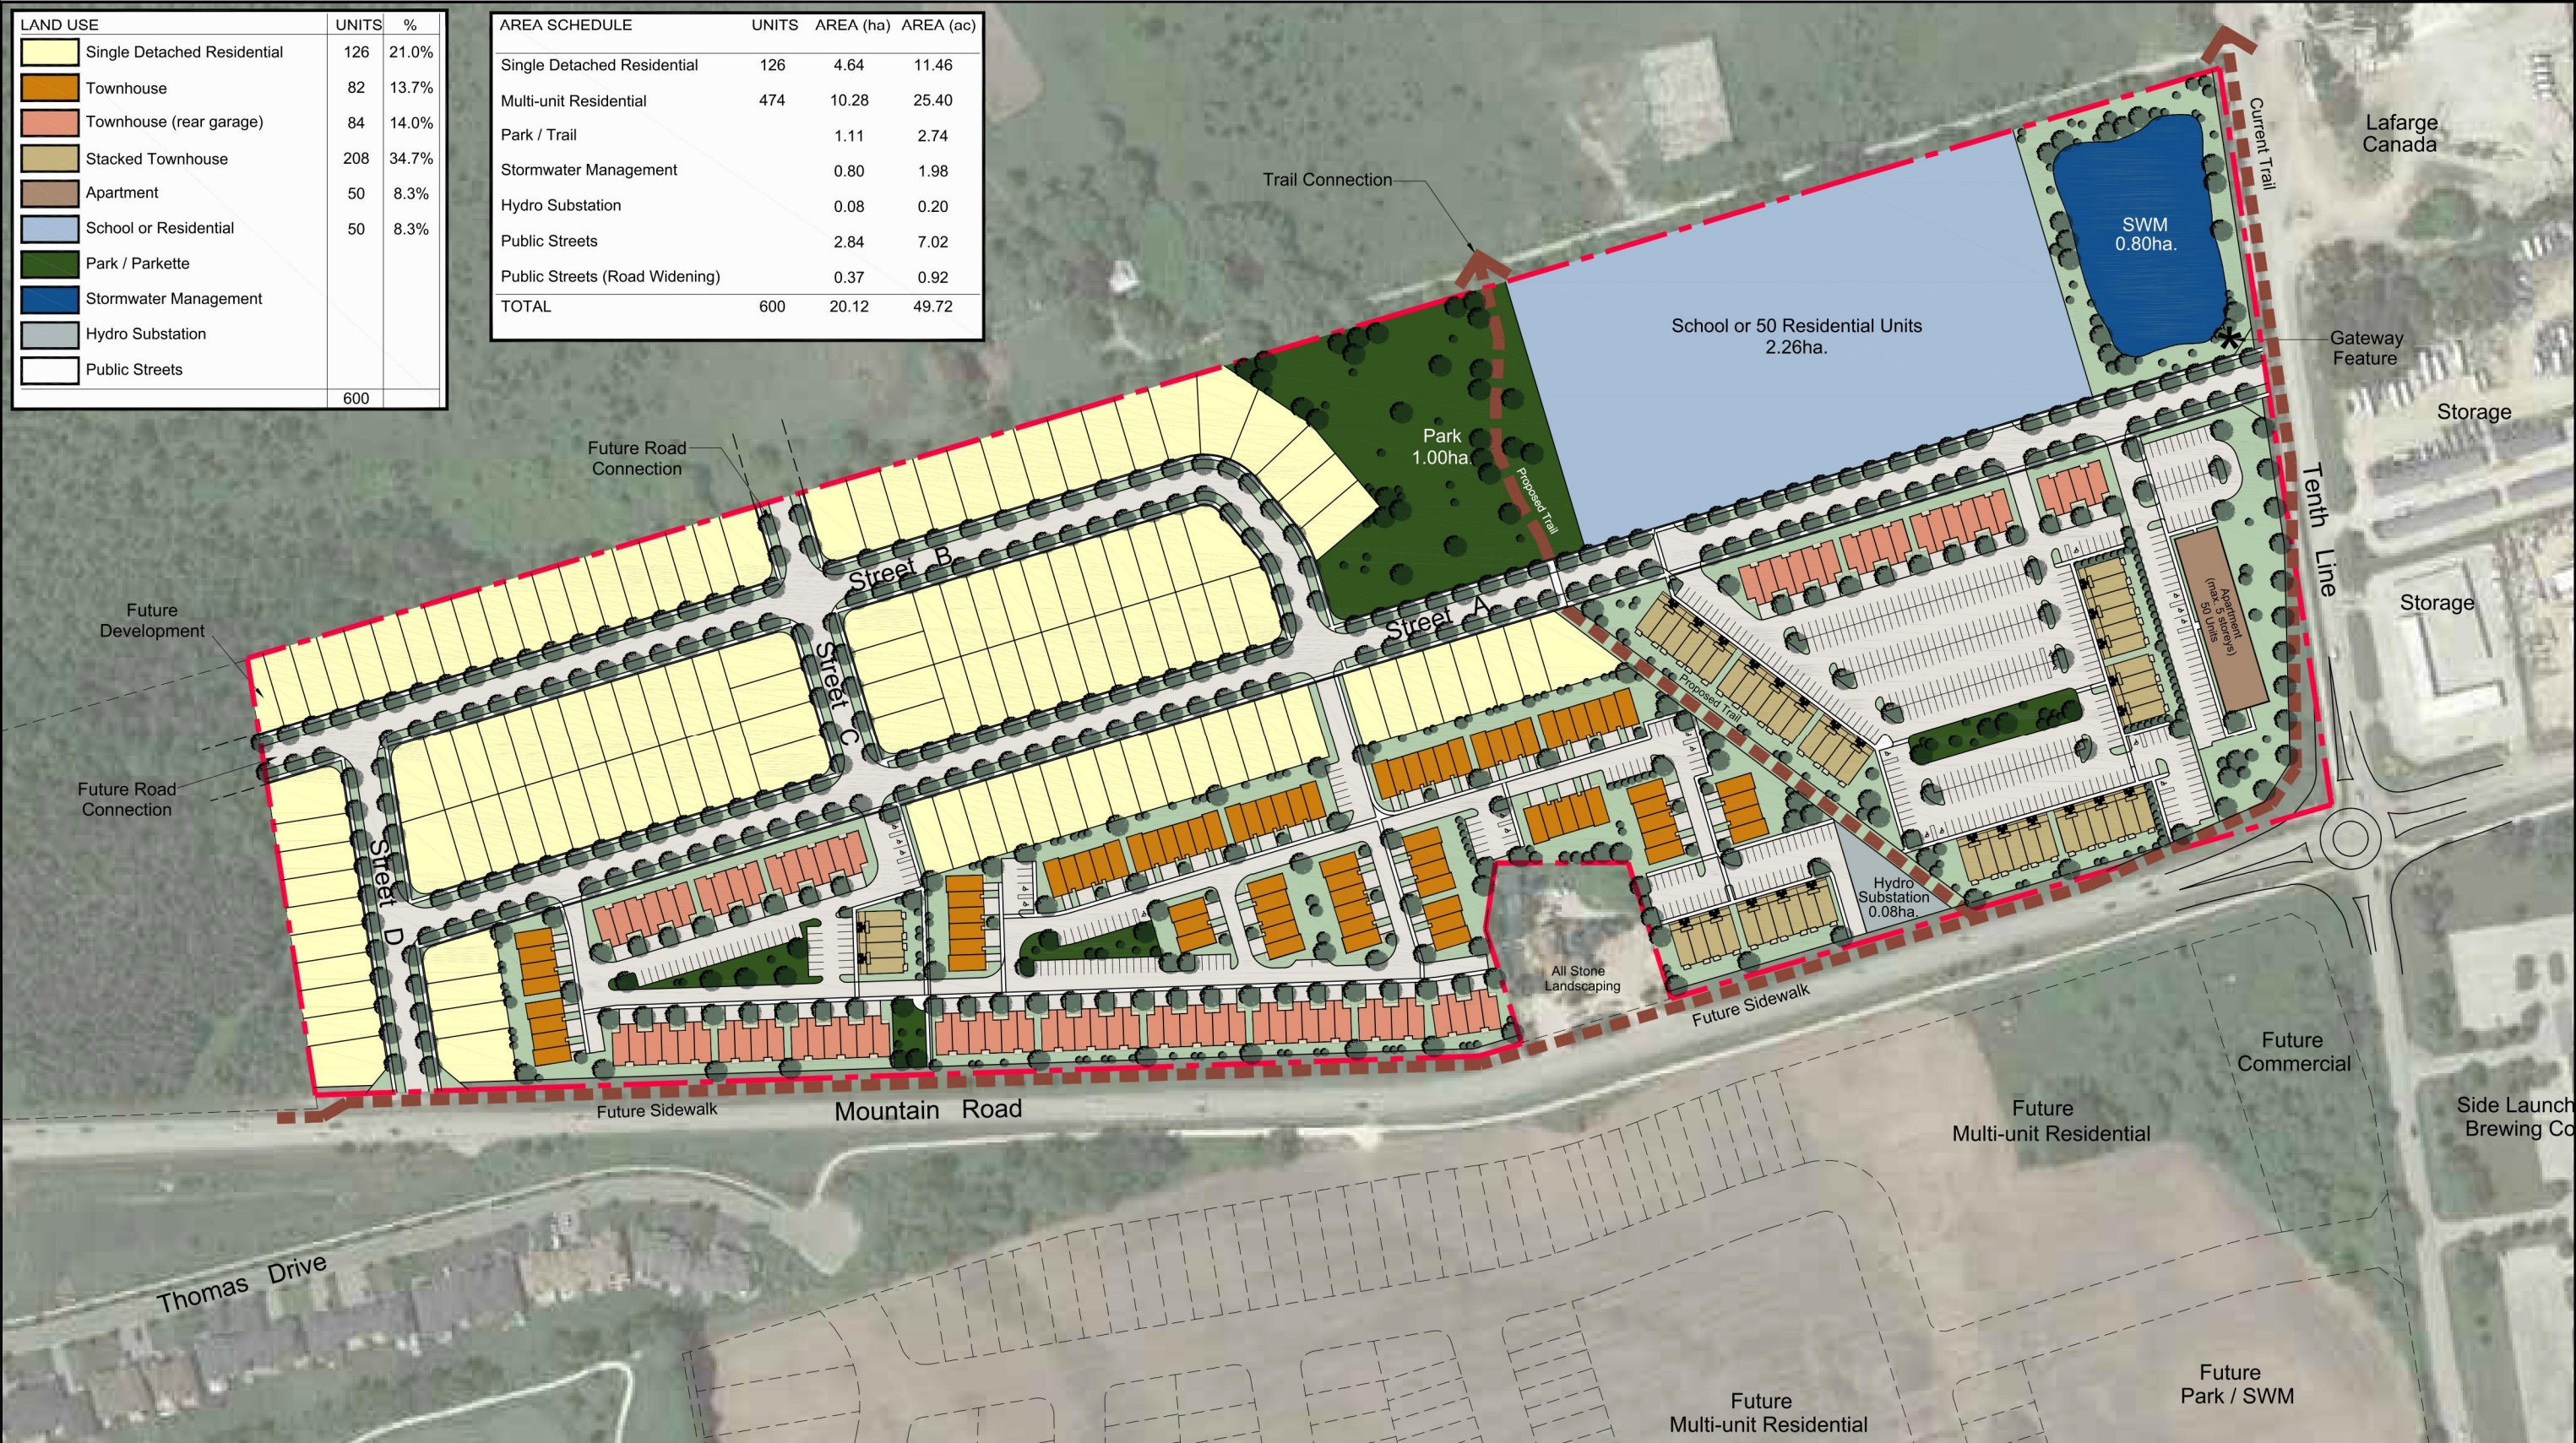
FIGURE 1.1

Source: GSP GROUP, PANORAMA NORTH, CONCEPT PLAN, TODCO INVESTMENTS INC., FEBRUARY 10, 2020.

The proposed Panorama North development prepared by GSP Group is provided in Figure 1.1. The development consists of a mixture of residential units (126 single detached, 166 townhouses, 208 stacked townhouses, 50 apartments), an elementary school (or 50 residential units), a park, stormwater management pond, and hydro substation. The Panorama North development is currently in the planning stages and as such, the information presented with regard to the proposed development may change based on comments received during the planning and development process.

The Panorama North development lands currently vary from 190.5 m AMSL on the north-east corner, 198 m AMSL on the north-west corner, and peaks at 204 m AMSL in the south-west corner. The site will be graded as part of the overall development and the actual elevations along the northern development limit will be altered, but in general terms will be similar to the elevations noted. The property along the northern portion of the development is scheduled to be either single detached homes or an elementary school as noted in Figure 1.1.
