**MAY 2, 2022**

**PROJECT NO: 593-6294**

**RE: 17 PORTLAND STREET, BLOCK 181, 51M-945, TOWN OF COLLINGWOOD  
TREE INVENTORY & ASSESSMENT, TREE PRESERVATION PLAN**

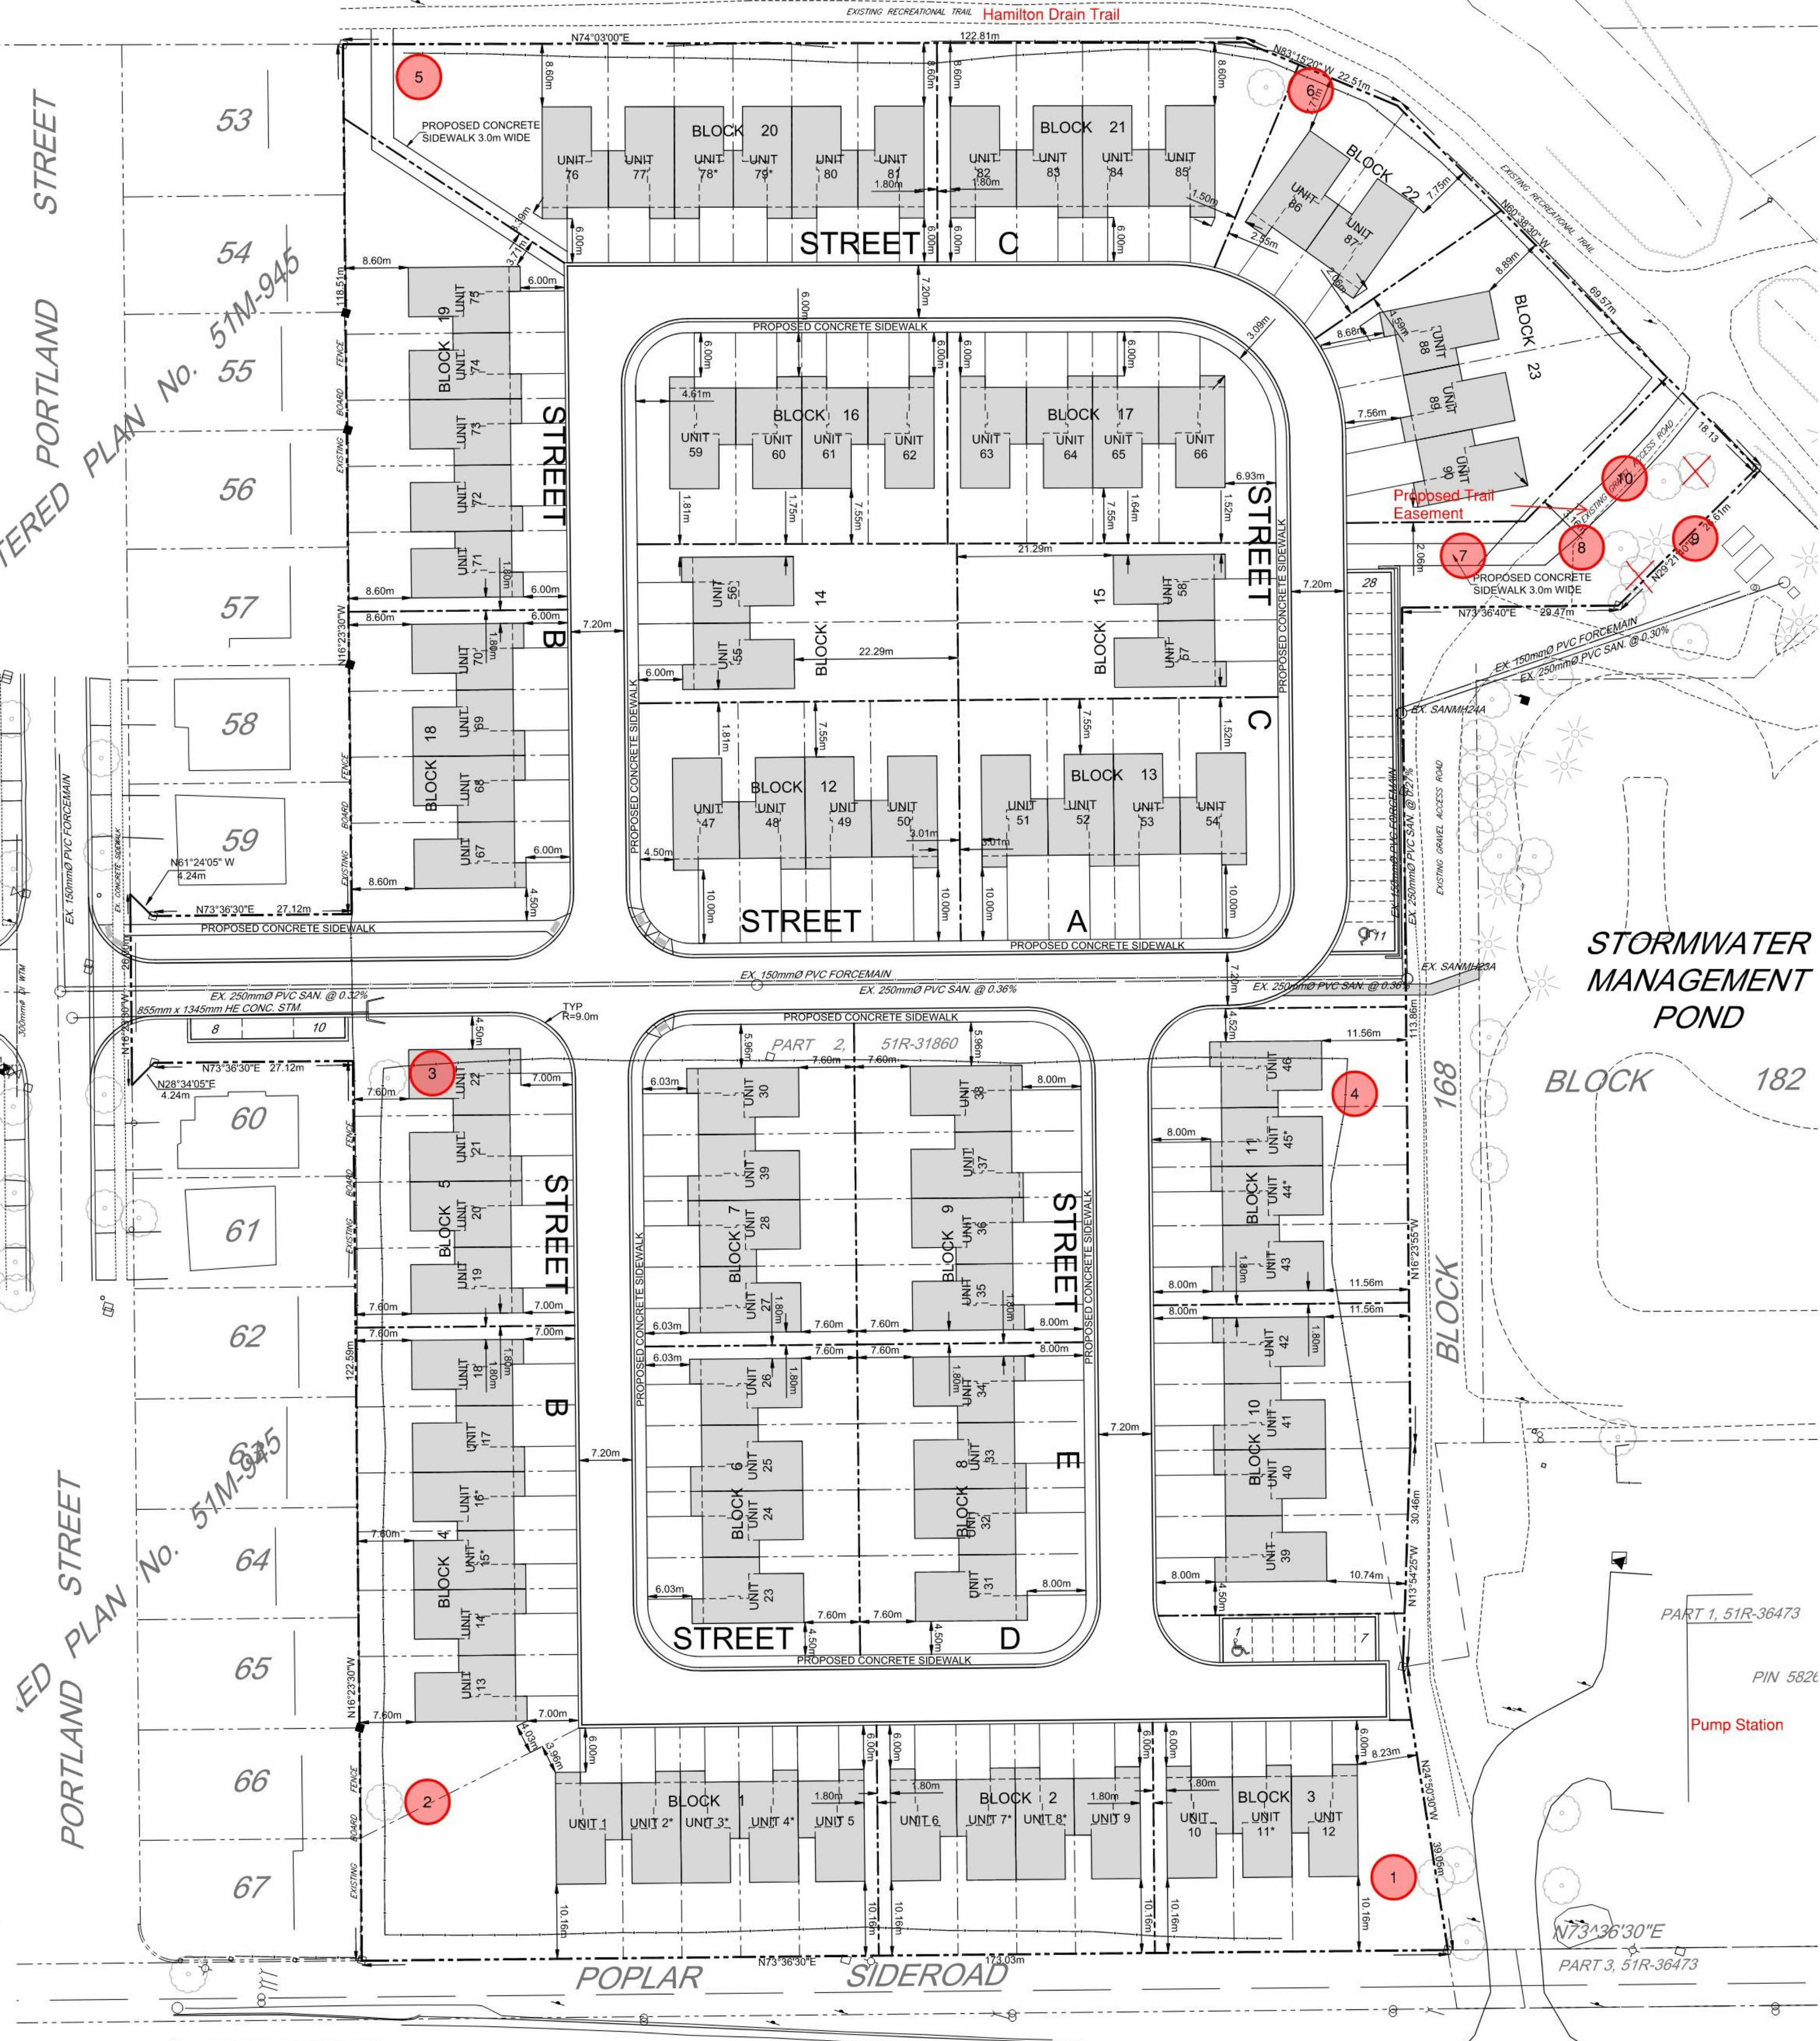
Enclosure  
Appendix A – Tree Location ID# Key Map

The property is a previously disturbed open grassy field with a large, stabilized topsoil stockpile occupying the northern half. Ten (10) trees were identified located around the property perimeter with some Staghorn Sumac thickets located along the northern property limits. Trees were assessed for species, size, and condition. The Tree Inventory & Assessment List can be found on the following page. Tree ID numbers are shown on Appendix A.

Tree number 1 is a 7cm diameter at breast height (DBH) Red Ash. Trees 2 to 7 are Manitoba Maples with a DBH ranging from 5 cm to 20 cm. Trees 8 to 10 are in the proposed trail easement and consist of two (2) Trembling Aspens ranging from 9 cm to 11 cm DBH and one (1) White Spruce. No endangered (Butternuts), threatened or species at risk were found on the property.

Trees 1 to 7 are recommended for removal as per the comments in the tree inventory and assessment list above. Trees 8 to 10 can be retained as the pre-consultation grading plans dated Nov. 8, 2021 indicate that existing grades will be maintained on the south side of the proposed concrete sidewalk trail connection. No endangered (Butternuts), threatened or species at risk were found on the property. Trees 8 to 10 and the trees and vegetation on adjacent lands will

not be adversely affected as they are located outside of the grading limits of the proposed development.
