1
TI-1
TREE INVENTORY, PROTECTION, AND REMOVALS PLAN
SCALE: 1:500

151 PEEL STREET
COLLINGWOOD, ONTARIO

FILE NAME	TREE INVENTORY, PROTECTION, AND REMOVALS	DWG NO.	TI-1
------------------	--	----------------	------

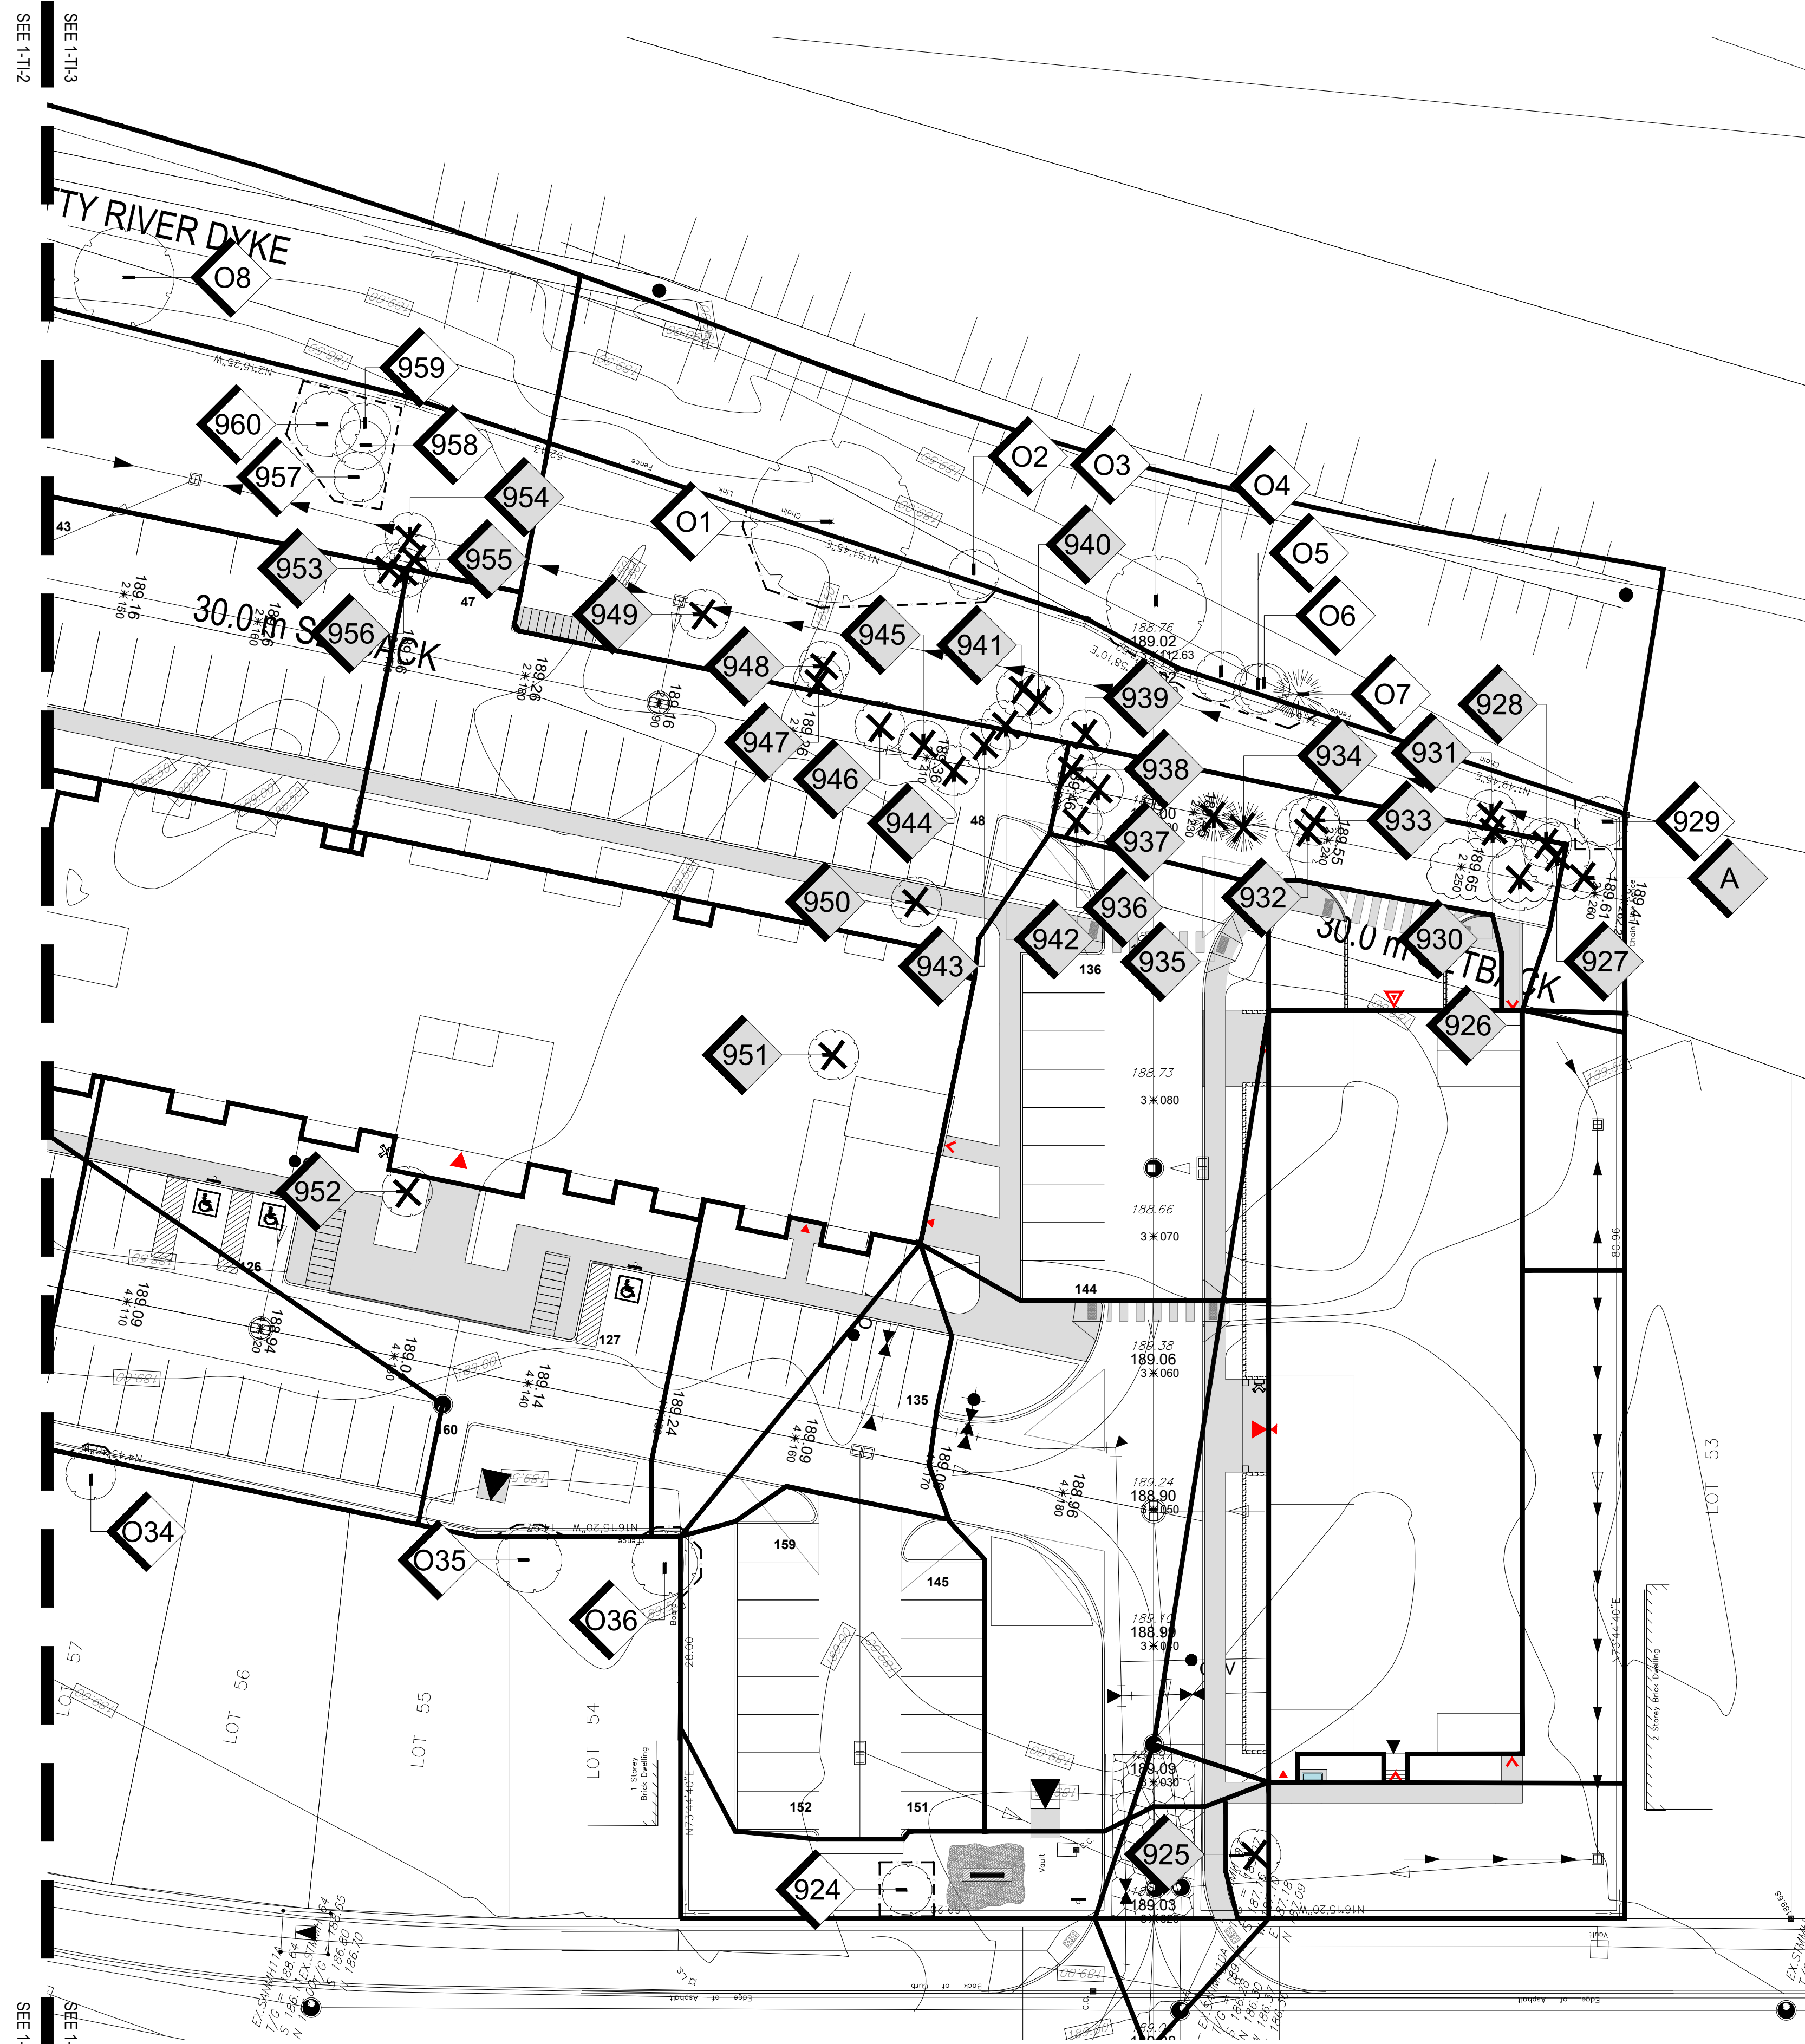
1 TREE INVENTORY, PROTECTION, AND REMOVALS PLAN
SCALE: 1:300

Tree #	Common Name	Botanical Name	DBH (CM)	Condition	Comments	Recommendation
904	Black Willow	Salix nigra	15	F	Multi-stem	Retain
905	Black Locust	Robinia pseudoacacia	23	F	Vines growing throughout	Remove due to construction
906	Birch Sp.	Betula Sp.	38	F	Growing within Cedar Hedge grouping	Remove due to construction
927	Birch Sp.	Betula Sp.	32	F	Mild lean away from development site	Remove due to construction
928	Birch Sp.	Betula Sp.	19	F	Mild lean away from development site, 2 stem at base	Remove due to construction
929	Poplar Sp.	Populus Sp.	27	F	Moderate lean away from development site	Retain
930	Poplar Sp.	Populus Sp.	24	F	Mild lean away from development site	Remove due to construction
931	Poplar Sp.	Populus Sp.	23	F	Mild to moderate lean away from development site	Remove due to construction
932	Trembling Aspen	Populus tremuloides	32	FFP	2 stem at base, smaller stem with wound at base showing rot column throughout trunk	Remove due to construction

933	Trembling Aspen	Populus tremuloides	25	F		Remove due to construction
934	Cedar Sp.	Thuja Sp.	20	FFP	Bow at base, vertical wound at base showing potential rot column in trunk	Remove due to construction
935	Cedar Sp.	Thuja Sp.	26	F	4 stem at 0.3 metres, minor deadwood throughout	Remove due to construction
936	Black Willow	Salix nigra	22	F	Mild lean	Remove due to construction
937	Trembling Aspen	Populus tremuloides	21	F		Remove due to construction
938	Black Locust	Robinia pseudoacacia	20	F		Remove due to construction
939	Birch Sp.	Betula Sp.	24	F	Mild lean away from development site	Remove due to construction
940	Birch Sp.	Betula Sp.	17	F	Mild lean away from development site	Remove due to construction
941	Birch Sp.	Betula Sp.	20	F	Mild lean away from development site	Remove due to construction
942	Black Willow	Salix nigra	17	F	Moderate lean away from development site, mild bow at base	Remove due to construction

943	American Elm	Ulmus americana	15	F	Moderate to significant lean away from development site	Remove due to construction
944	Trembling Aspen	Populus tremuloides	18	F	Mild lean towards development site	Remove due to construction
945	Trembling Aspen	Populus tremuloides	15	F	Mild lean towards development site	Remove due to construction
946	Trembling Aspen	Populus tremuloides	19	F		Remove due to construction
947	American Elm	Ulmus americana	18	F	Mild lean away from development site	Remove due to construction
948	Birch Sp.	Betula Sp.	17	F	Mild lean away from development site	Remove due to construction
949	Birch Sp.	Betula Sp.	17	F	Multi-stem	Remove due to construction
950	Black Locust	Robinia pseudoacacia	16	F		Remove due to construction
951	Black Locust	Robinia pseudoacacia	16	F		Remove due to construction
952	Black Locust	Robinia pseudoacacia	19	F		Remove due to construction
953	Trembling Aspen	Populus tremuloides	24	F		Remove due to construction

954	Trembling Aspen	Populus tremuloides	18	F		Remove due to construction
955	Trembling Aspen	Populus tremuloides	15	F		Remove due to construction
956	Trembling Aspen	Populus tremuloides	15	F		Remove due to construction
957	Poplar Sp.	Populus Sp.	18	F		Retain
958	American Elm	Ulmus americana	29	FFP	Suckers at base, internal rot suspected, minor deadwood throughout	Retain
959	American Elm	Ulmus americana	25	F	2 stem at base	Retain
960	American Elm	Ulmus americana	31	FFP	Suckers at base, 3 stem at 0.5 metres, 2 stems with vertical splits throughout trunk	Retain
961	Red Pine	Pinus resinosa	17	F		Remove due to construction
962	Black Locust	Robinia pseudoacacia	16	F	Bow at base, multi-stem	Retain
963	Black Willow	Salix nigra	20	F		Remove due to construction
964	Black Locust	Robinia pseudoacacia	31	F	Vertical split at main union	Remove due to construction
965	Black Locust	Robinia pseudoacacia	15	F		Remove due to construction

966	Manitoba Maple	Acer negundo	25	F	Moderate lean, bows throughout	Remove due to construction
967	American Elm	Ulmus americana	22	F	Bow in trunk	Remove due to construction
968	American Elm	Ulmus americana	34	F		Remove due to construction
969	Black Locust	Robinia pseudoacacia	23	F		Remove due to construction
970	Manitoba Maple	Acer negundo	44	PD	Internal rot evident at main union, multiple previous limb failures evident, water shoots throughout, large cavity at main union	Remove due to construction
971	Black Locust	Robinia pseudoacacia	29	F		Retain
972	Ash Sp.	Fraxinus Sp.	28	F		Retain
973	Black Locust	Robinia pseudoacacia	19	F	Mild lean towards development site	Retain
974	Manitoba Maple	Acer negundo	21	FFP	Significant lean towards development site	Retain
975	Norway Maple	Acer platanoides	36	F	2 stem at base	Retain
976	American Elm	Ulmus americana	40	F	2 stem at base	Retain
977	Black Locust	Robinia pseudoacacia	42	F		Retain

978	Manitoba Maple	Acer negundo	29	P	Main limb previously failed in upper canopy	Retain
979	Black Locust	Robinia pseudoacacia	29	F		Remove due to construction
980	Black Willow	Salix nigra	16	F		Retain
981	Black Locust	Robinia pseudoacacia	42	F		Retain
982	Black Locust	Robinia pseudoacacia	35	F	2 stem at 0.8 metres	Remove due to construction
983	Black Willow	Salix nigra	25	F	Multi-stem	Retain
984	Common Hickberry	Ostrya occidentalis	15	F		Retain
985	Common Hickberry	Ostrya occidentalis	15	F		Retain
986	Black Locust	Robinia pseudoacacia	15	F	2 stem at base	Remove due to construction
987	Black Locust	Robinia pseudoacacia	15	F	Multi-stem	Remove due to construction
988	Black Locust	Robinia pseudoacacia	12	FFP	Exposed root flare	Remove due to construction
989	Black Locust	Robinia pseudoacacia	13	F	Wound at base	Remove due to construction
990	Black Locust	Robinia pseudoacacia	13	F		Remove due to construction

O1	Black Willow	Salix nigra	-110	F	Multi-stem at 1.7 metres	Retain
O2	American Elm	Ulmus americana	-30	F		Retain
O3	Black Willow	Salix nigra	-58	F		Retain
O4	Birch Sp.	Betula Sp.	-15	F	Mild lean towards development site	Retain
O5	American Elm	Ulmus americana	14	F		Retain
O6	American Elm	Ulmus americana	14	F		Retain
O7	Scots Pine	Pinus sylvestris	-18	FFP	Sparse canopy	Retain
O8	Black Willow	Salix nigra	-56	F	Mild lean towards development site, canopy overhangs into development site	Retain
O9	Black Willow	Salix nigra	-82	F	Canopy overhangs into development site	Retain
O10	Black Willow	Salix nigra	-98	F	Canopy overhangs into development site	Retain
O11	Manitoba Maple	Acer negundo	-30	P	Multiple previous limb failures, significant lean into development site, tree is structural hazard	Retain
O12	Manitoba Maple	Acer negundo	22	FFP	Significant lean into development site, tree is parallel to ground	Retain
O13	Manitoba Maple	Acer negundo	-25	FFP	Significant lean into development site	Retain

O14	Manitoba Maple	Acer negundo	-24	FFP	Significant lean into development site, 2 stem at 0.2 metres, not suspected at stem union	Retain
O15	Black Willow	Salix nigra	-77	F		Retain
O16	Manitoba Maple	Acer negundo	-18	F		Retain
O17	Black Locust	Robinia pseudoacacia	-46	F	2 stem at 0.1 metres	Retain
O18	Black Willow	Salix nigra	-62	F		Retain
O19	Black Locust	Robinia pseudoacacia	-58	F		Retain
O20	Black Locust	Robinia pseudoacacia	-30	F		Retain
O21	Black Locust	Robinia pseudoacacia	-49	F		Retain
O22	Manitoba Maple	Acer negundo	-28	FFP	Moderate lean	Retain
O23	Black Willow	Salix nigra	-125	F	Minor deadwood throughout, canopy overhangs into development site	Retain
O24	Manitoba Maple	Acer negundo	-27	F		Retain
O25	Black Willow	Salix nigra	-34	F	Canopy overhangs into development site	Retain
O26	Black Willow	Salix nigra	-100	F	Minor deadwood throughout, canopy overhangs into development site	Retain
O27	Black Willow	Salix nigra	-95	F	Minor deadwood throughout, canopy overhangs into development site	Retain

O28	Black Willow	Salix nigra	-59	P	Major previous limb failures throughout, moderate deadwood throughout, tree is expected to decline, canopy overhangs into development site	Retain
O29	Manitoba Maple	Acer negundo	28	F		Retain
O30	Basswood	Tilia americana	-18	FIG	Canopy overhangs into development site	Retain
O31	Colorado Blue Spruce	Picea pungens var. glauca	-10	FIG		Retain
O32	Red Maple	Acer rubrum	-14	FIG		Retain
O33	Norway Maple	Acer platanoides	-13	F		Retain
O34	Red Maple	Acer rubrum	-16	FIG		Retain
O35	Red Maple	Acer rubrum	-33	FIG	Canopy overhangs into development site	Retain
O36	Red Maple	Acer rubrum	-34	FIG	Canopy overhangs into development site	Retain
A	Cedar Sp.	Thuja Sp.	-	F/FFP	Cedar Hedge with ~20 stems at 10-20cm, minor to moderate deadwood throughout	Remove due to construction
